June 27, 2019

Musselshell River Flood Rehabilitation River Assessment Triage Team (RATT II) 2018 Summary Report

Prepared By:
Karin Boyd
Applied Geomorphology, Inc.

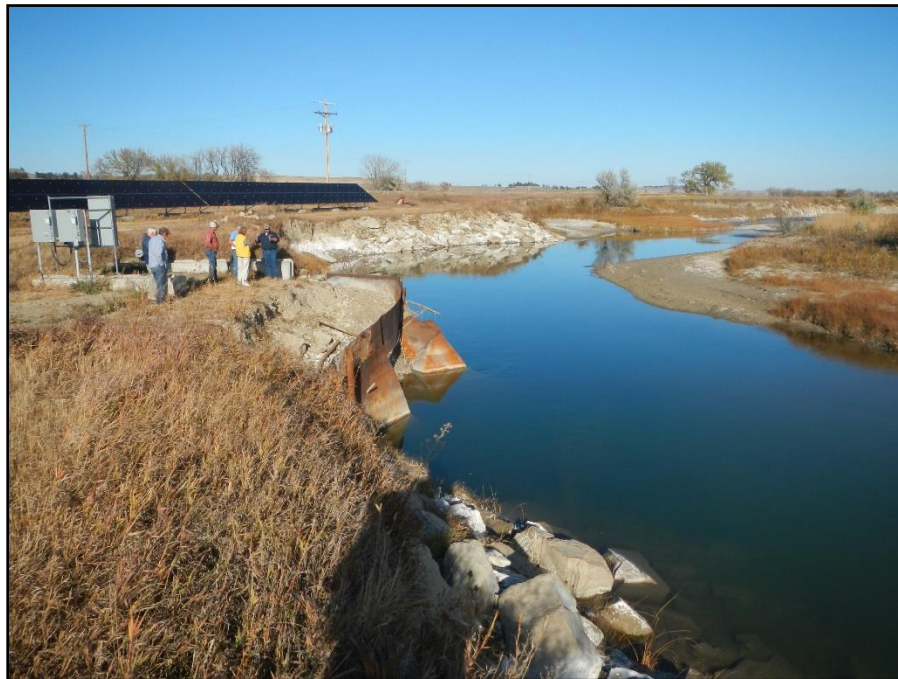
Figure 1. River Assessment Triage Team (RATT) observing a damaged pump site below Roundup.

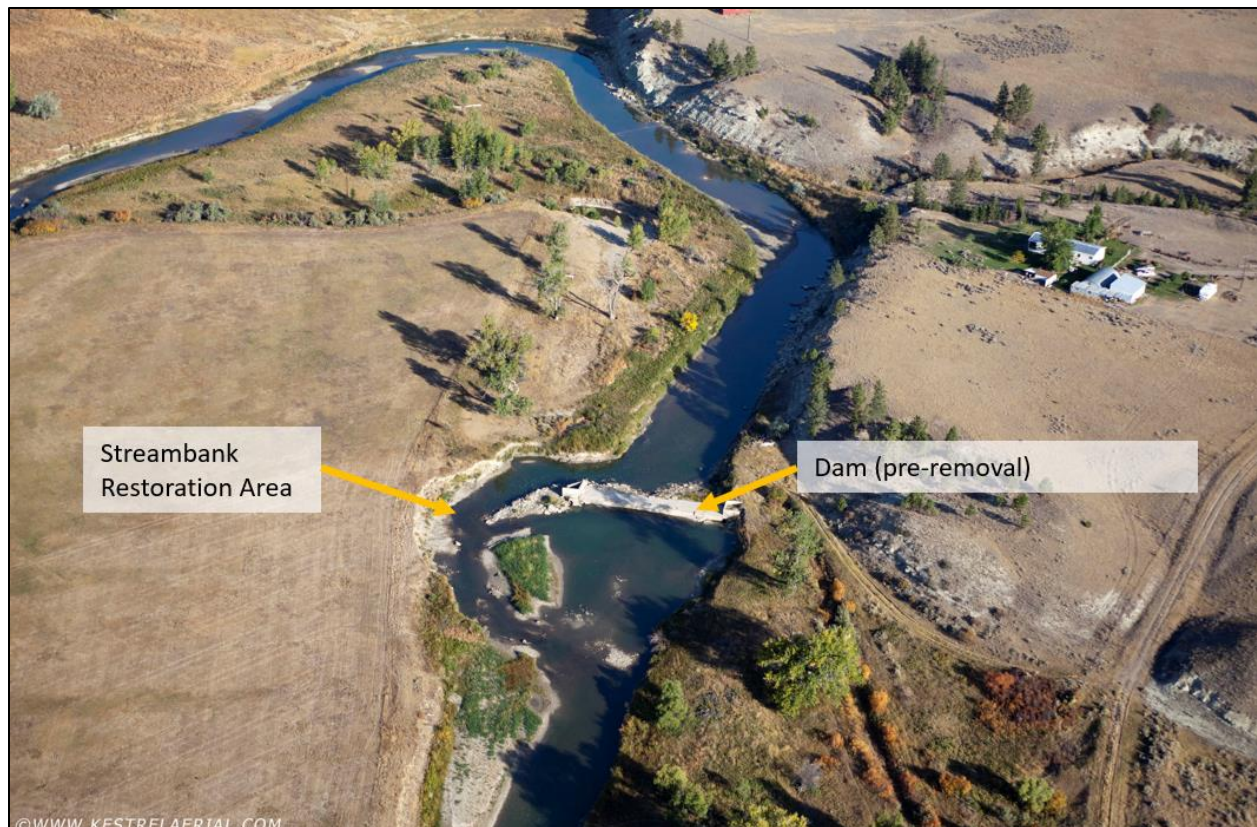
Figure 7. View upstream of Egge Dam after its flanking and prior to its removal following the 2011 flood.

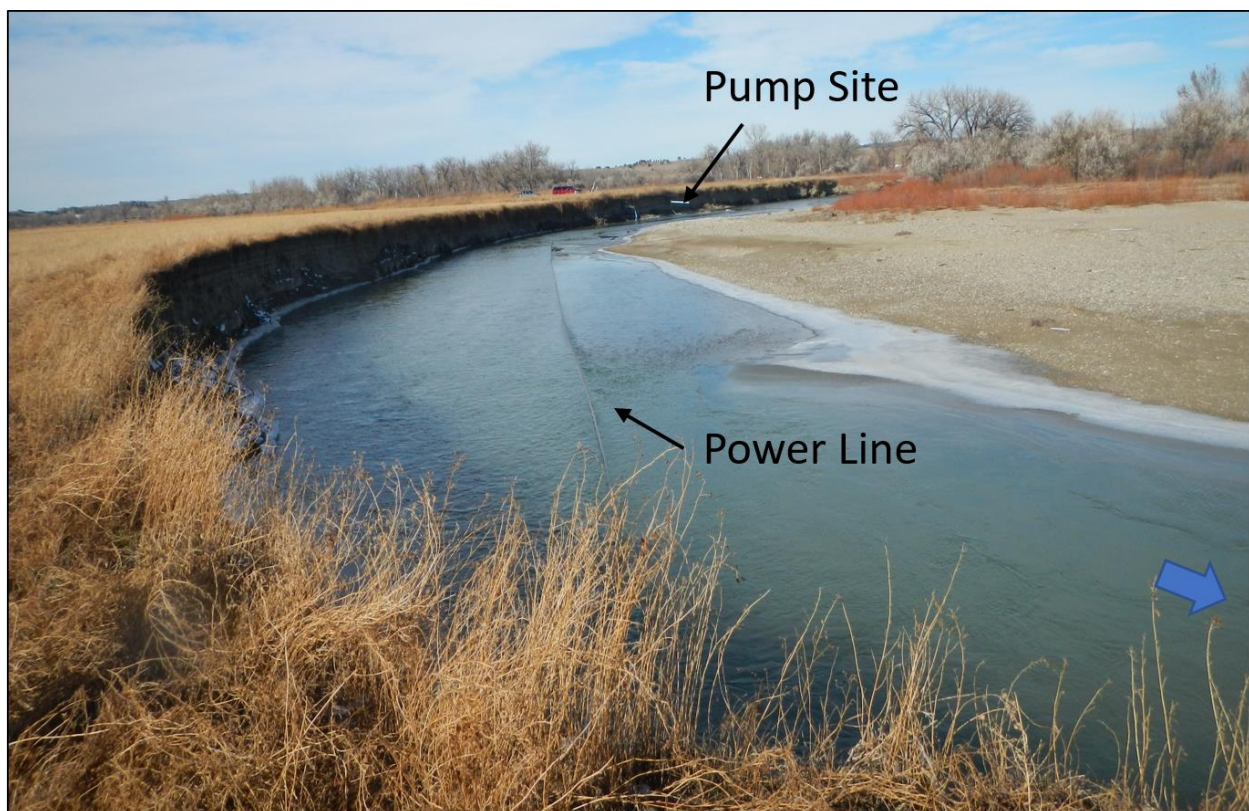
Figure 18. View upstream towards pump site showing electrical line in middle of river above Roundup.

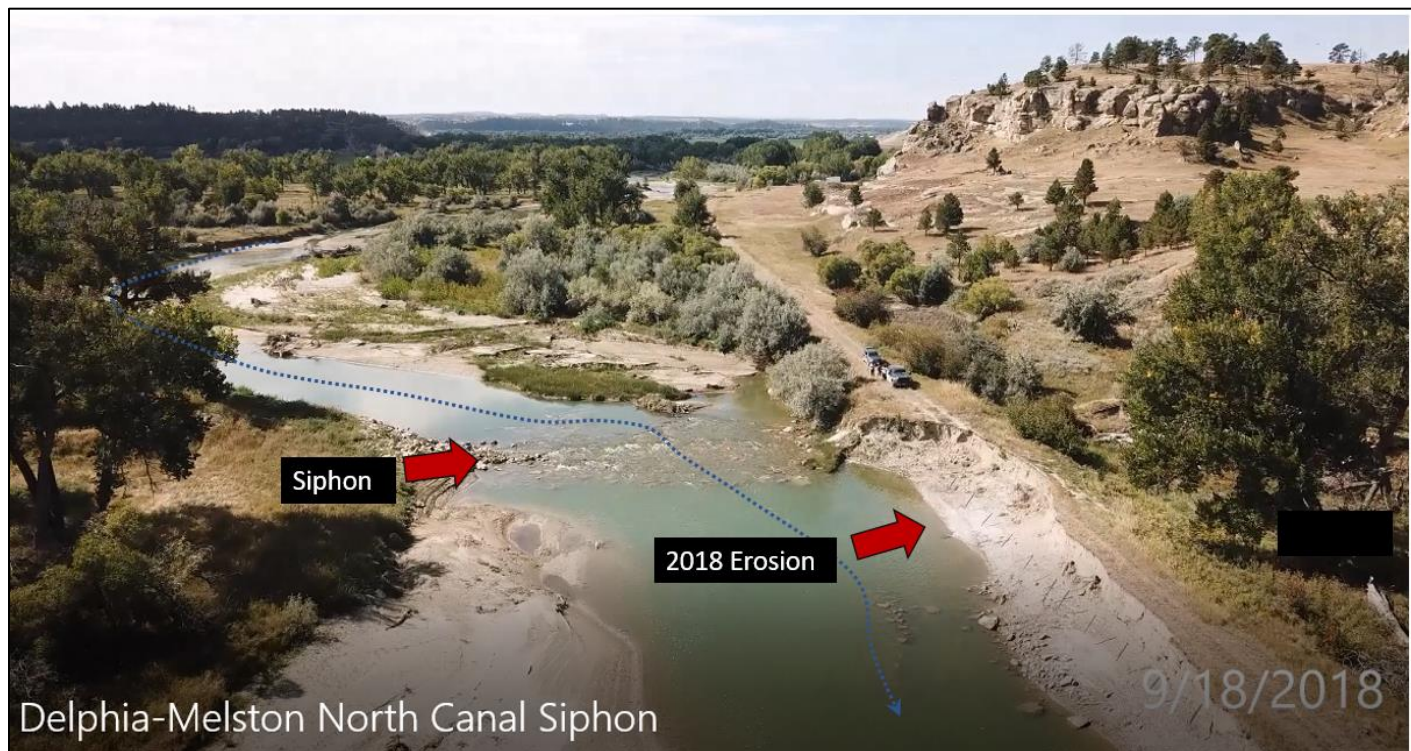
Figure 22. View upstream showing 2018 erosion just below rocky siphon crossing.

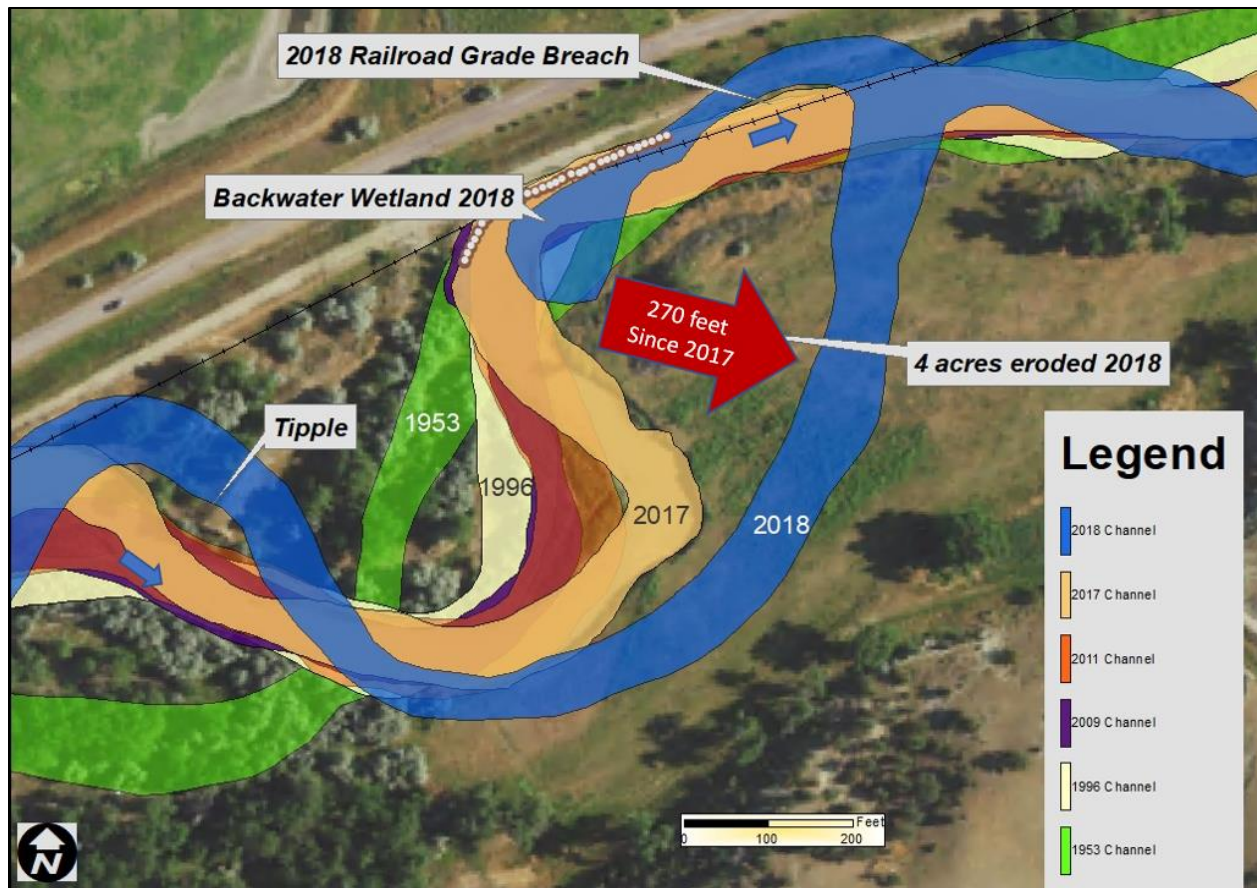
Where we had post-2018 flood air photos, we mapped banklines to determine the rates and extents of bank movement for landowners. At one site above the Number 4 Road, for example, bank movement during the 2018 event eroded about four acres of a hayfield within one river bend (Figure 23).

Figure 23. Mapped banklines below Roundup showing four acres of field erosion in 2018.

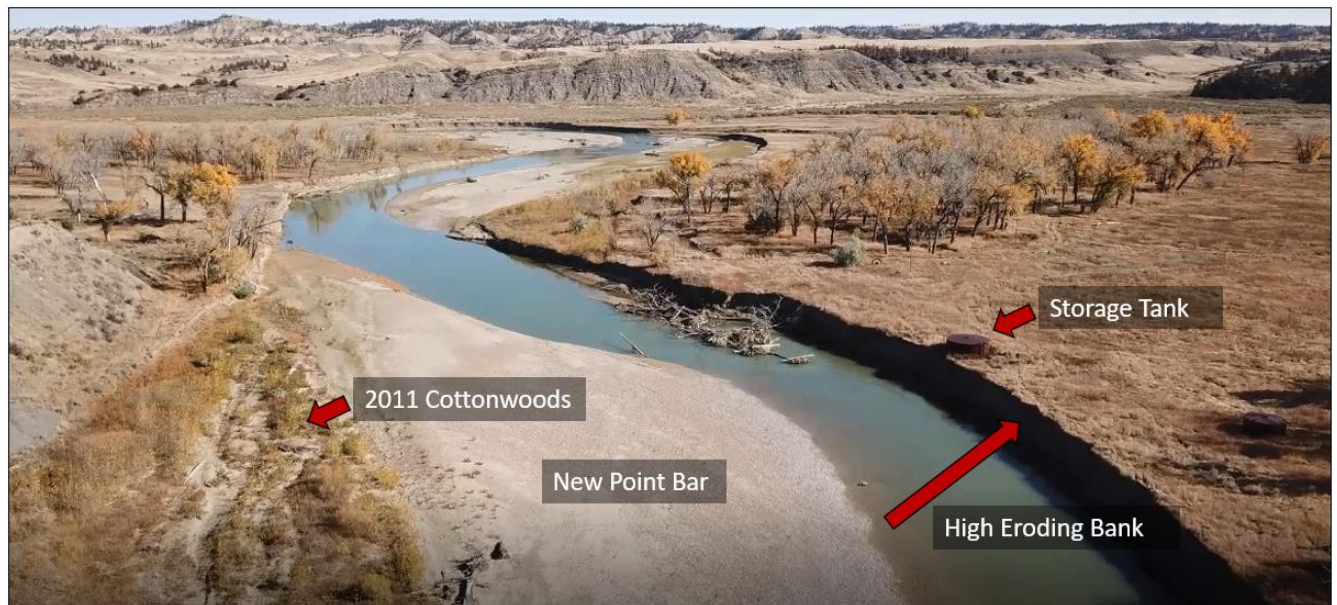
The severe bank erosion seen since 2011 can be attributed to long high flow periods that transported massive sediment loads, building point bars that put additional pressure on cutbanks, driving the channel migration process (Figure 24). The process is somewhat self-perpetuating during long duration floods, as the erosion incorporates sediment into the channel that builds a point bar downstream, driving more erosion and incorporating more sediment. The underlying driver for this is the “regaining” of length on a river that has been straightened by both intentional projects and the 2011 flood. Figure 25 shows an example area below Mosby where a large 2011 cutoff was followed by channel re-lengthening. This process is an important aspect of the geomorphic evolution of the river and is discussed in more detail in Chapter 6.

Figure 24. View downstream showing storage tank on right bank and large point bar on opposite side driving erosion.

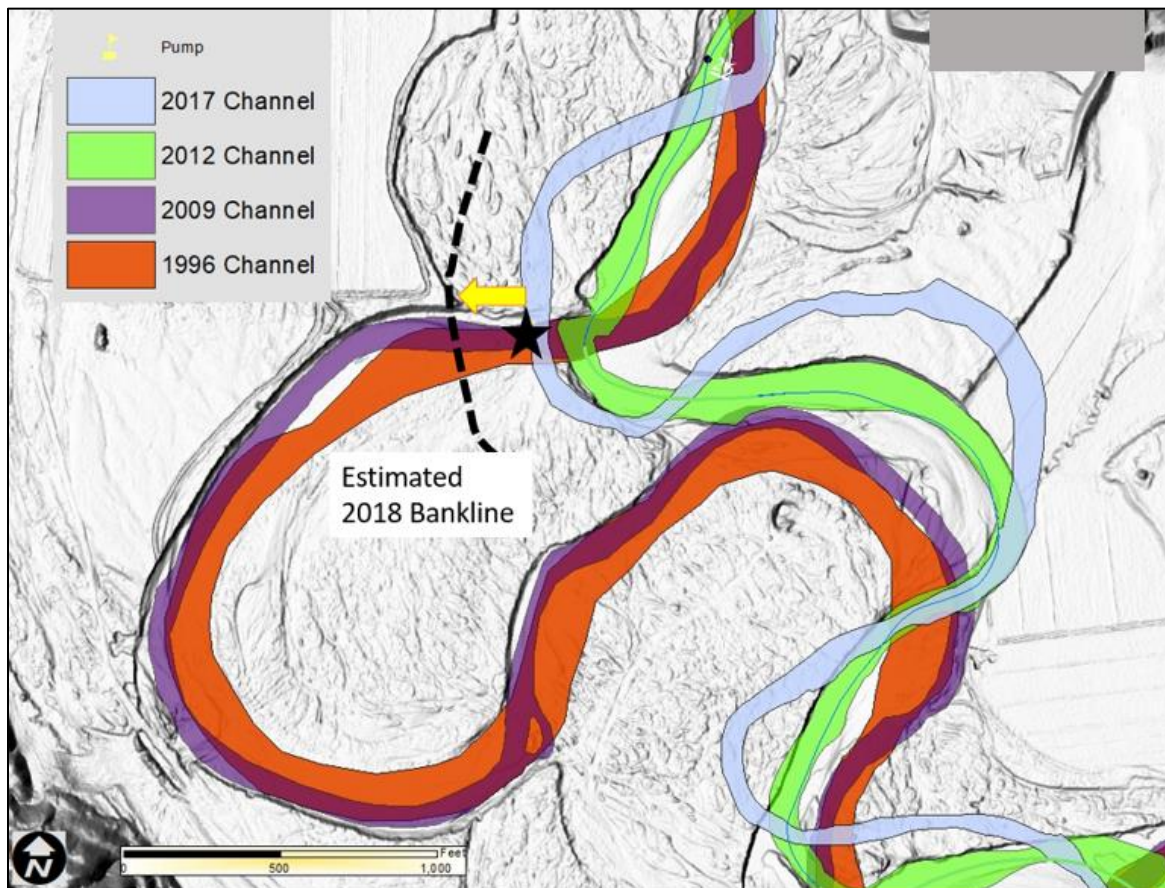
Figure 25. Channel migration through time below Mosby; note lengthening following 2011 cutoffs. The black star marks a pump site that was eroded out during 2018 flood.

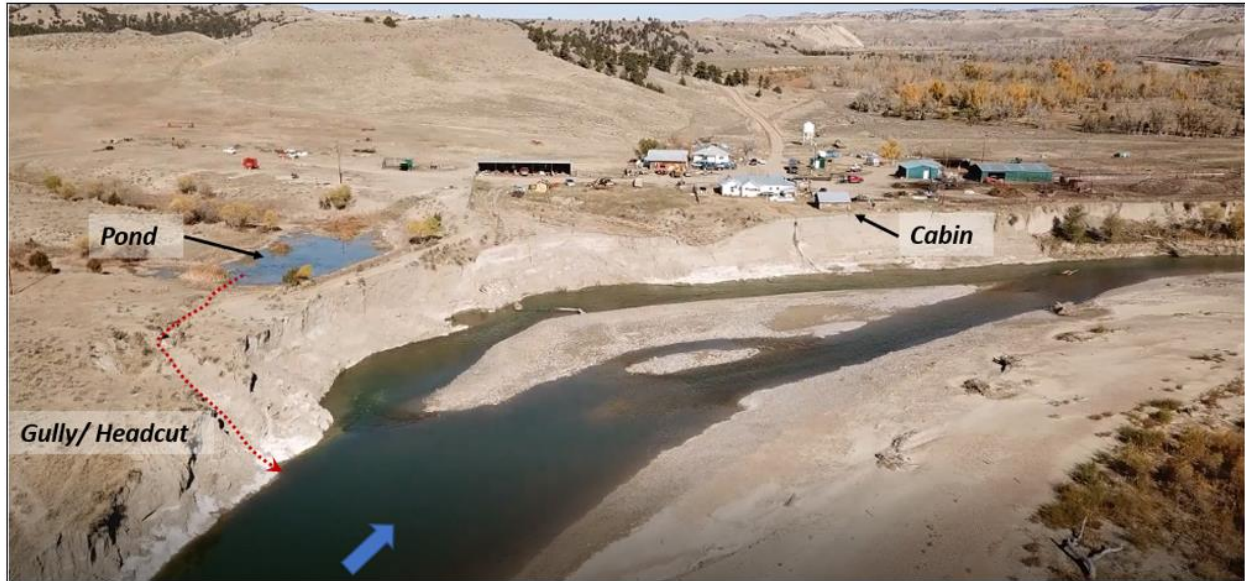
In many cases, the erosion has geotechnically destabilized banks that will continue to change, even with moderate river flows. Figure 26 and Figure 27 show a site below Mosby where erosion of a high bankline against a pond has caused the development of deep tension cracks on the topbank that will continue to destabilize the bank.

Figure 26. View downstream showing pond, headcutting spillway, and cabin at risk.

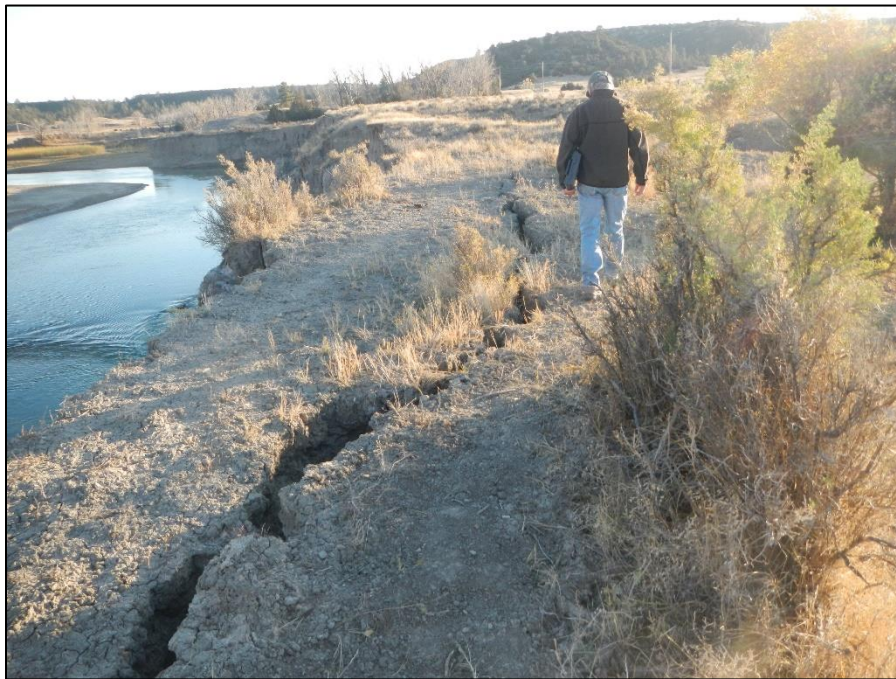
Figure 27. View upstream showing tension cracks in bluff between river and pond.

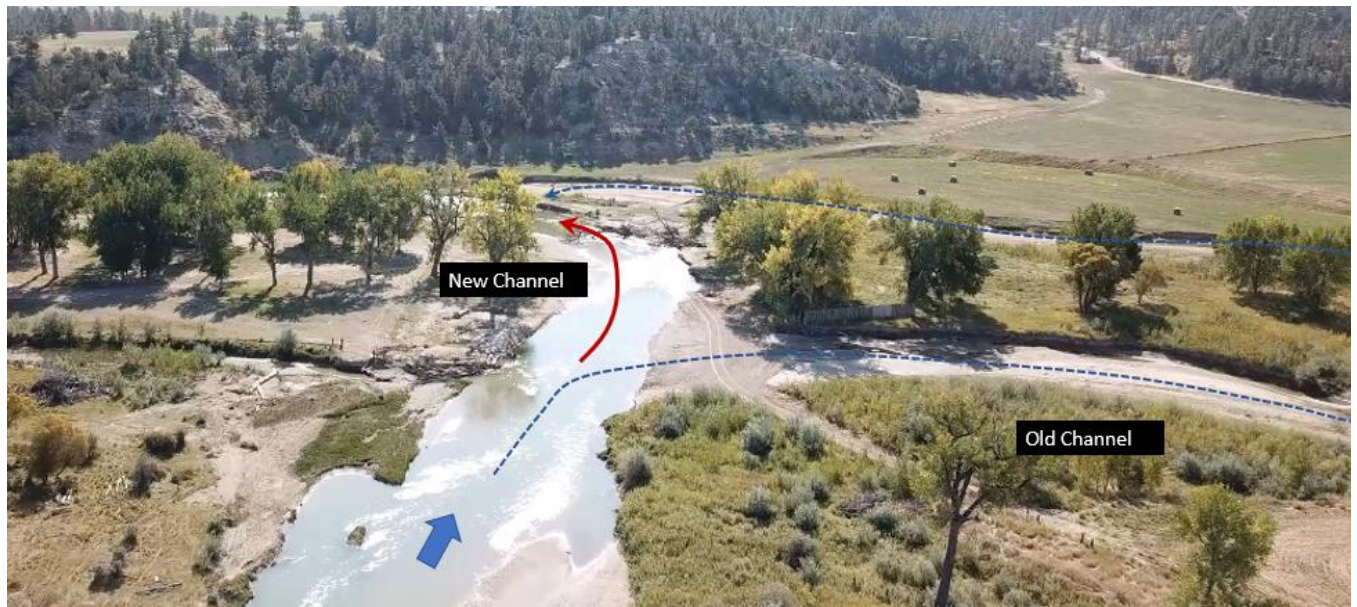
Figure 30. View downstream showing 2018 avulsion (red) that abandoned about 1,500 feet of channel (blue).

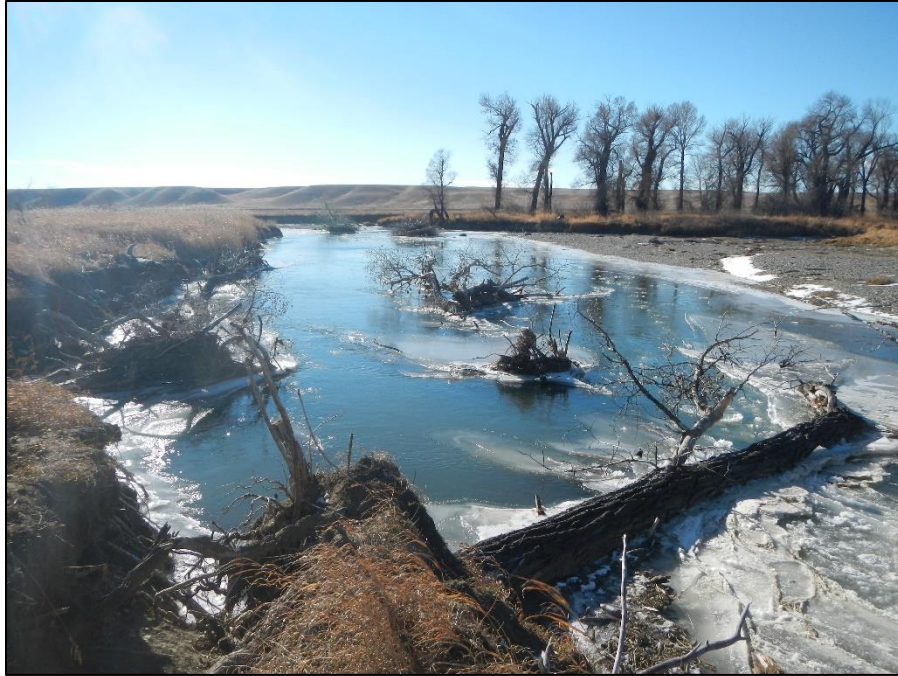
Figure 32. View downstream through avulsion path showing large wood in channel.

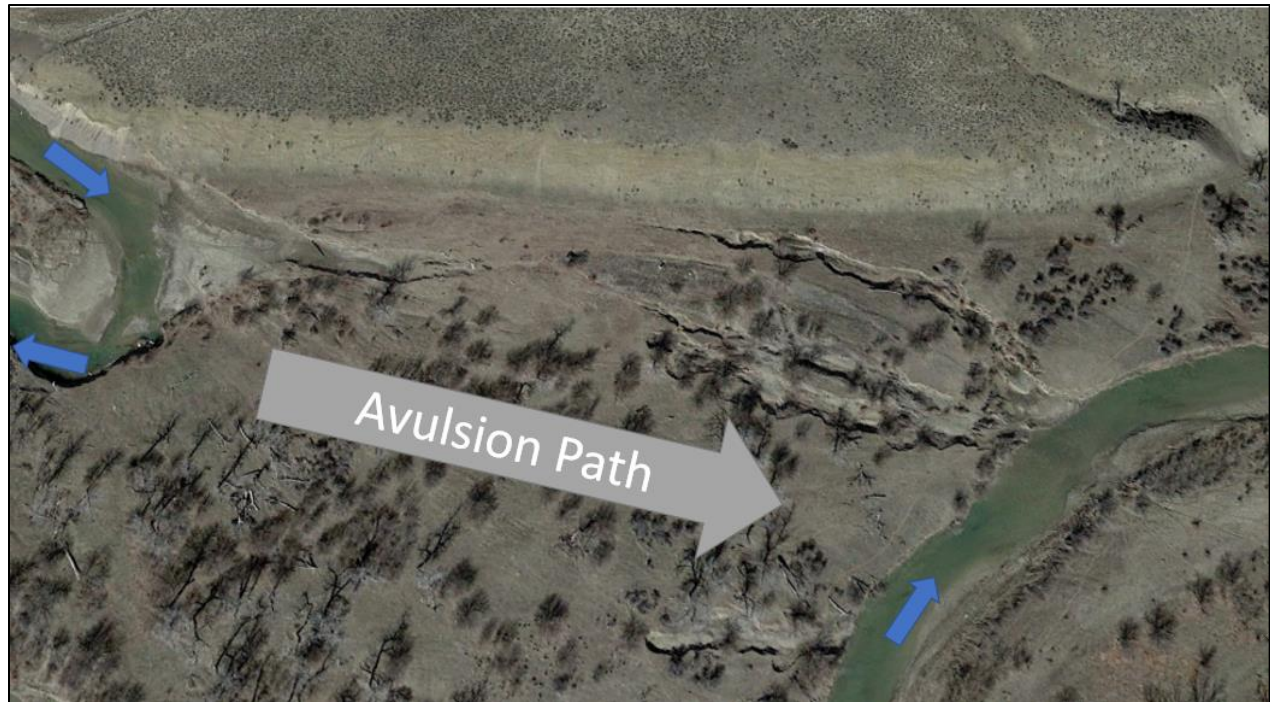
Figure 42. Google Earth image showing 2011 floodplain headcuts creating avulsion path; this bend cut off in 2018.

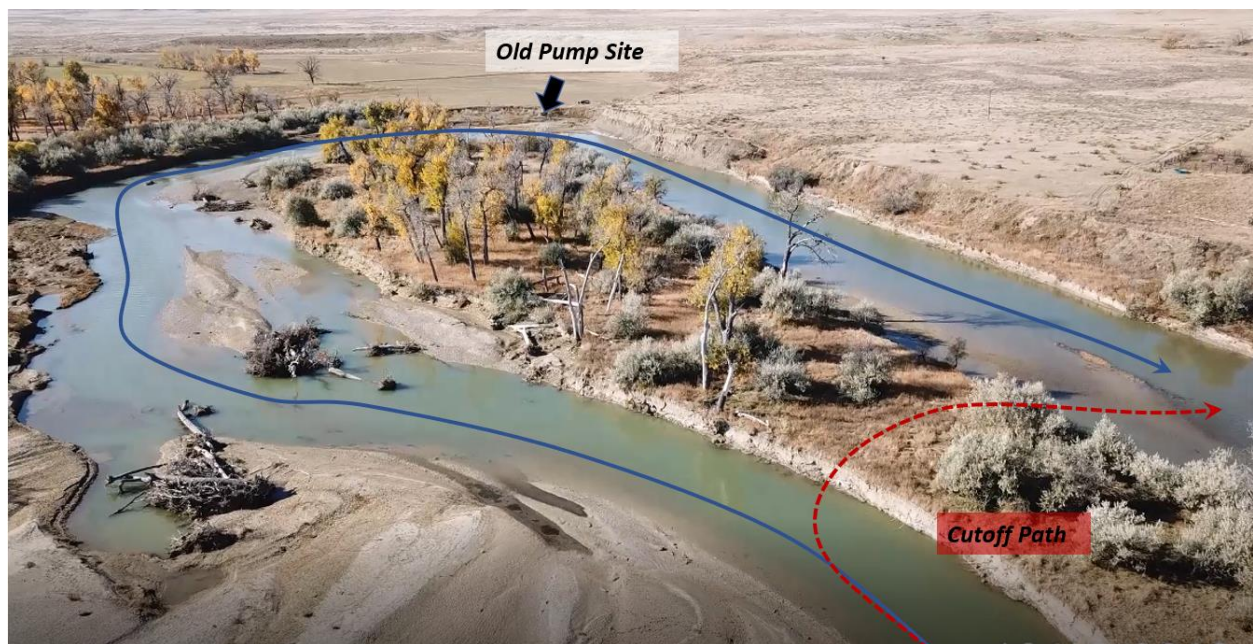
Figure 45. View downstream of bendway showing old pump site and likely cutoff path that will abandon meander.

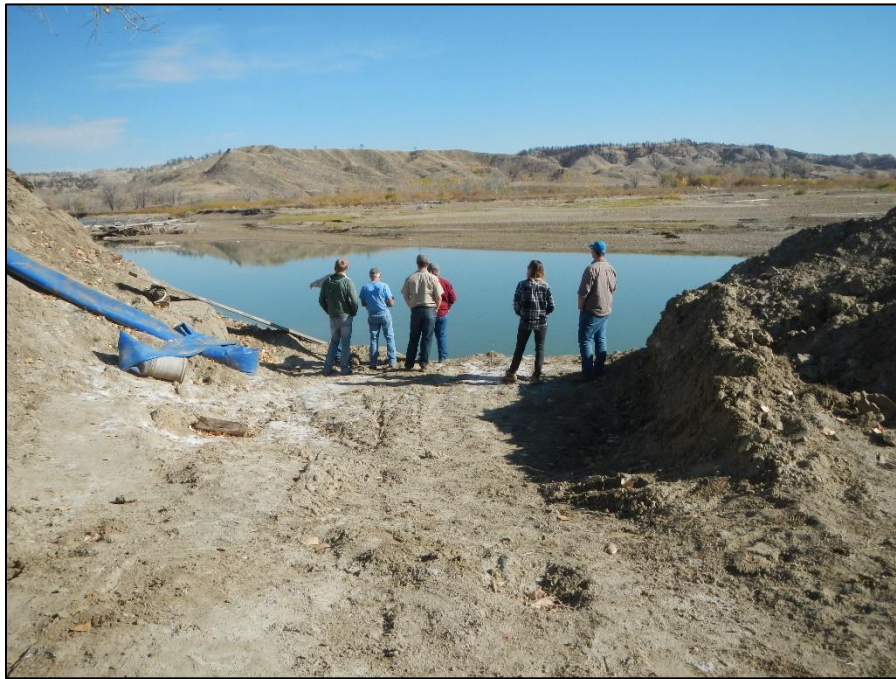
Figure 46. View down pump site access ramp that washed out during the 2018 flood.

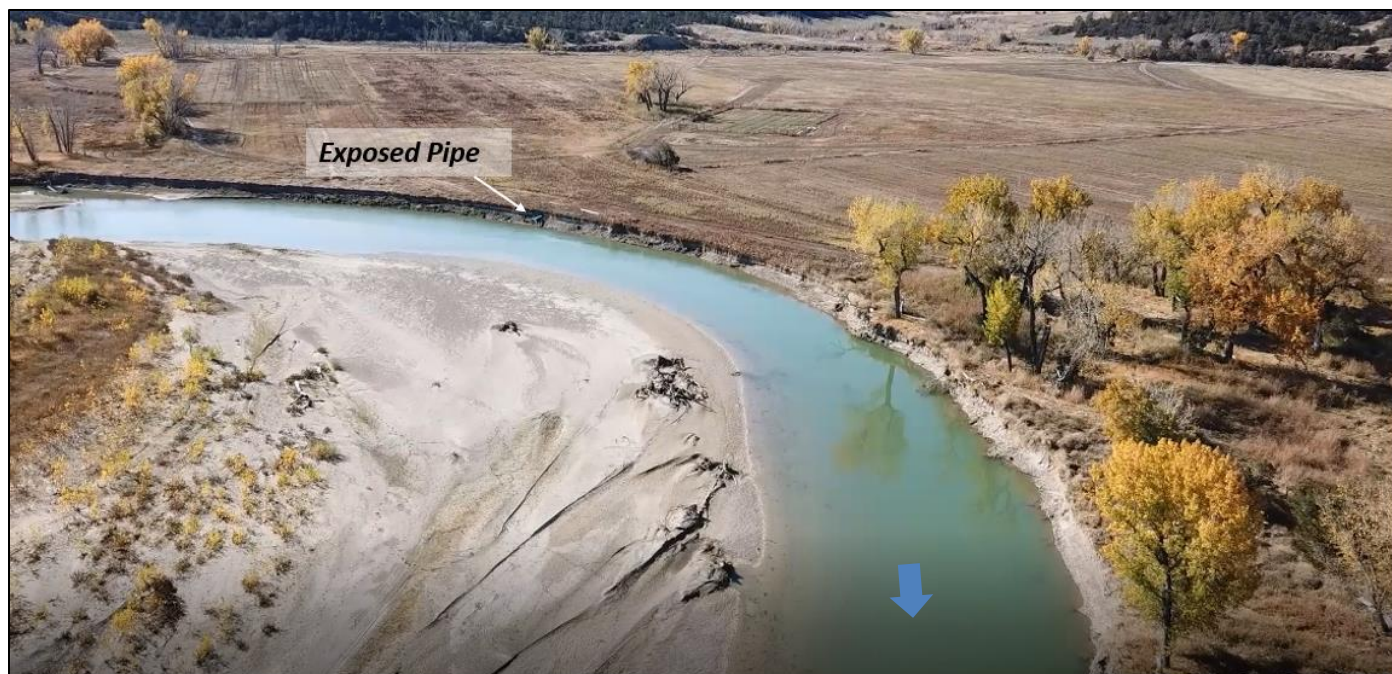
Figure 47. View upstream of pump site with buried irrigation pipe exposed in streambank (2018 drone flight).

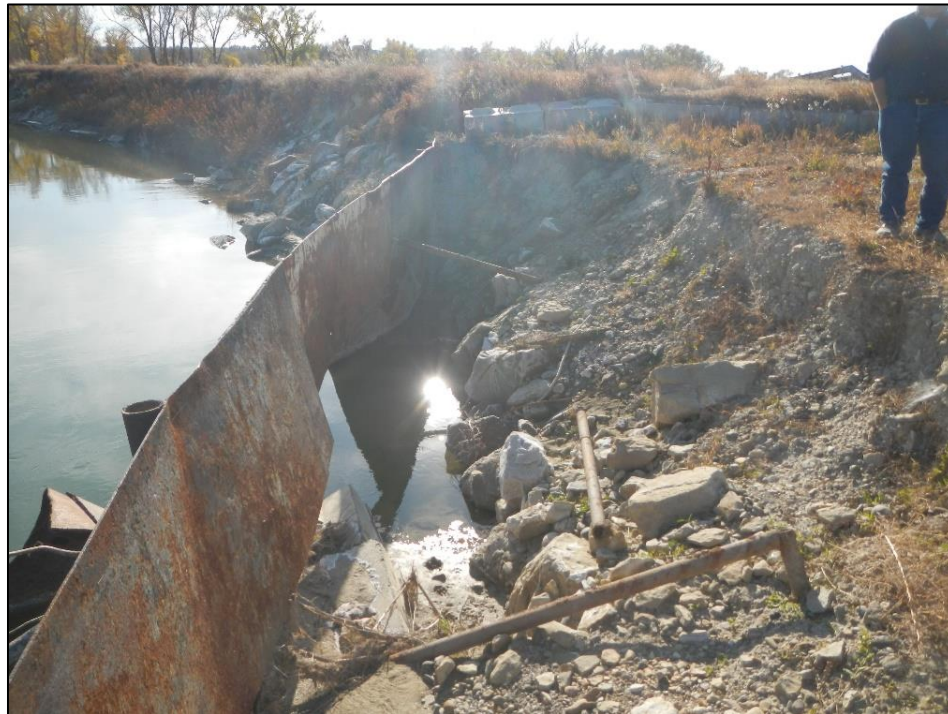
Figure 48. Lost pump site foundation behind and below metal plates.

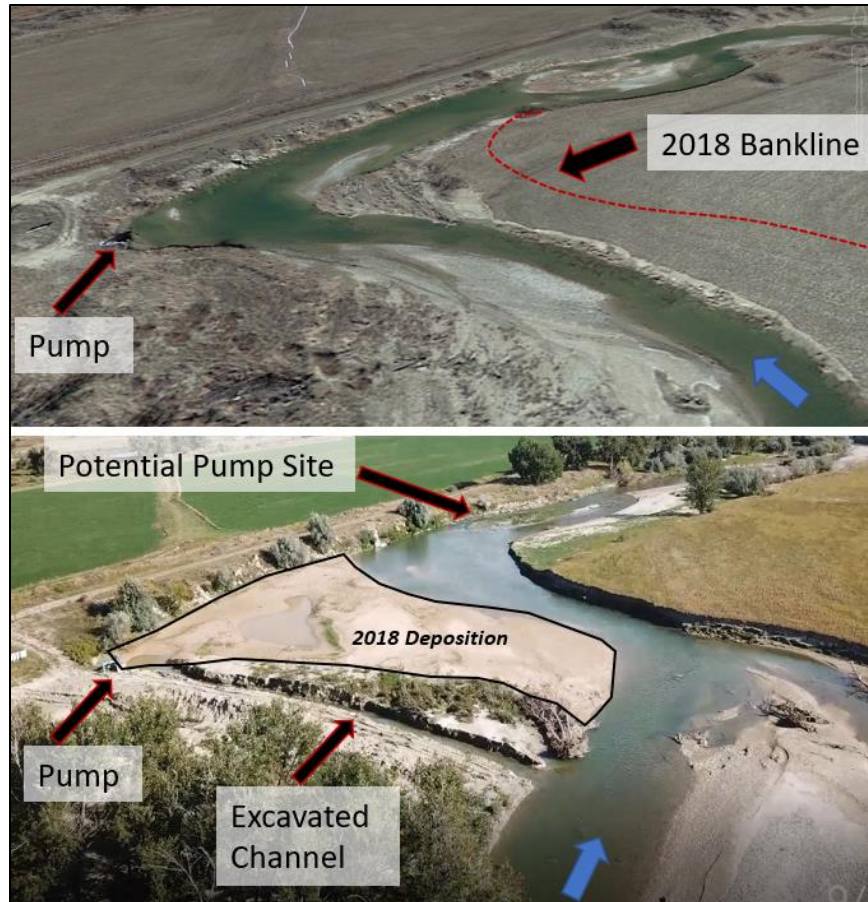
Figure 49. Images from Google Earth (top) and drone flight (bottom) showing buried pump site due to 2018 flood event; the recommended pump site relocation would be along the riprapped left bank shown in lower image.

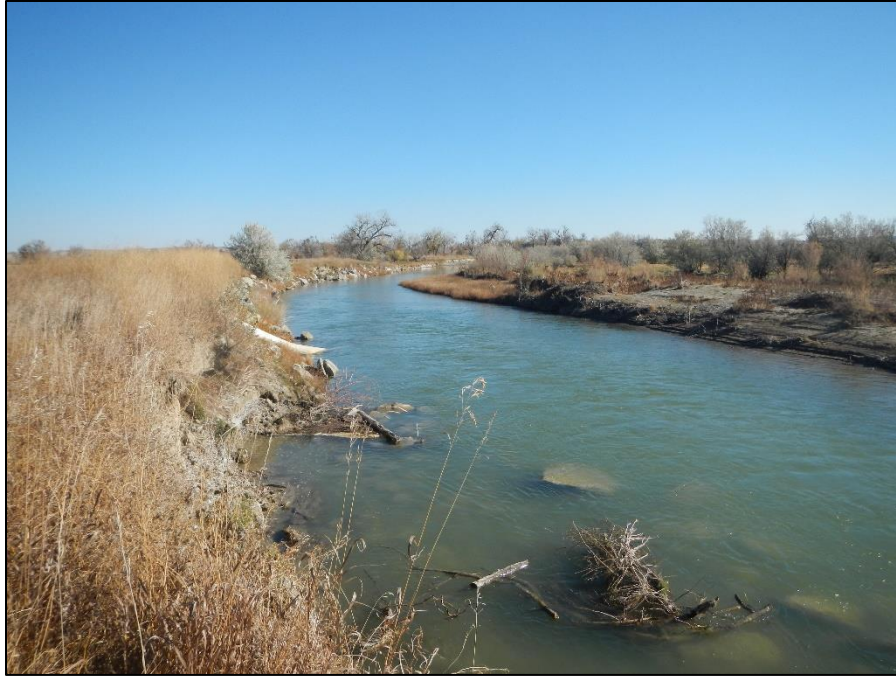
Figure 50. View downstream from damaged pump site—note flanked rock riprap in channel.

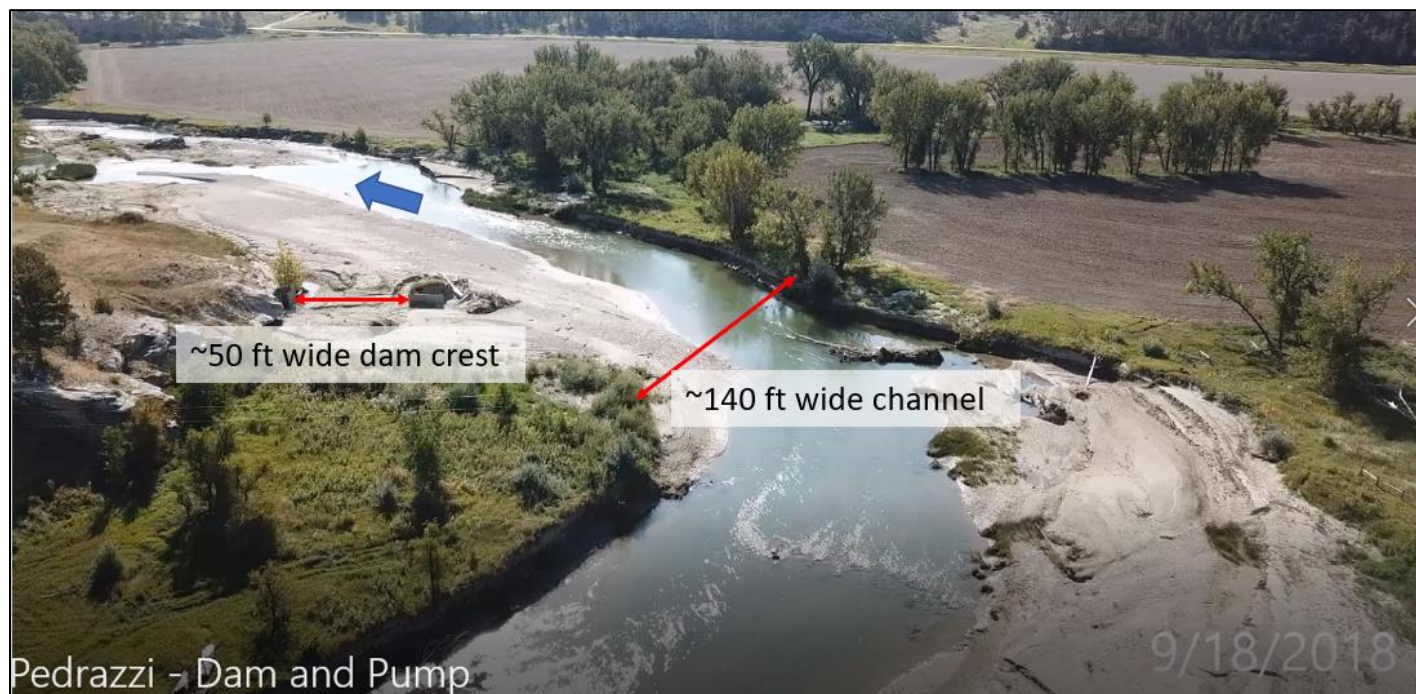
Figure 52. 2018 drone image of flanked diversion dam and channel widening.

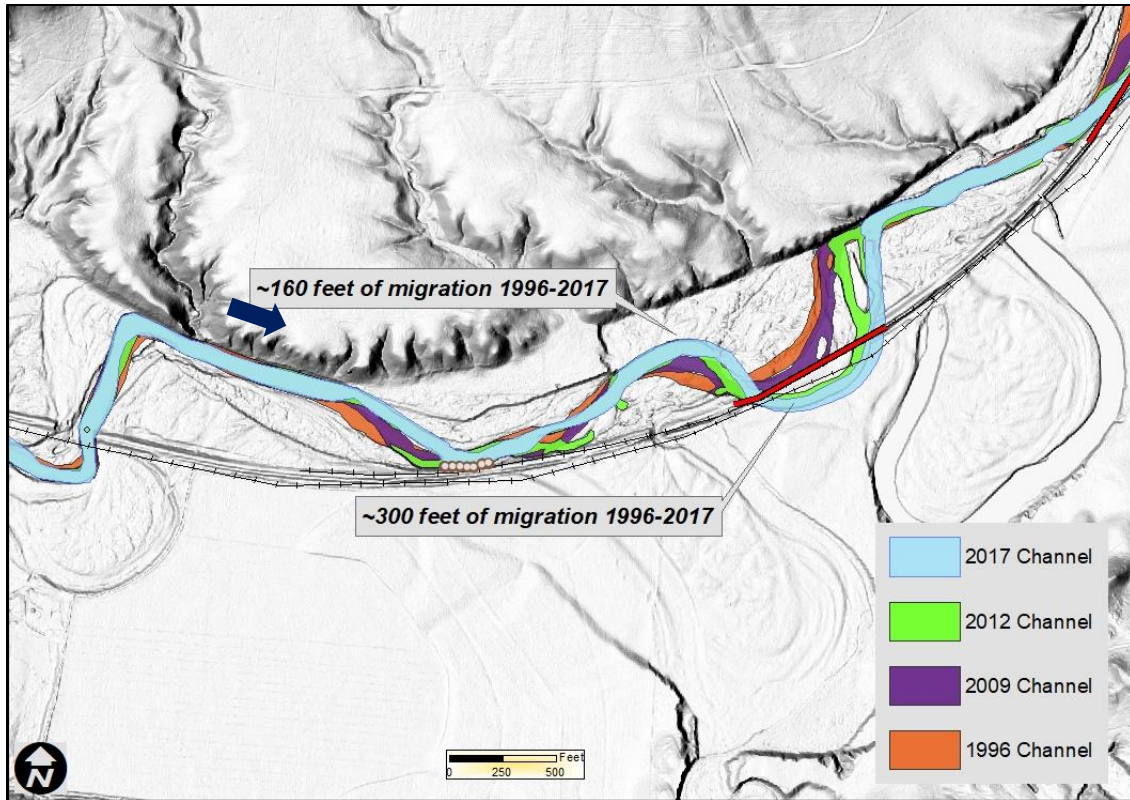
Figure 54. Digitized banklines showing railroad breach about two miles below Painted Robe Creek.

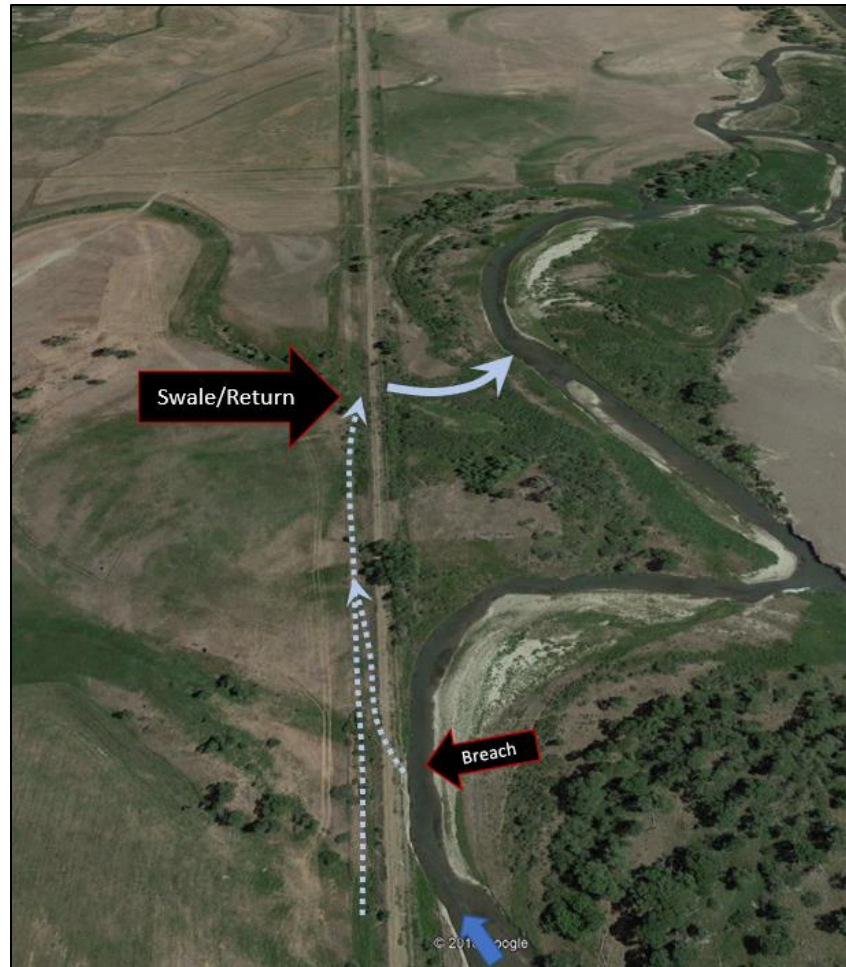
Figure 56. View downstream showing overflow paths and one potential return flow point through an old swale.

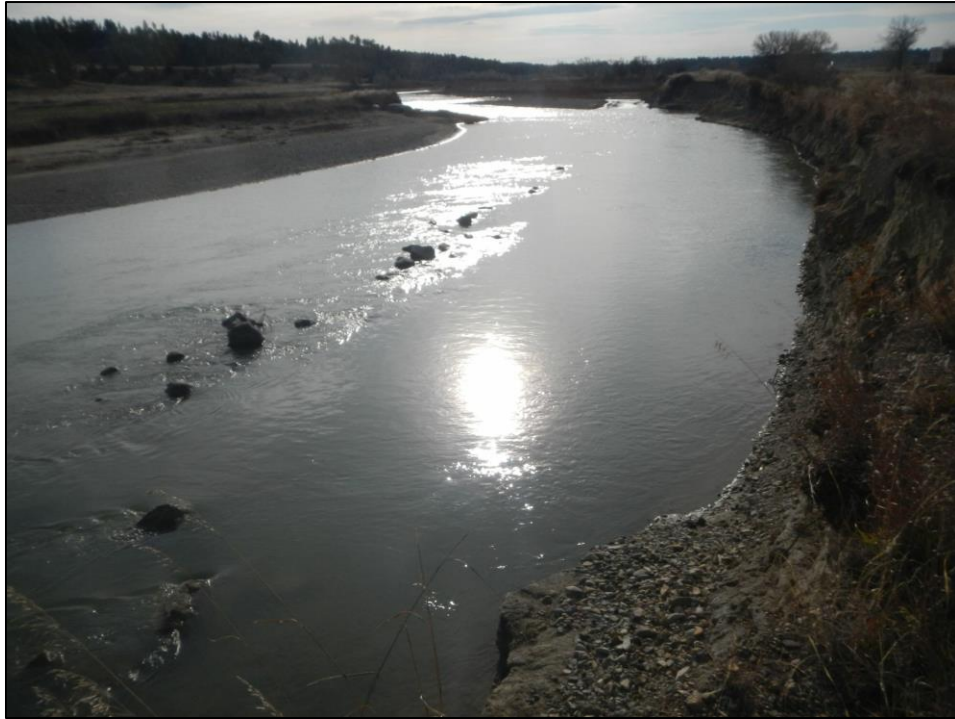
Figure 88. View upstream of flanked bank armor, Musselshell River.

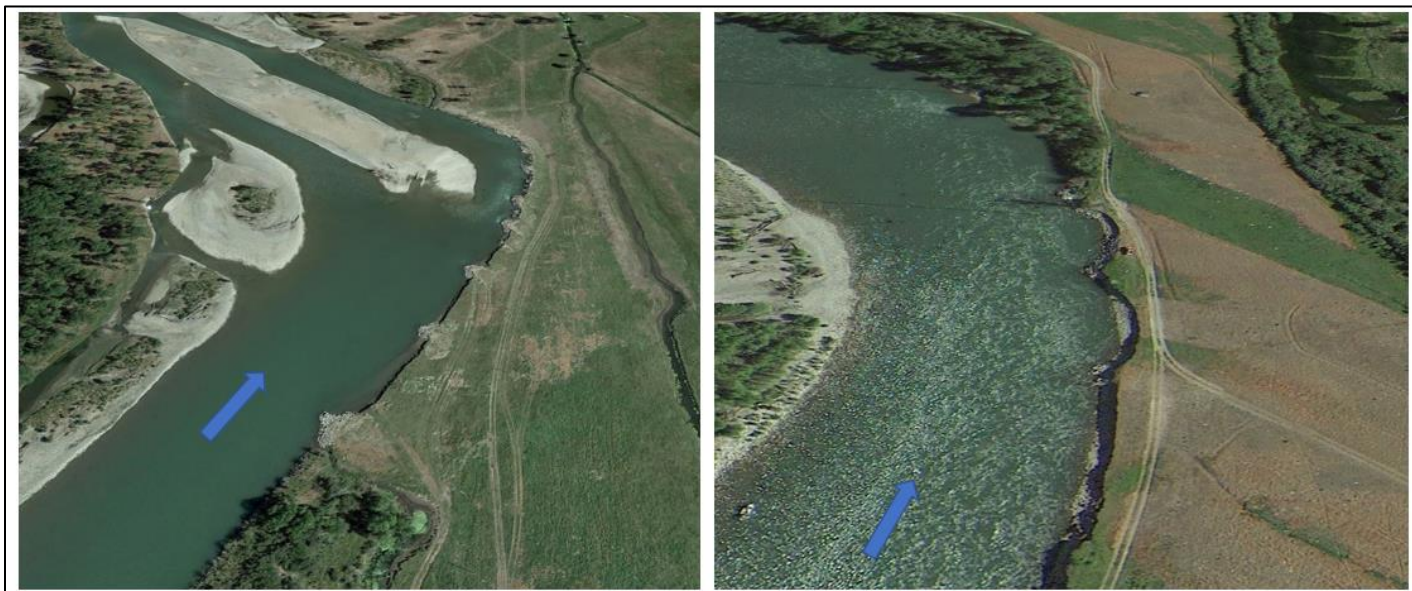
Figure 96. View downstream showing recently constructed (left) and older (right) barbs showing erosion between structures in older projects.
