## Musselshell River Flood Rehabilitation River Assessment Triage Team (RATT) Summary Report

Lower Musselshell Conservation District

Applied Geomorphology, Inc.

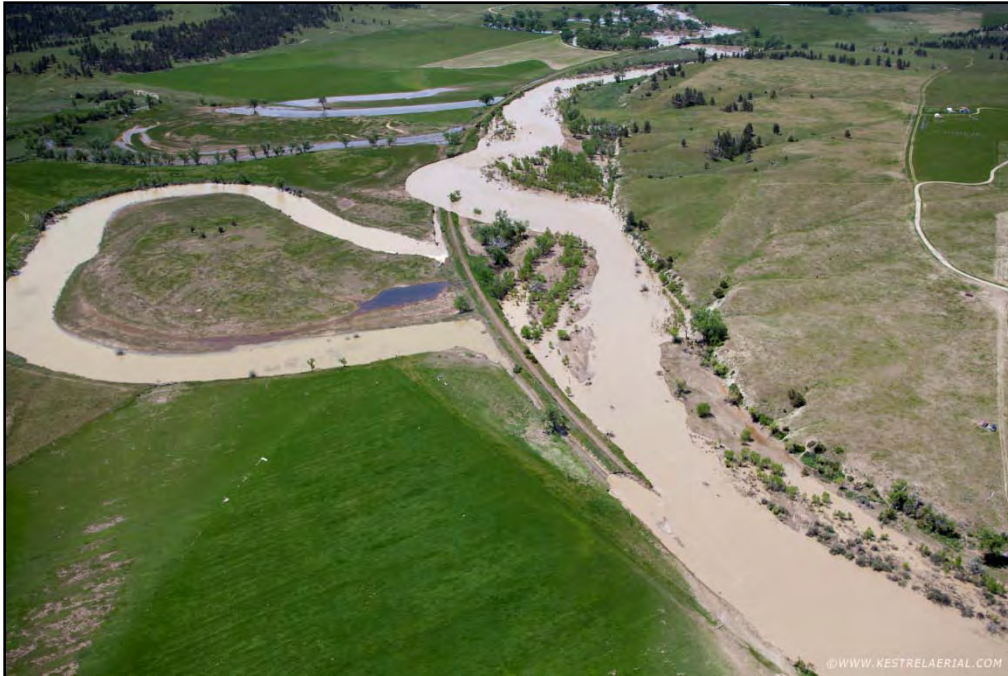
Figure 8. View upstream at RM 205 showing rail berm breach and floodwater access to previously isolated channel (©www.kestrelaerial.com).

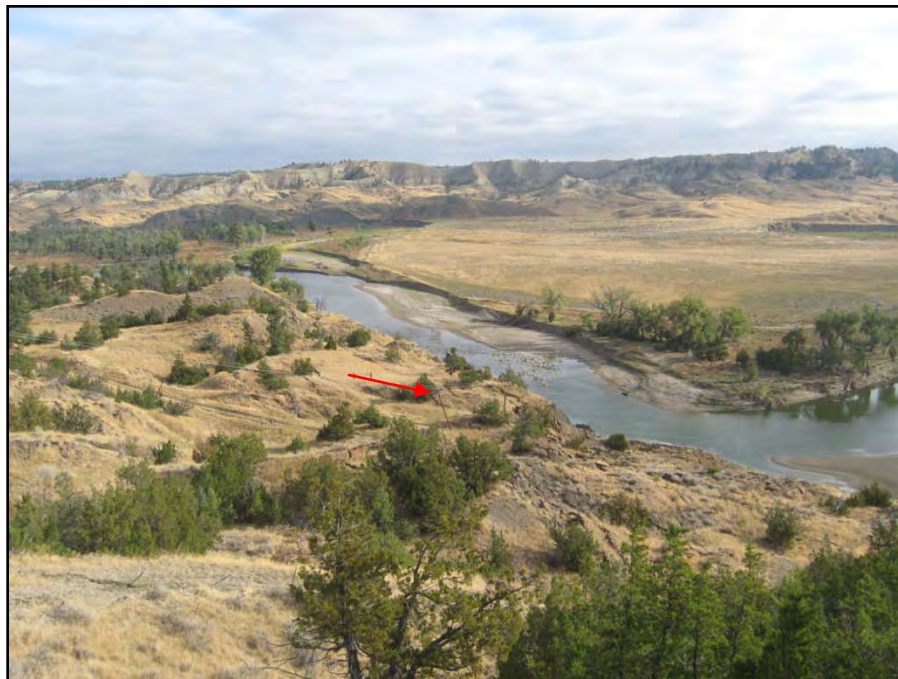
**Figure 24. View downstream of Musselshell River below Mosby showing hummocky Bearpaw shale mass failures (landslide) in foreground; note leaning power pole in center of photo (arrow).**

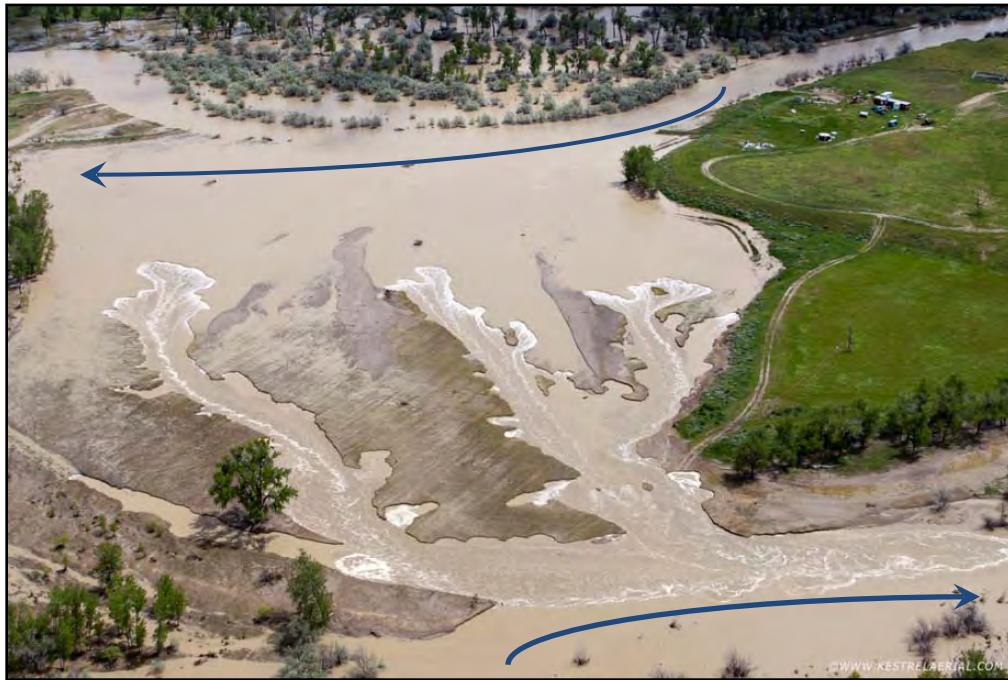
**Figure 32. Avulsion in process through core of bendway at RM 87, May 23, 2011; arrows show main channel path (©www.kestrelaerial.com).**

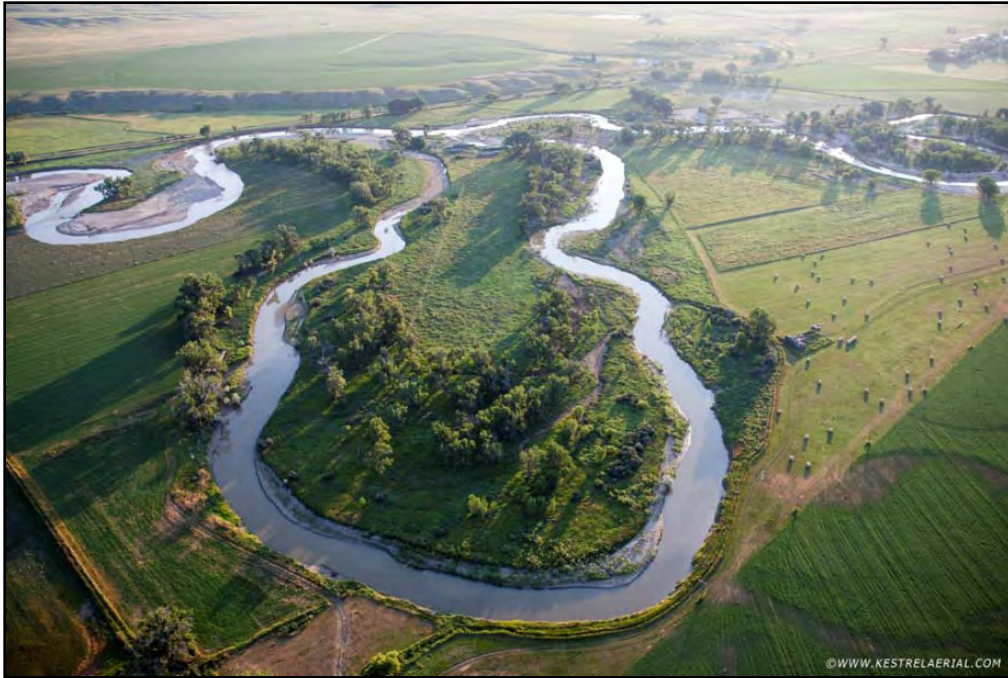
**Figure 33.** Abandoned channel at avulsion, RM 222 just above Lavina; flow is left to right; note dry channel on upstream (left) limb of abandoned channel segment, or “oxbow” (©www.kestrelaerial.com).

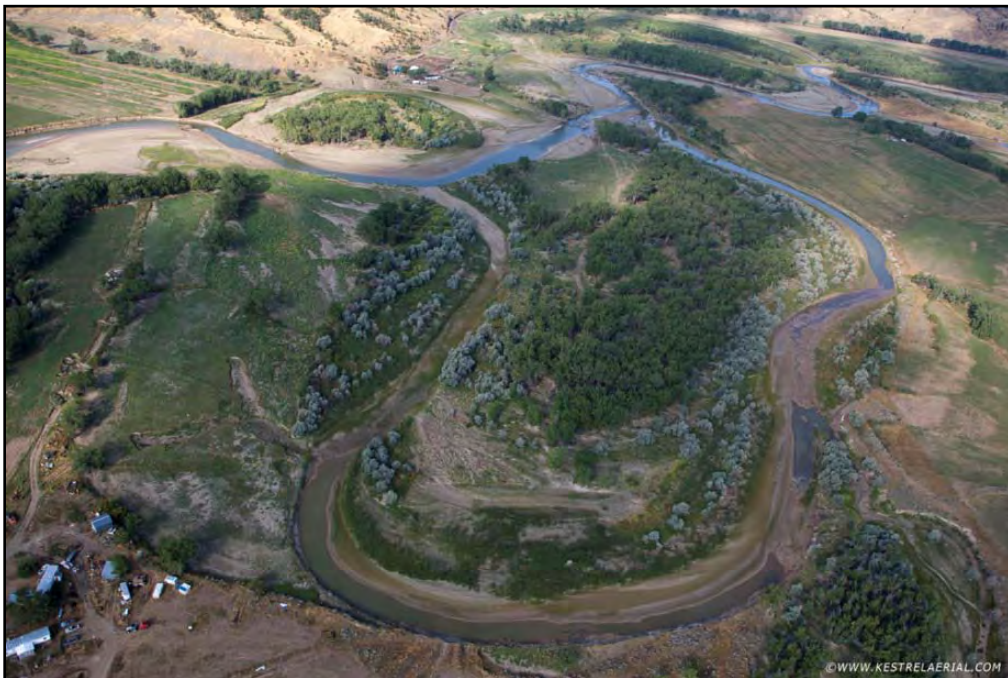
**Figure 34.** Abandoned channel caused by avulsion at RM 27 near Calf Creek; flow is from left to right (©www.kestrelaerial.com).

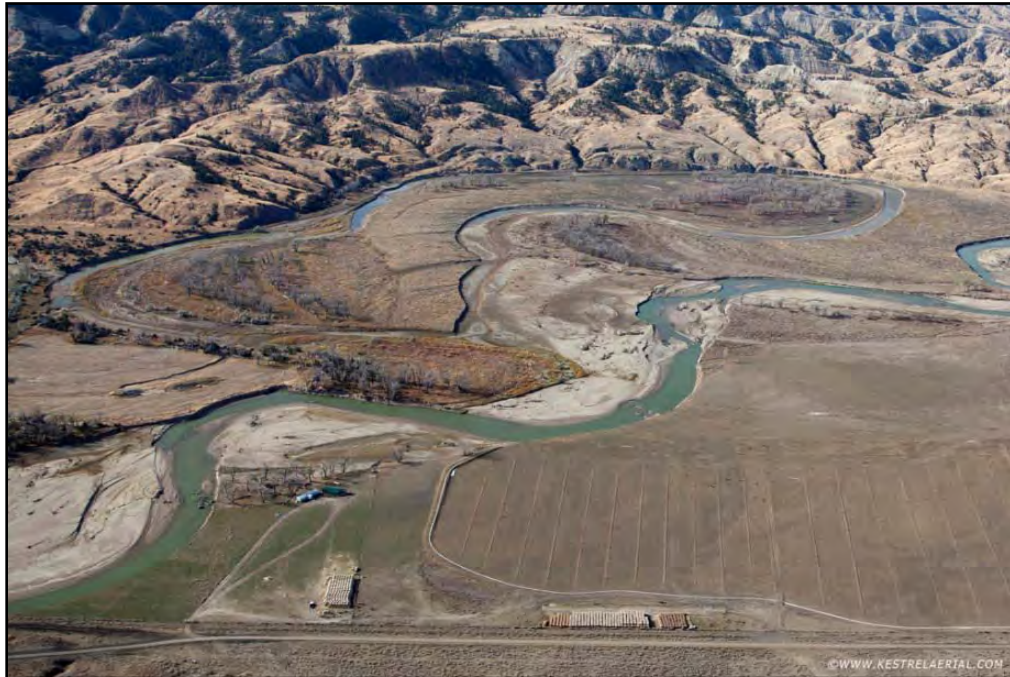
Figure 35. View across river at RM 23 showing a 2.6 mile long abandoned channel, the longest segment measured; flow is left to right (©www.kestrelaerial.com).

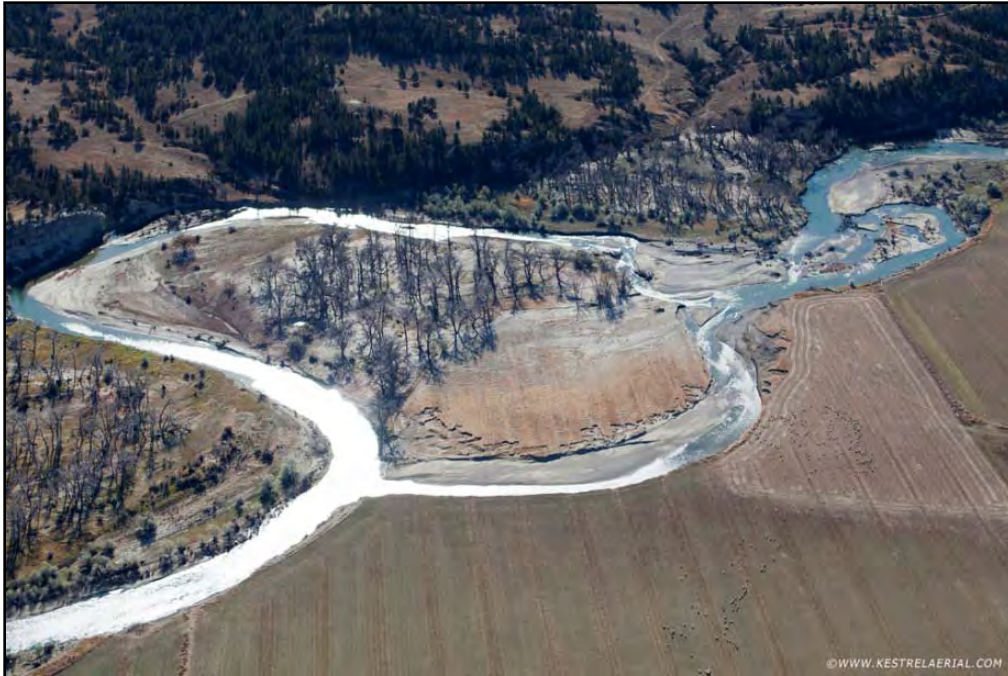
**Figure 41. View upstream of avulsion at RM 159.9 showing post-flood split flow condition (©www.kestrelaerial.com).**

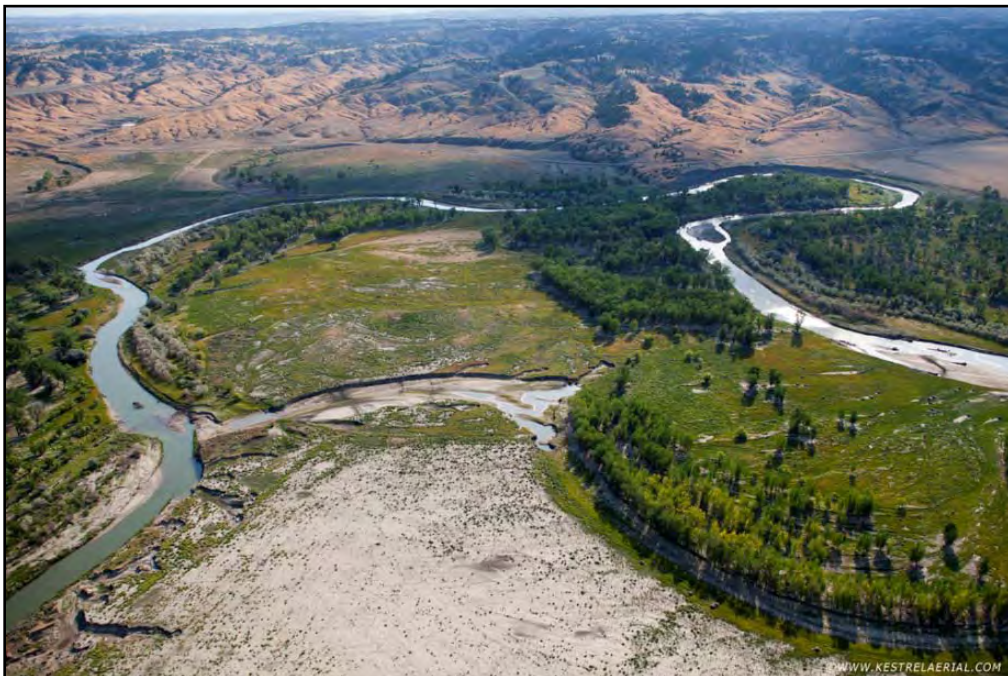
**Figure 42. Failed avulsion at RM 16; flow is right to left (©www.kestrelaerial.com).**

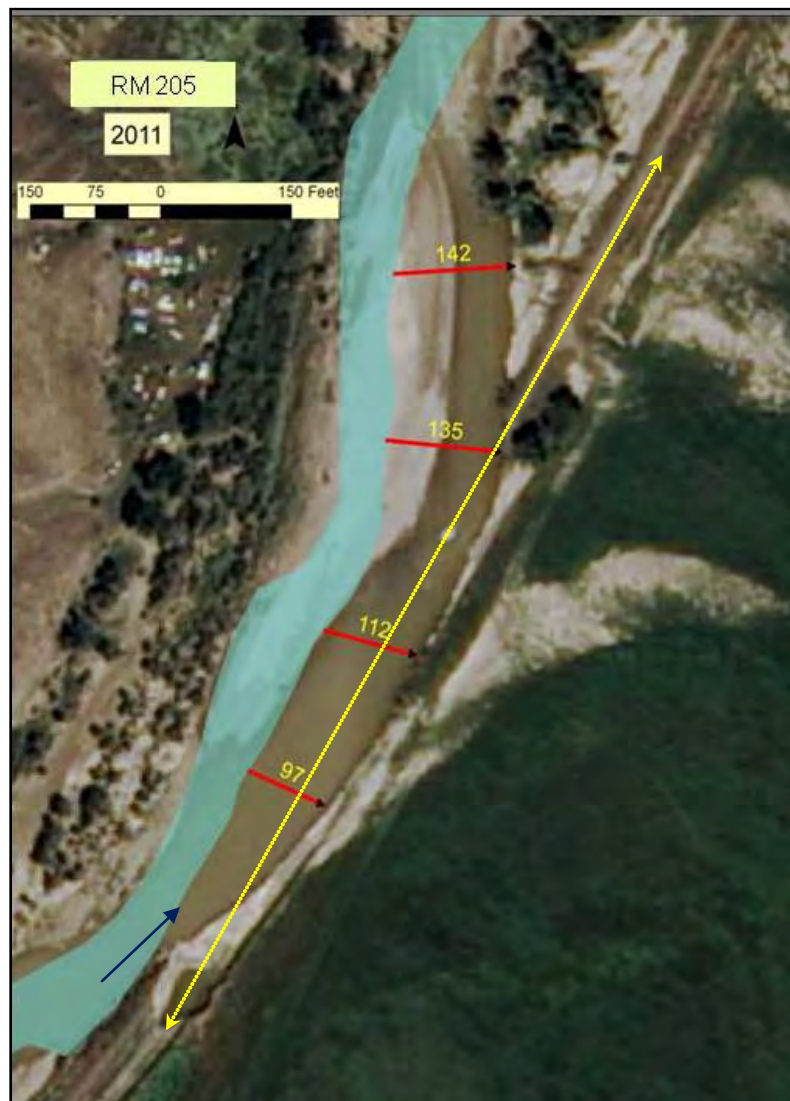
**Figure 43. Right bank erosion at RM 205 showing 2009 channel in blue and migration distance in feet (note breached rail berm in yellow).**

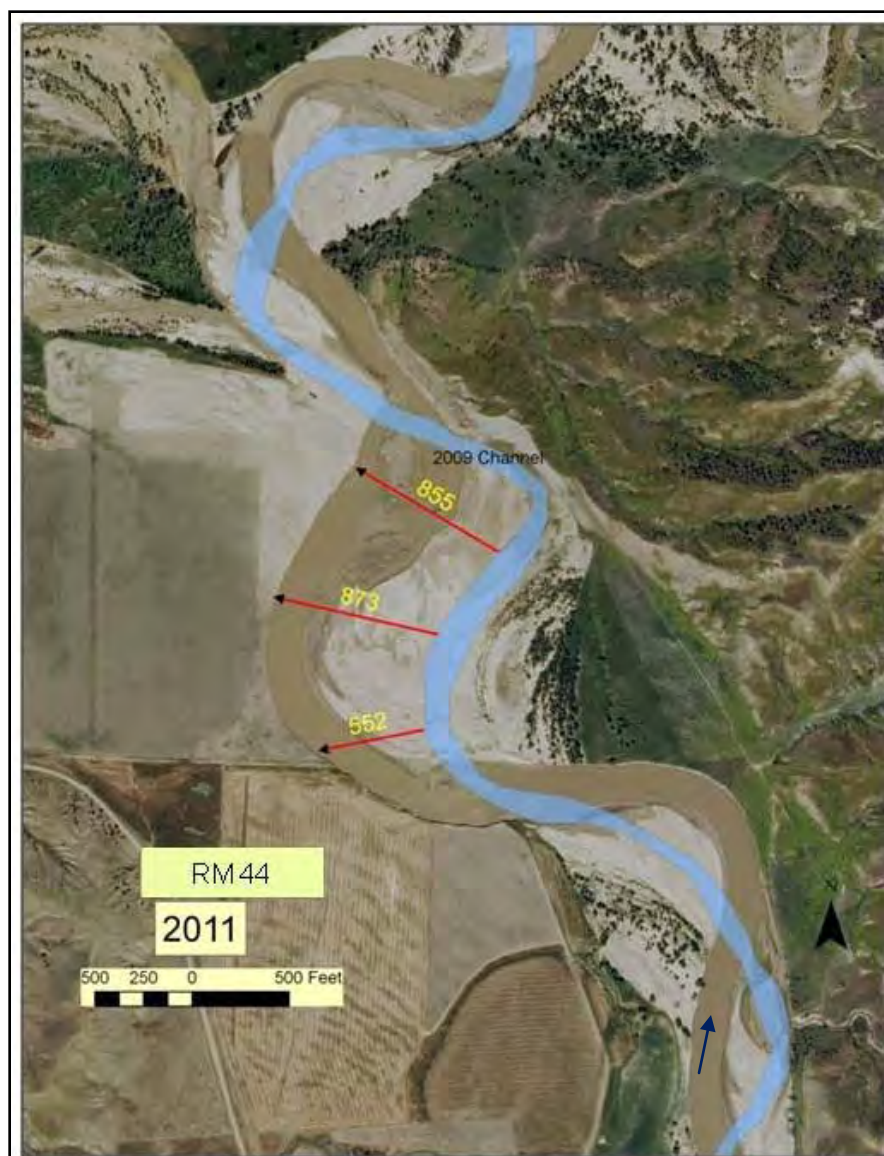
Figure 45. Left bank erosion (measured in feet) showing 2009 channel in blue superimposed on 2011 air photo.

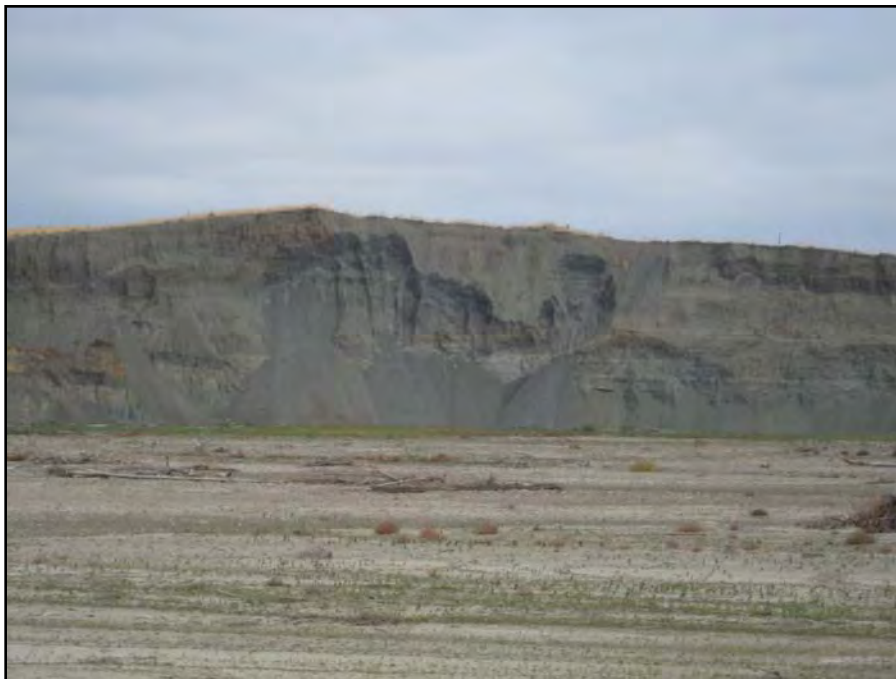
**Figure 47. View of mass failing Bearpaw Shale in west valley wall, Reach 1.**

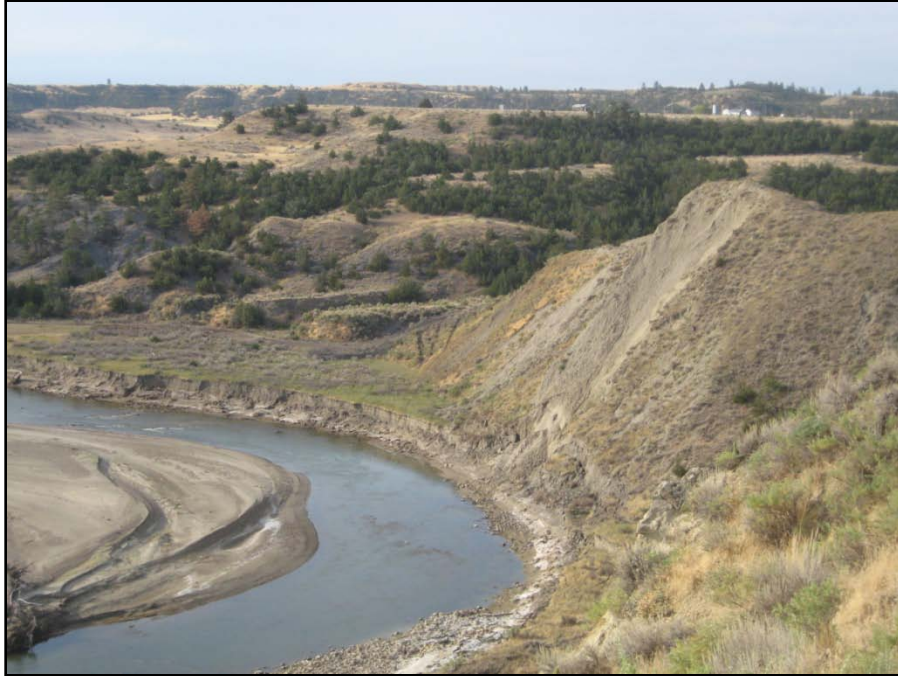
**Figure 48. View upstream of massive point bar (left) and valley wall erosion on cutbank (right), Reach 1.**

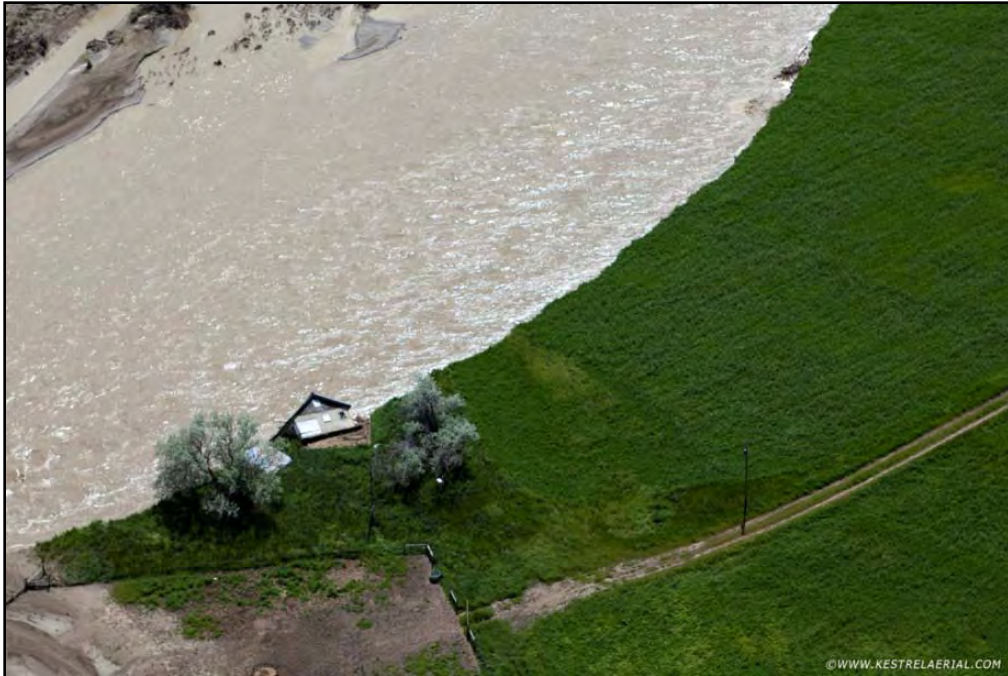
**Figure 49. Collapse of house into river, RM 42 (©www.kestrelaerial.com).**

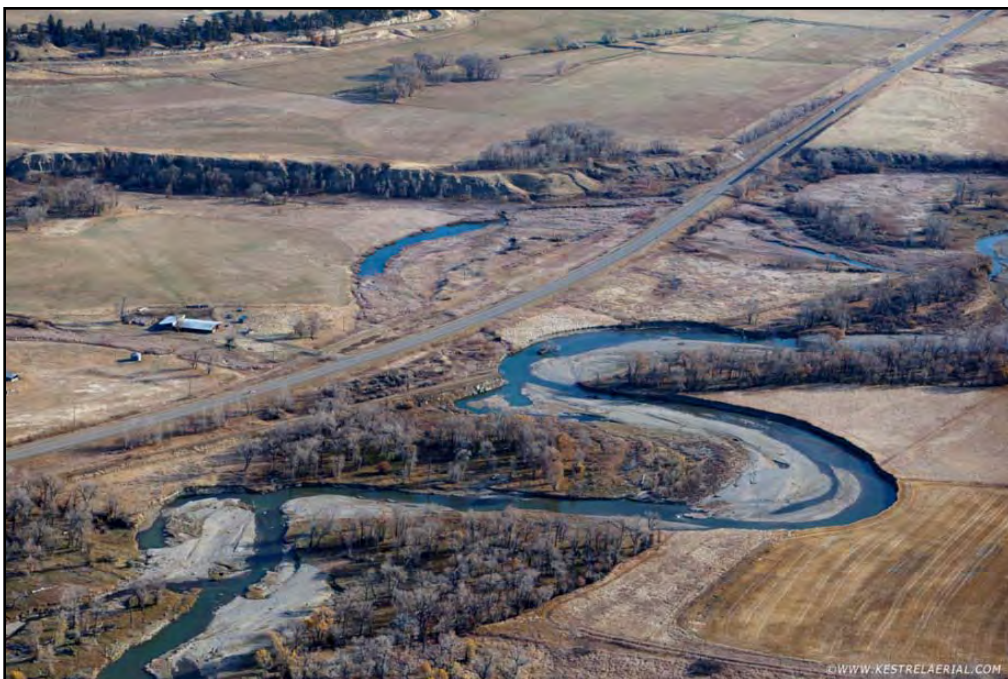
**Figure 50. View downstream of point bar formation, bank erosion, and channel lengthening near Shawmut (RM 265) (©www.kestrelaerial.com).**

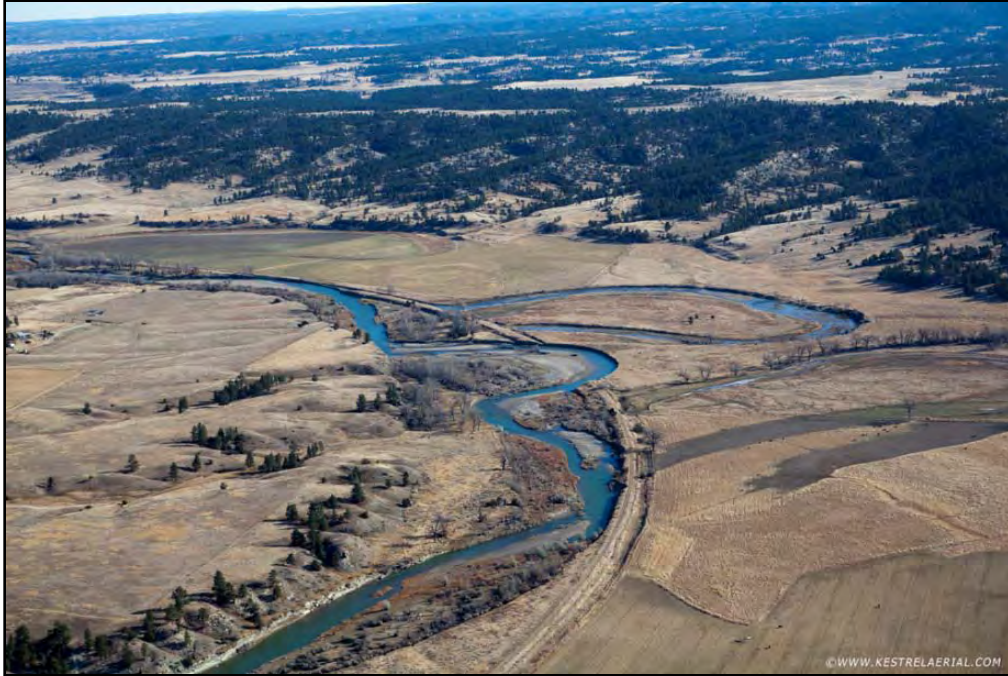
**Figure 52. View downstream of breached railroad grade at RM 206 (©www.kestrelaerial.com).**

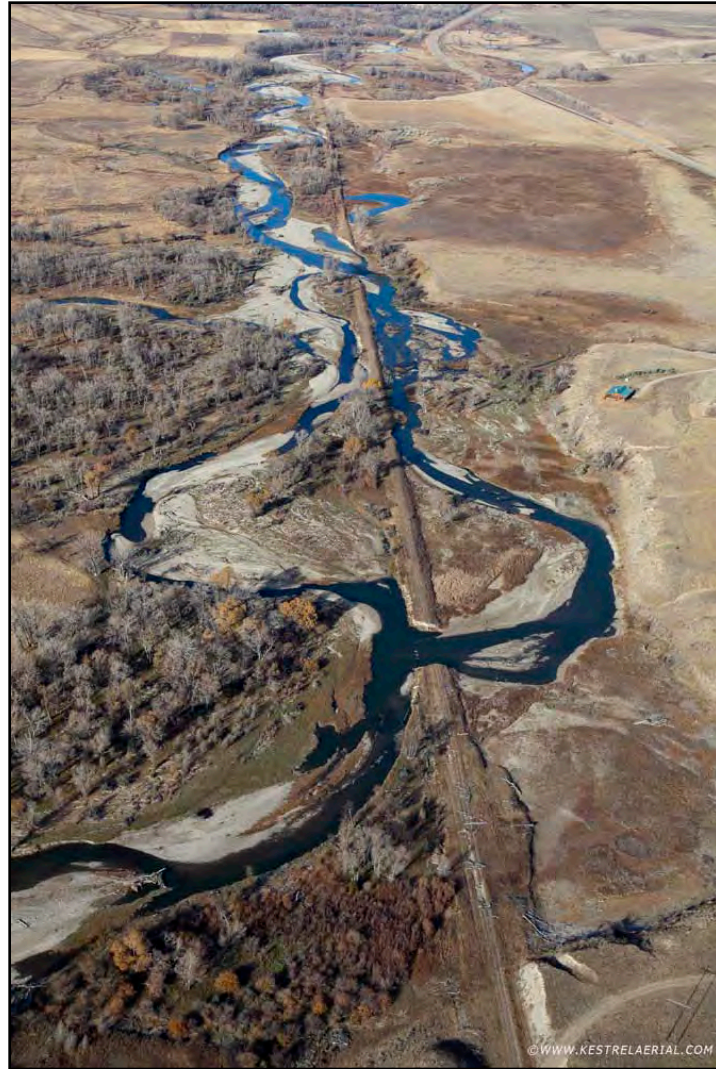
**Figure 53. View upstream (west) of long railroad grade breach east of Shawmut at RM 263 (©www.kestrelaerial.com).**

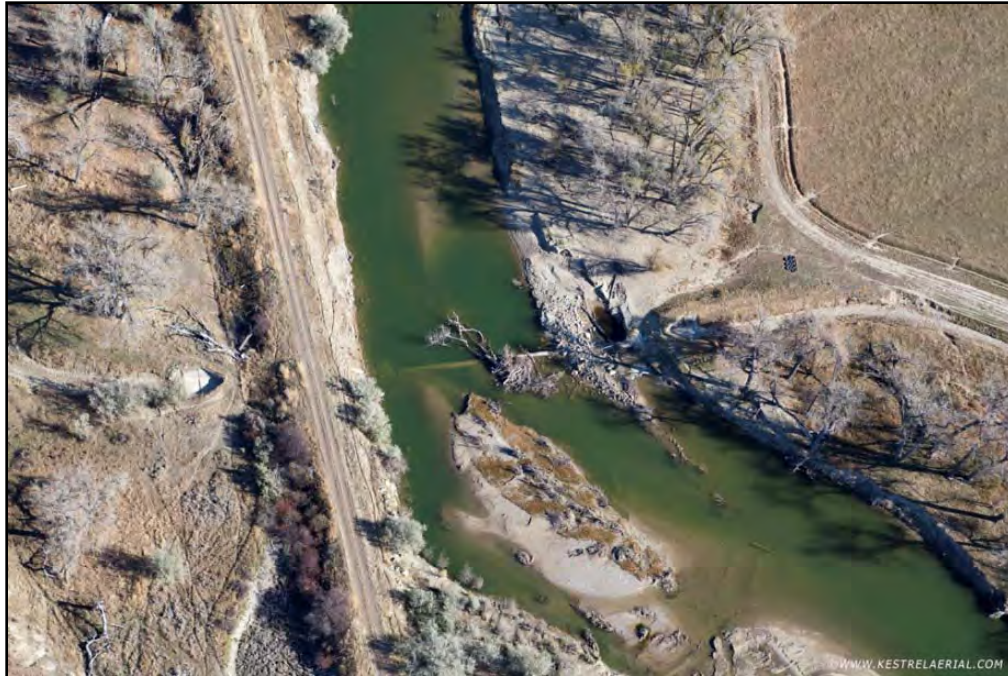
Several irrigation canal siphons were significantly damaged by the flood. Damages consist of both exposure of the siphon in the channel bed, as well as bank erosion that exposed sections of siphon previously buried behind the stream bank. Figure 54 shows the Delphia-Melstone North Ditch Siphon, which experienced over 60 feet of right bank erosion that flanked protective armor. A large cottonwood had lodged on the exposed pipe last fall, however that debris has since been removed.

**Figure 54. November 2, 2011 photo of Delphia-Melstone North Ditch Siphon (RM 138) showing exposed pipe and flanked right bank armor (©www.kestrelaerial.com).**

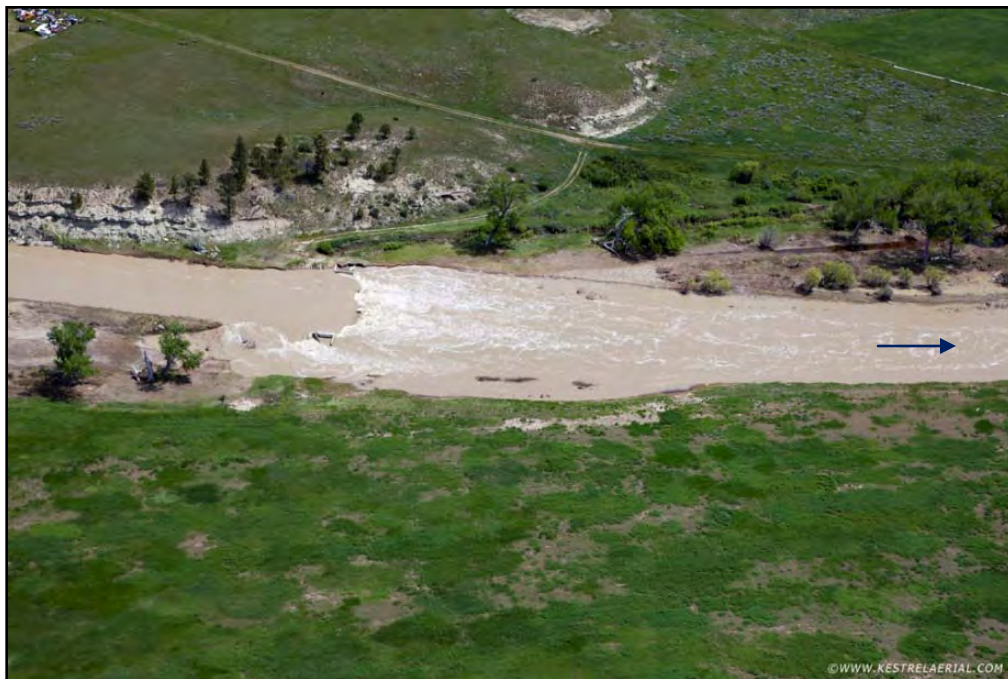
Several damaged structures were visited in the field by the RATT team. Damage at these structures consisted of flanking around abutments (Egge Diversion), or complete avulsion around the structure (Naderman Diversion). These diversions were rendered completely non-functional by the flood. Figure 56 and Figure 57 show an example of flanking at the Egge Diversion, and the avulsion around Naderman Diversion Dam is shown in Figure 58 and Figure 59.

Figure 56. Egge Diversion (RM 210) on June 16, 2011 showing active flanking on near (right) bank (©www.kestrelaerial.com).

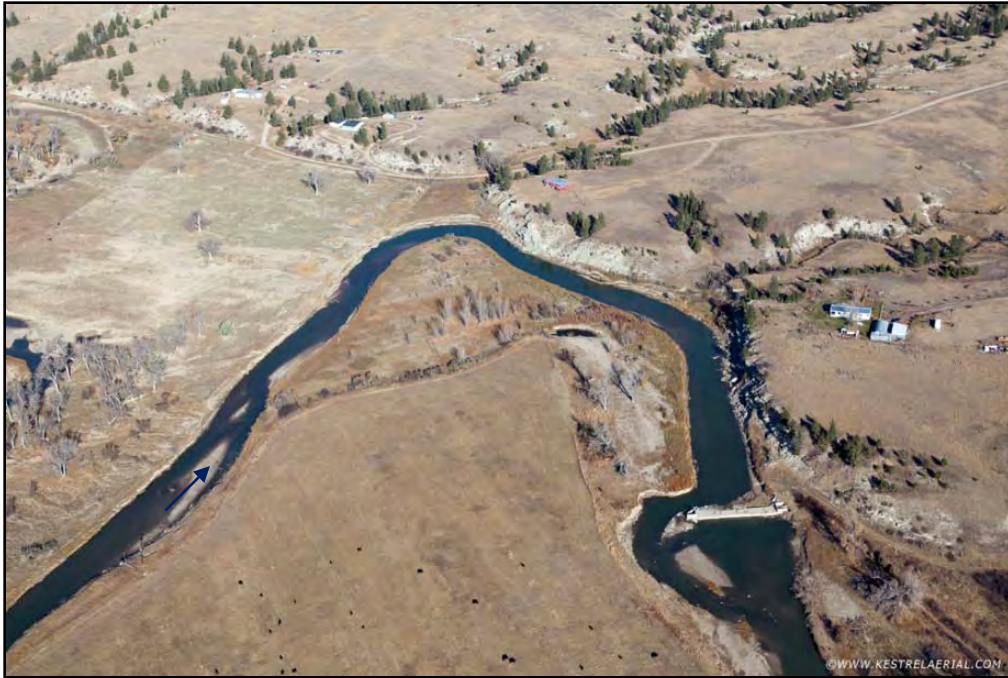
Figure 57. Post-flood image of flanked Egge Diversion Dam (©www.kestrlaerial.com).

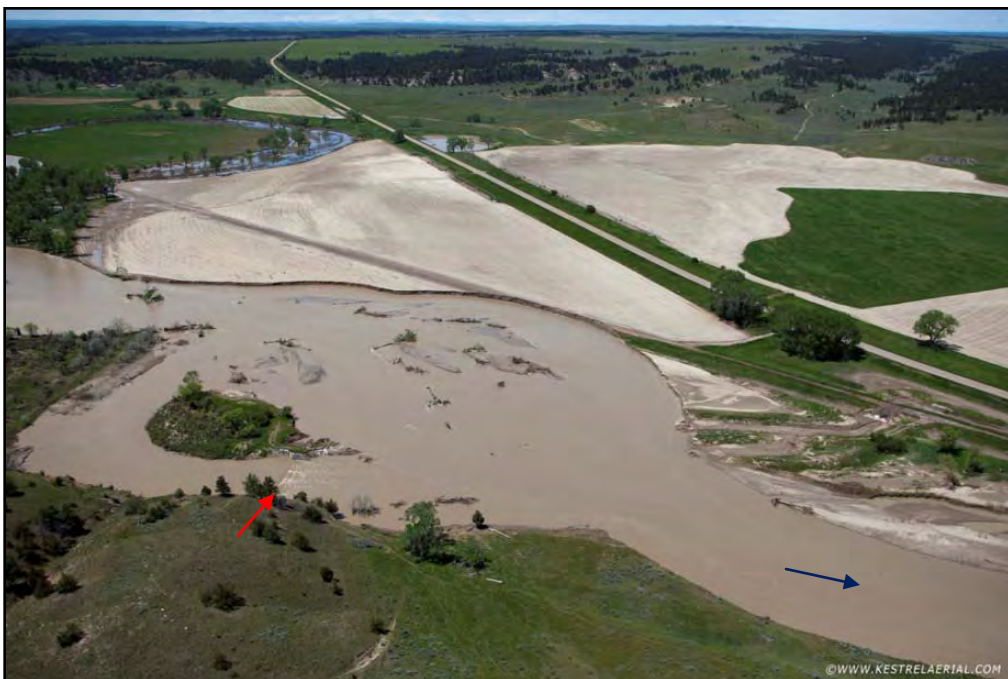
Figure 58. June 16 2011 flood image of Naderman Diversion at RM 194.2 (left foreground) showing active avulsion around structure (©www.kestrlaerial.com).

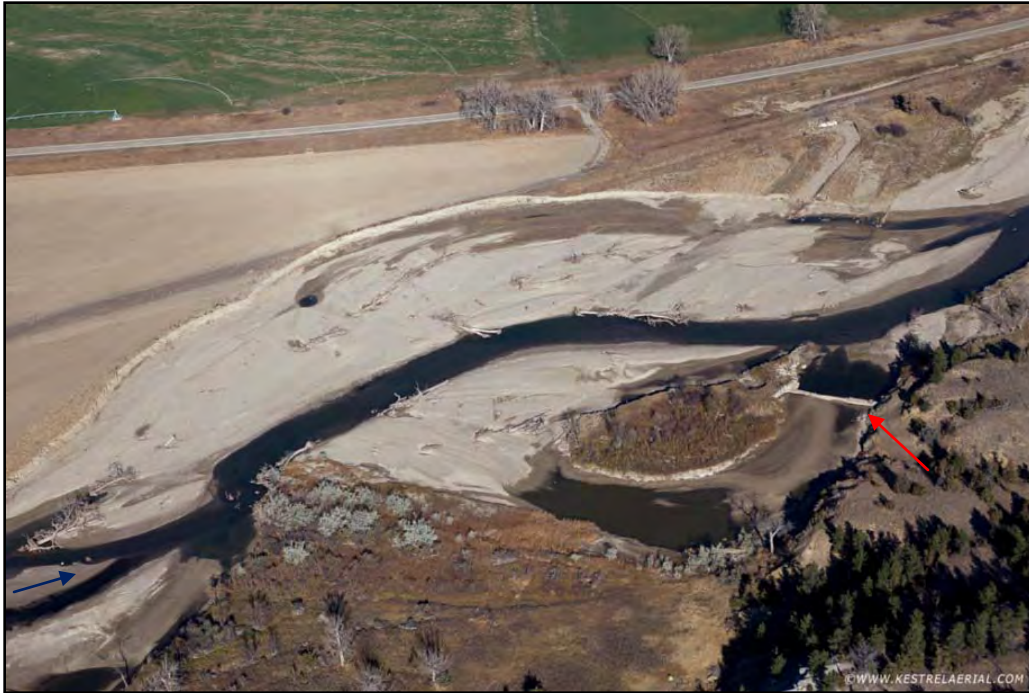
**Figure 59. Post-flood view of abandoned Naderman Diversion (©www.kestrelaerial.com).**

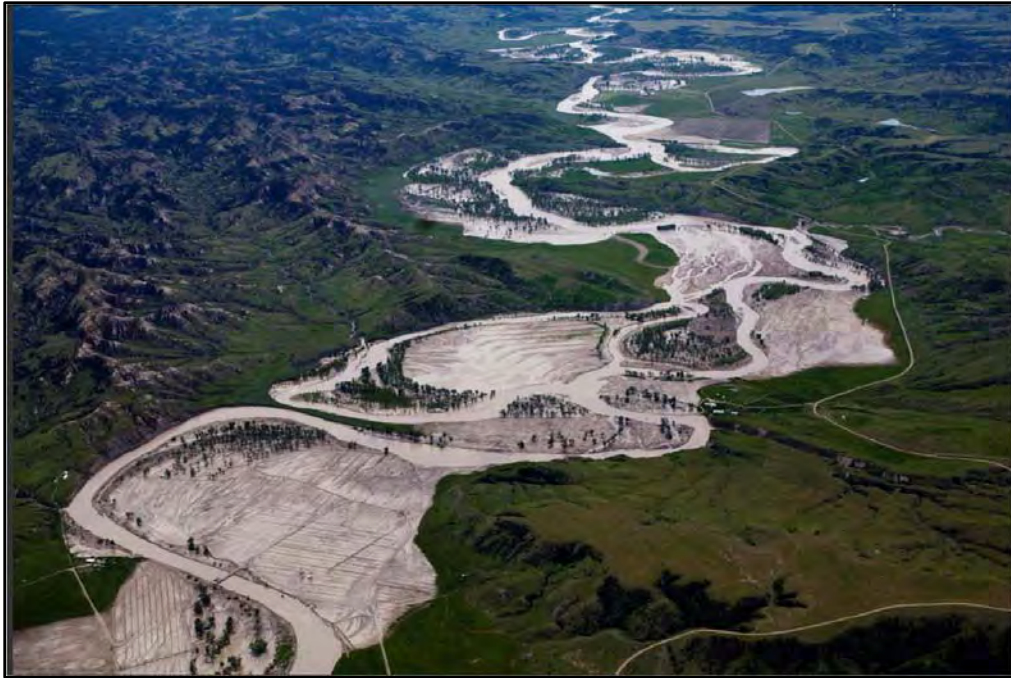
**Figure 60. View upstream of floodplain deposition in Reach 1 (RM 36) (©www.kestrelaerial.com).**

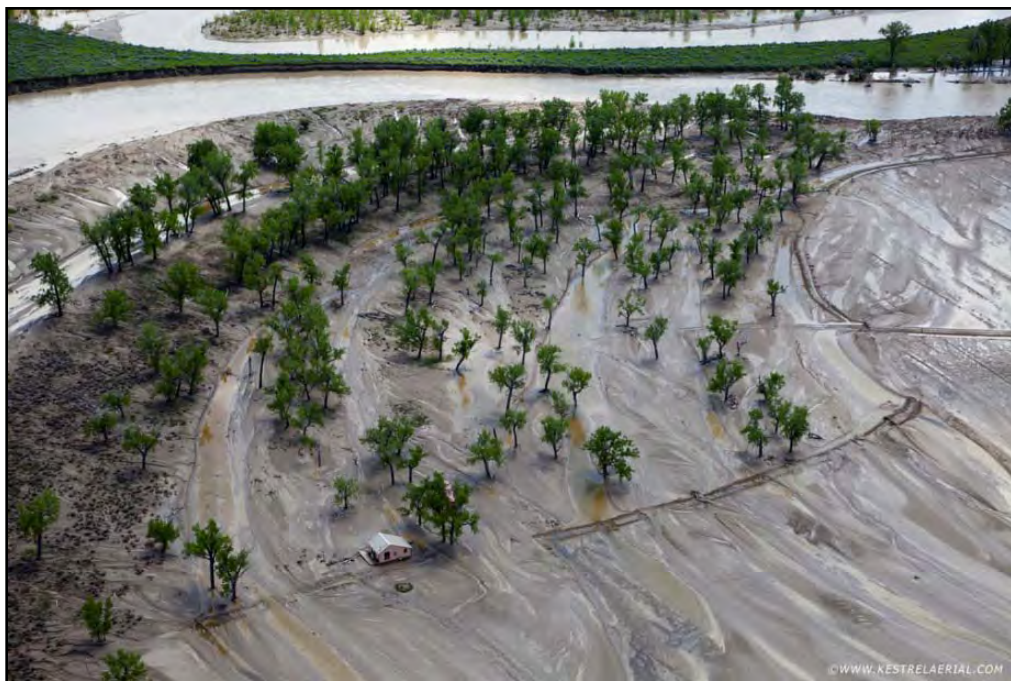
**Figure 61. Floodplain deposition on meander core at RM 35, Reach 1 (©www.kestrelaerial.com).**

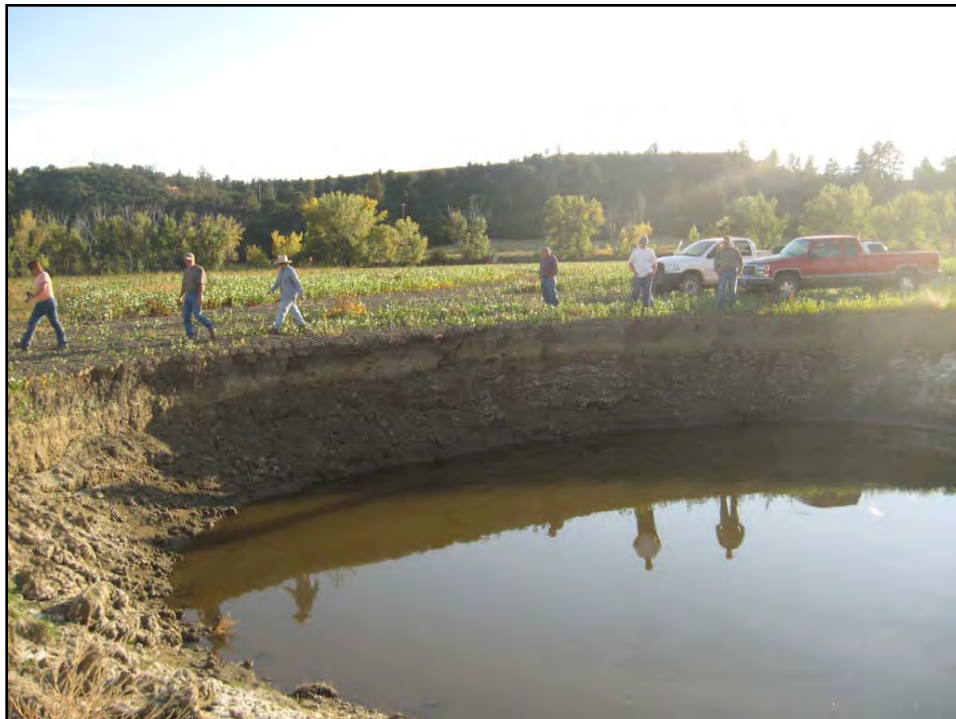
**Figure 66. Large floodplain scour hole formed by velocity concentrations through a breached elevated ditch that served as a floodplain dike, RM 50.**

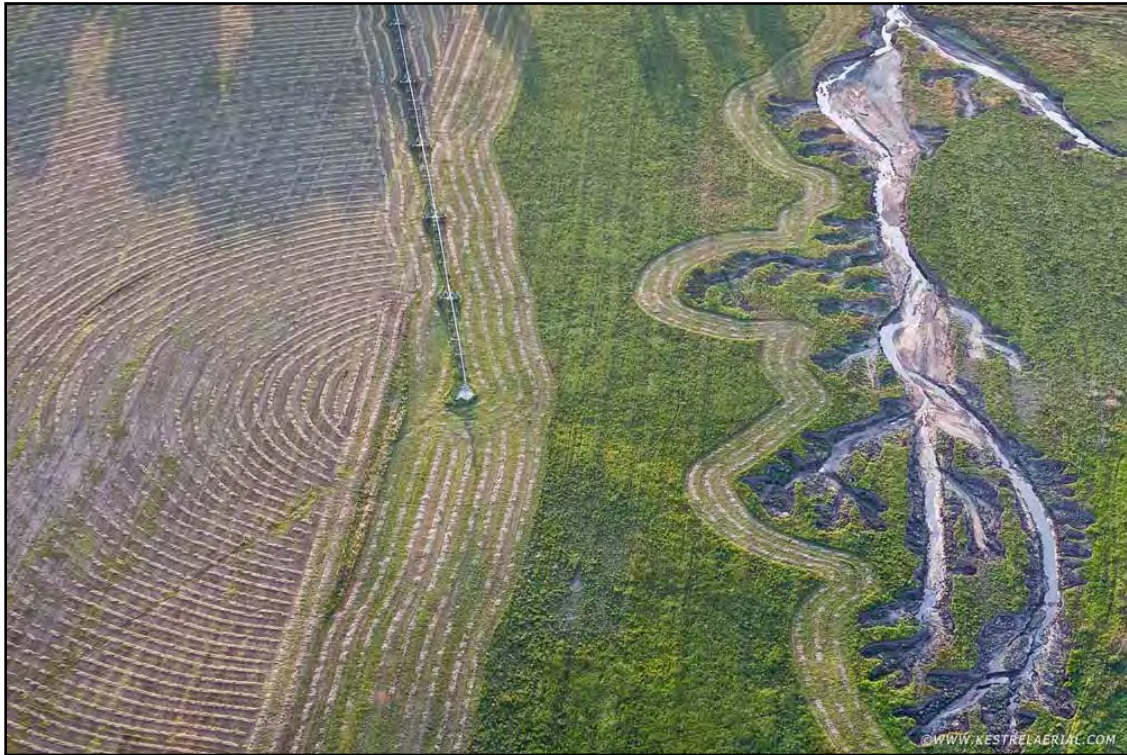
**Figure 67. Fall 2011 land use modifications around area of floodplain scour near Ryegate (©www.kestrelaerial.com).**

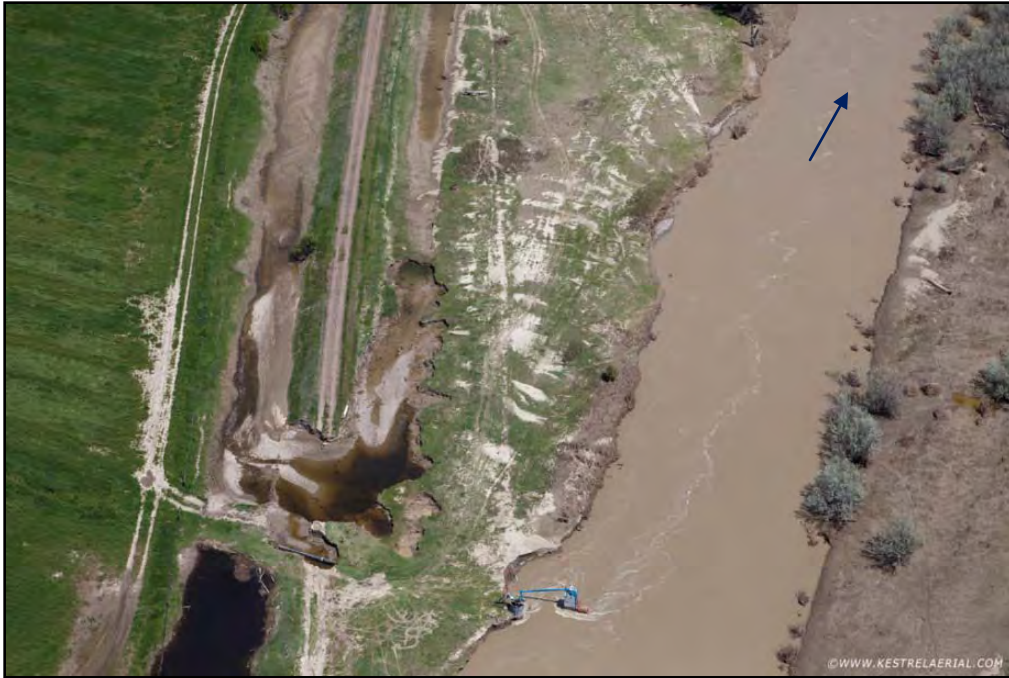
Pump site damage is commonly due to bank erosion at the pump site, and in some cases, erosion of receiving ditches (Figure 68) or channel scour at the pump site. In many cases pump sites were completely lost due to bank erosion (Figure 69). Several pump sites were lost due to channel avulsions where the new channel by-passed the pump.

**Figure 68. Pump site erosion and receiving ditch damage, RM 195.2 (©www.kestrelaerial.com).**

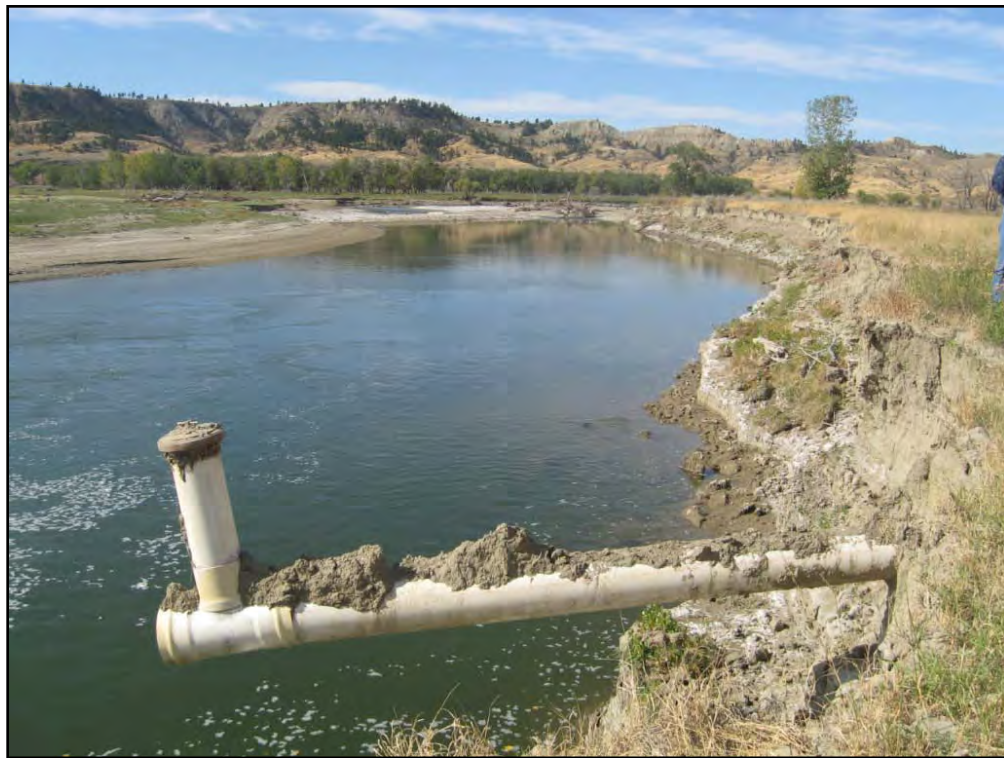
**Figure 69. View downstream of destroyed pump site, RM 25.**

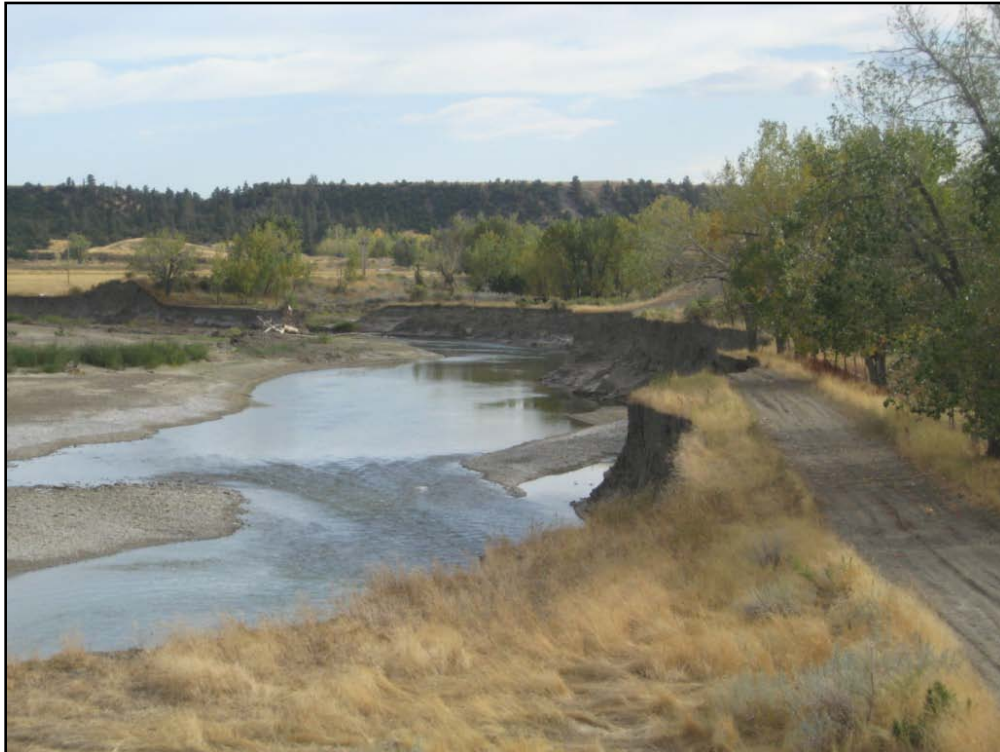
The transportation infrastructure damaged by the flood includes roads and bridges that were impacted by both bank erosion and avulsion. In lower reaches of the river, farm access roads on erodible Bearpaw shale were seriously damaged and in some cases completely lost (Figure 70). At River Mile 120, an avulsion at Harvey Road completely destroyed a road embankment that crossed the river floodplain (Figure 71). Upstream of Melstone, some of the old railroad grade bridges were damaged; many of these bridges continue to provide road access, although several appear to be largely abandoned (Figure 72).

**Figure 70. View upstream of field road damage, RM 43.**

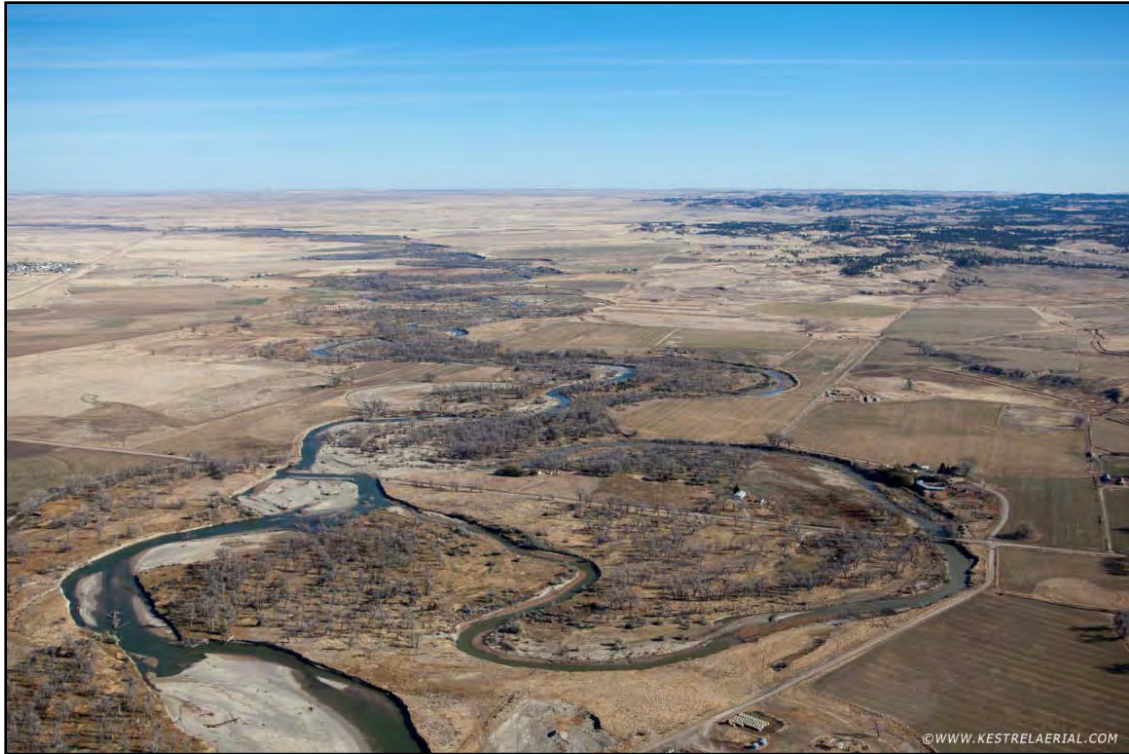
**Figure 71. View downstream of an avulsion at Harvey Road (RM 120) that destroyed a road embankment (©www.kestrelaerial.com).**
