## Musselshell River Flood Rehabilitation River Assessment Triage Team (RATT) Summary Report

Lower Musselshell Conservation District

Applied Geomorphology, Inc.

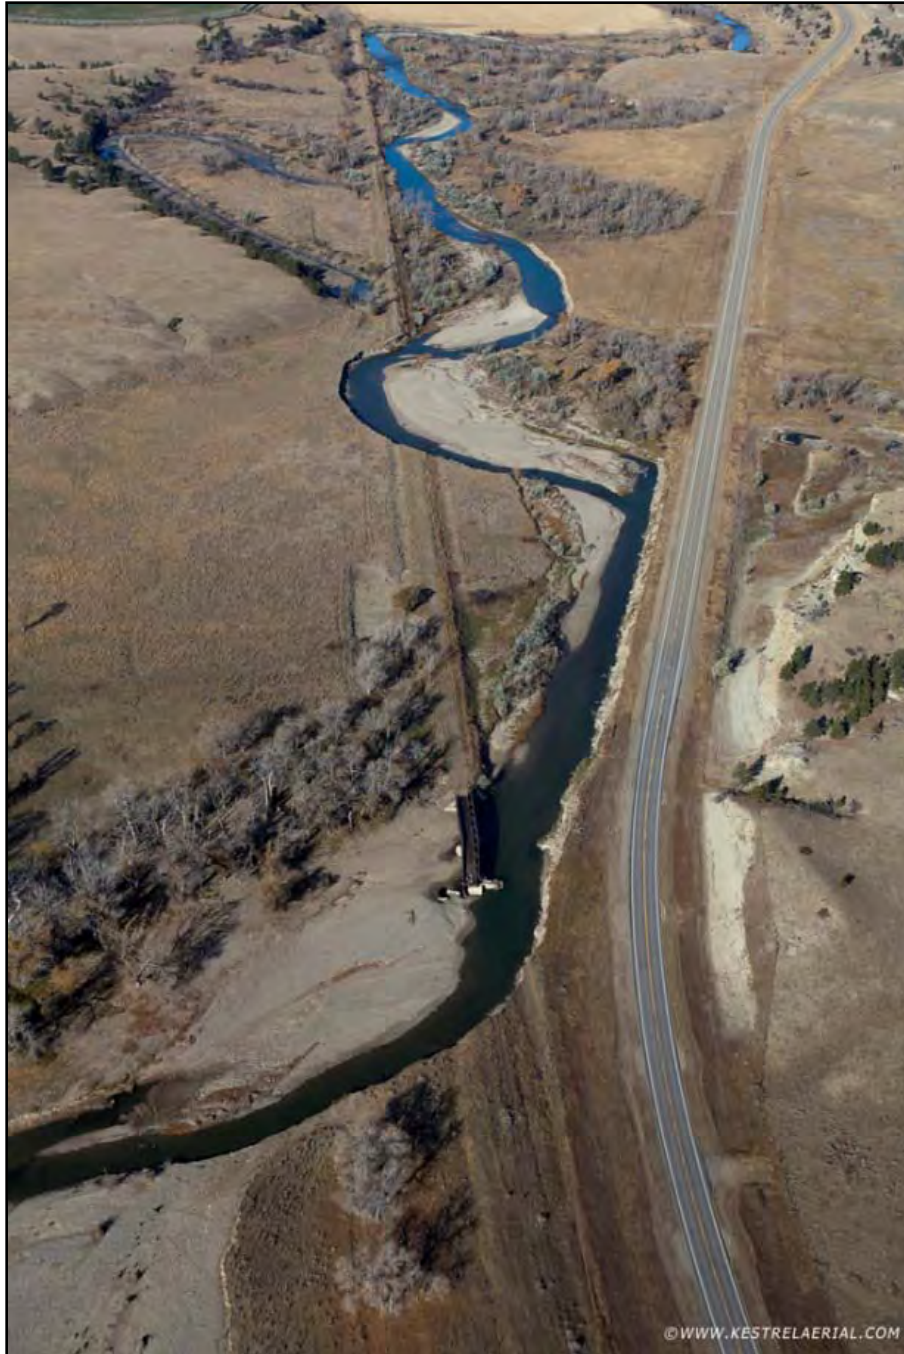
**Figure 72. View upstream of flanked railroad bridge, RM 233 (©www.kestrelaerial.com).**

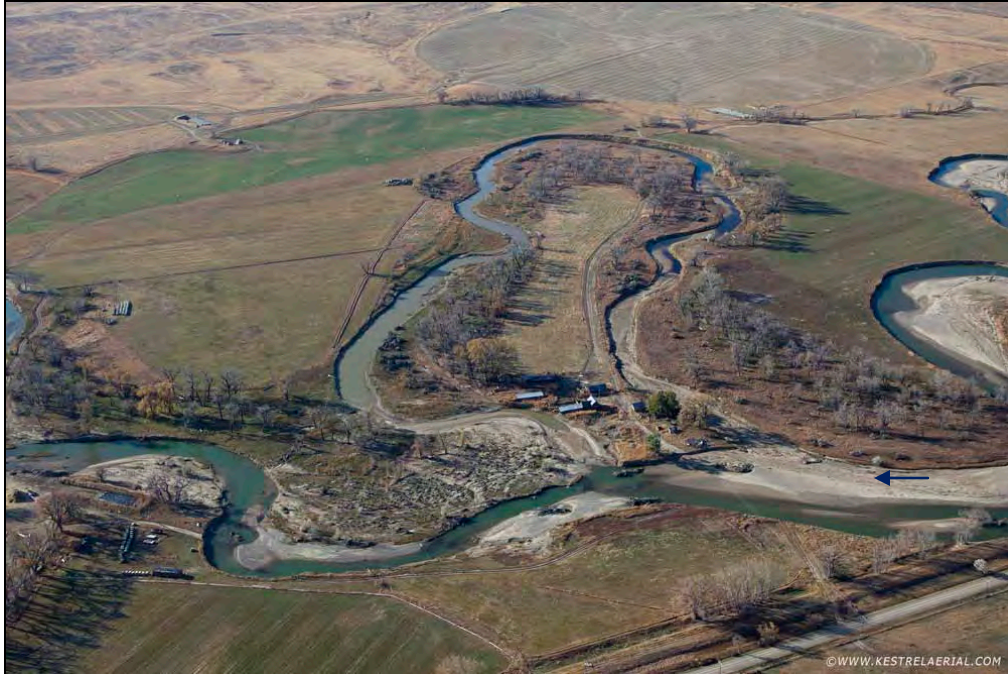
**Figure 73. View south of complete avulsion, RM 222, upstream from Lavina.**

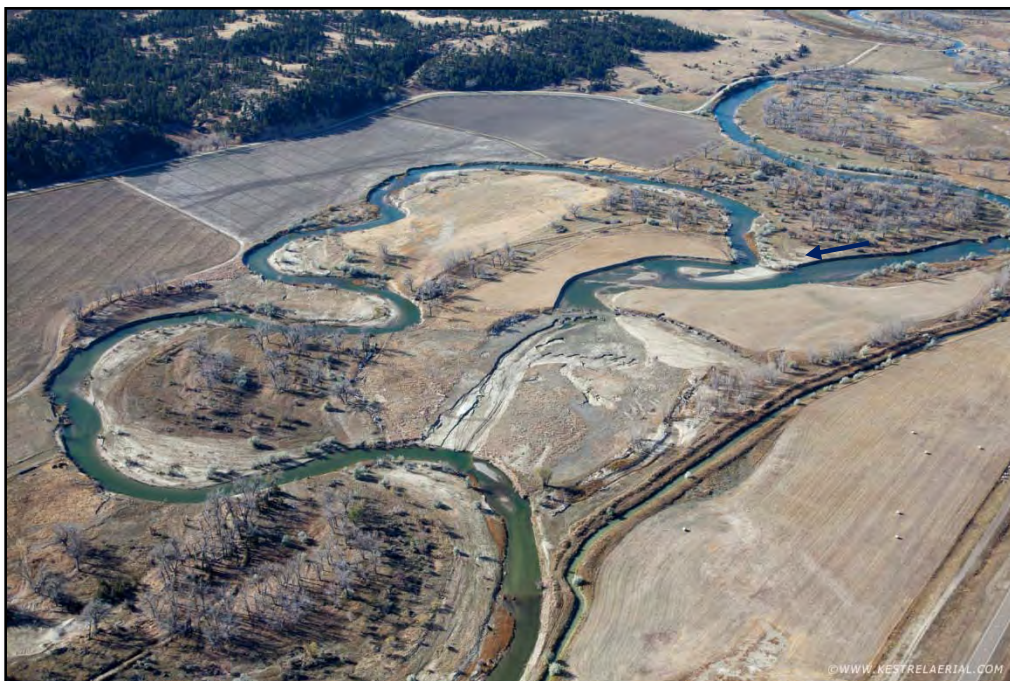
**Figure 74. View upstream of partial avulsion, RM 165.**

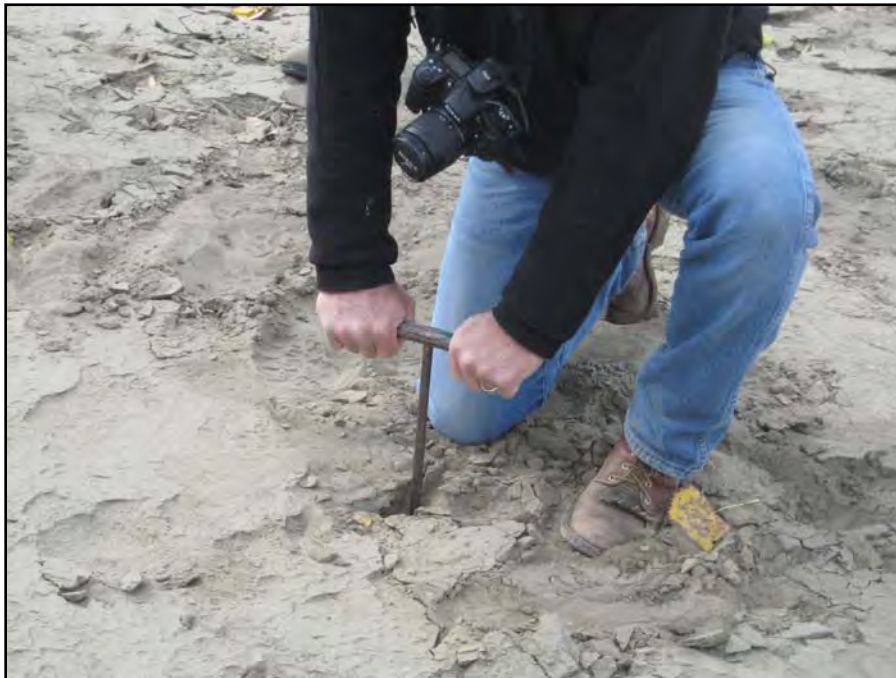
**Figure 75. Massive sand deposition on irrigated field (3 ft probe), RM 43.**

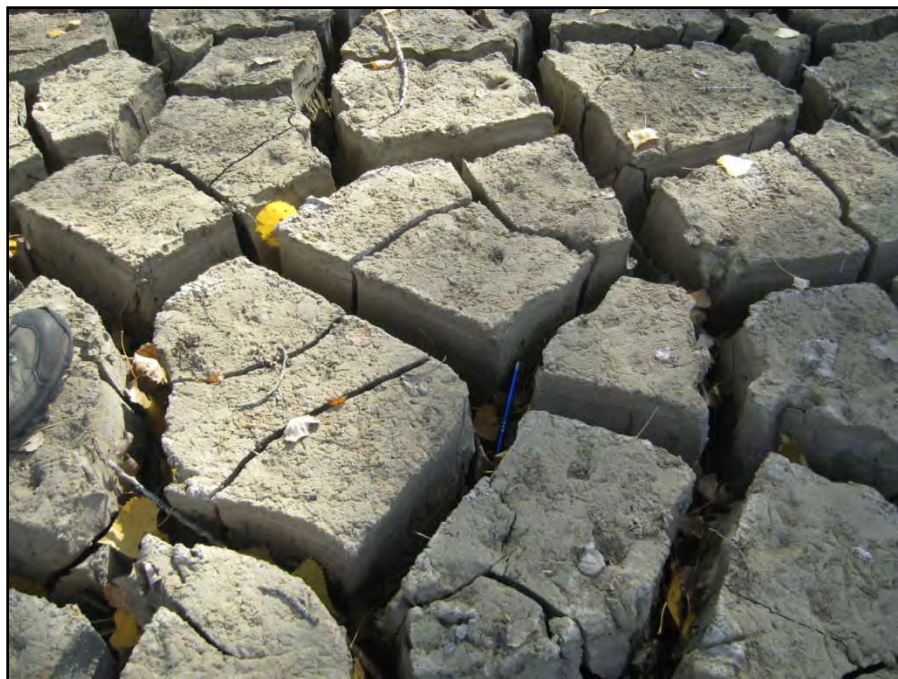
**Figure 76. Deep desiccation cracks in floodplain deposits, RM 57.**

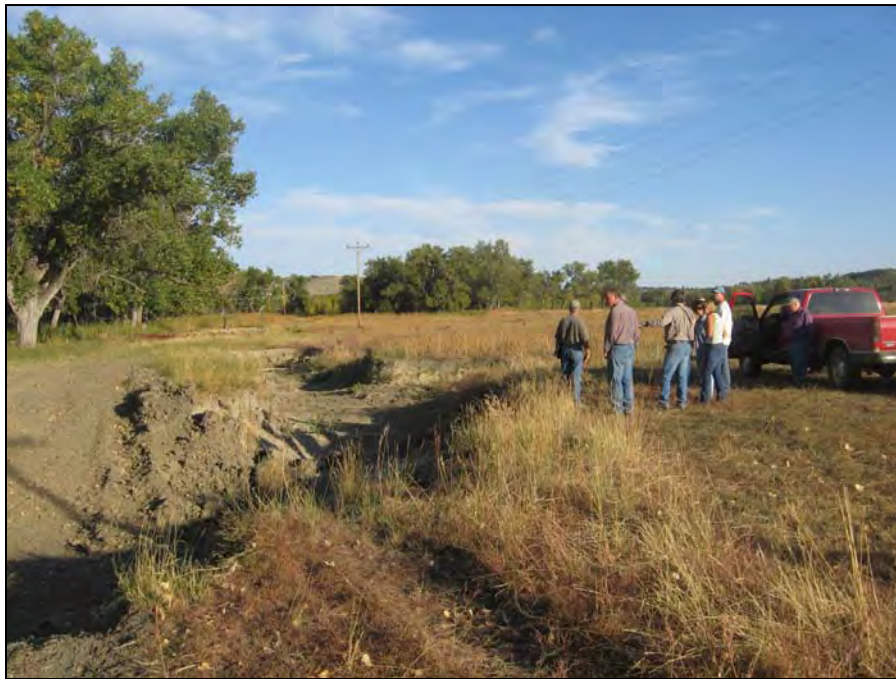
**Figure 78. Example of floodplain scour extending into field, RM 27.5.**
