Riparian Protections

Applicability

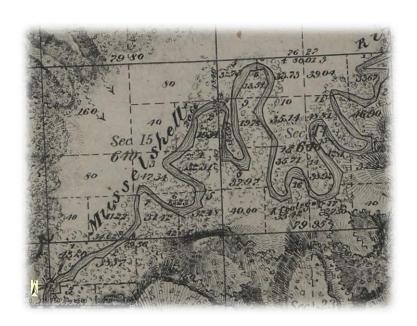
Figure 1. 1883 survey map of Musselshell Valley below Musselshell.

General Land Office (GLO) survey maps show that in 1883, the Musselshell River historically supported a wide berth of woody vegetation where irrigated fields exist today. The floodplain clearing that has taken place over the past 130 years has reduced the ability of the river corridor to resist erosion and remain stable during floods. In 2011, flooding resulted in not only floodplain erosion, but also massive recruitment of riparian seedlings, both native and non-native. Cottonwood and willow germination was extensive throughout the river corridor, concentrating on bare sand,

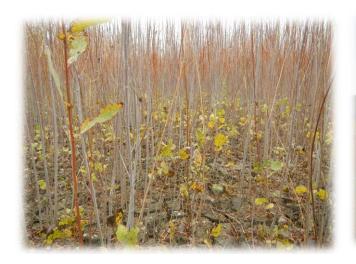
Figure 3. Cottonwood and willow growth in 2011 abandoned channel. Photo credit: Karin Boyd.

Abandoned channels maintain depressions that provide riparian vegetation easy access to shallow groundwater. Some of the most rapid and dense riparian recovery following the 2011 flood has been in such channels. Survival rates are high, the vegetation is dense, and the land is not conducive to crop production. These areas are recommended for active riparian protections through carefully managed land uses, especially short-term riparian fencing and/or long-term grazing systems.

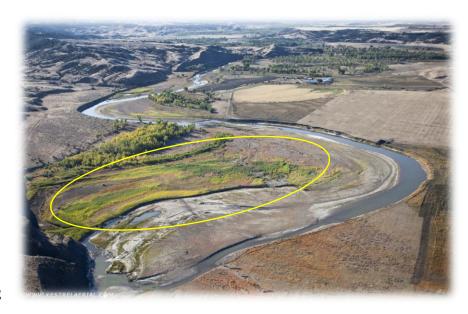
Figure 4. Example of channel margin area supporting new woody riparian growth. Photo credit: Chris Boyer, Kestrel Aerial Services, Inc.

that are above the most severe influences of winter ice and spring runoff, but close enough to the channel to provide shallow groundwater access and some river disturbance. In general, these areas are between the area wetted by the typical spring runoff (~2-year event) and the ~5year flood. Most of this ground would be within the overall channel cross section that enlarged during the 2011 flood, and has remained several feet above the main channel. These

near channel areas are where most seedlings typically establish, hence require special attention with respect to riparian protections. Riparian areas on the low floodplain and within abandoned channels should be carefully managed for livestock use, especially in the winter months when livestock can have the biggest impact on woody plants. If grazing is used to help manage vegetation, a grazing plan is necessary.
