Abandoned Channels (Avulsions)

Applicability

The following Best Management Practices (BMPs) summarize several recommended approaches to managing abandoned channels within the Musselshell River stream corridor. The information is based upon the on-site evaluation of floodplain features and discussions with producers and is intended for producers and residents who are living or farming in areas where abandoned channel segments exist.

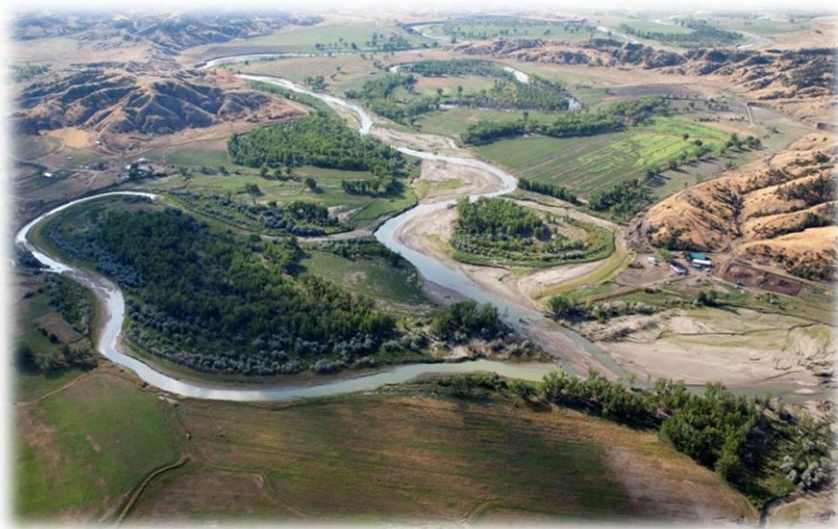
Figure 1. 2011 avulsion, Musselshell River.

Perhaps the most dramatic 2011 flood impact on the Musselshell River was the number of avulsions that occurred over the period of a few weeks. An “avulsion” is the rapid formation of a new river channel across the floodplain that captures the flow of the main channel thread. River avulsions typically occur when rivers find a relatively steep, short flow path across their floodplain. When floodwaters re-enter the river over a steep bank, they form headcuts that migrate upvalley, creating a new channel, causing intense erosion, and sending a sediment slug down stream. If the new channel completely develops, it can capture the main thread, resulting in a successful avulsion. If floodwaters recede before the new channel is completely formed, or if the floodplain is resistant to erosion, the avulsion may fail. From near Harlowton to Fort Peck Reservoir, 59 avulsions occurred on the Musselshell in the spring of 2011, abandoning a total of 39 miles of channel. The abandoned channel segments range in length from 280 feet to almost three miles. One of the reasons there were so many avulsions on the Musselshell River in 2011 is because the floodwaters stayed high for weeks, allowing channels to fully develop on the floodplain

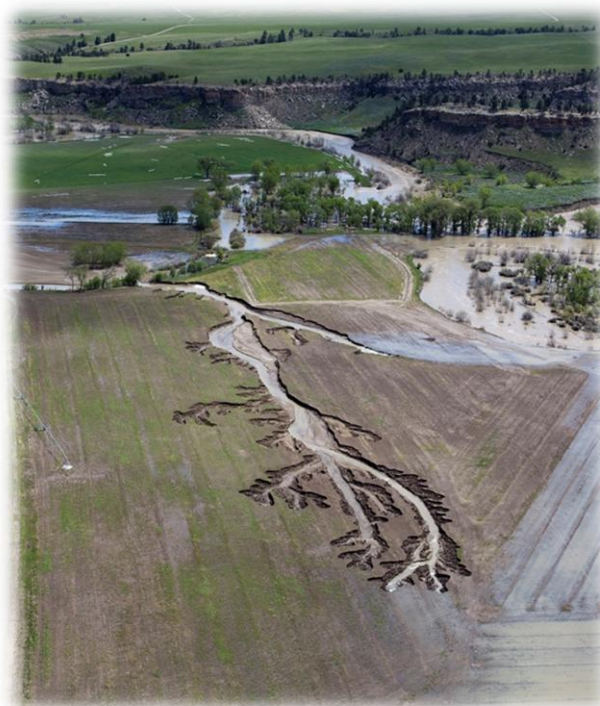
Figure 2. Upstream-migrating headcuts showing creation of avulsion path, 2011.

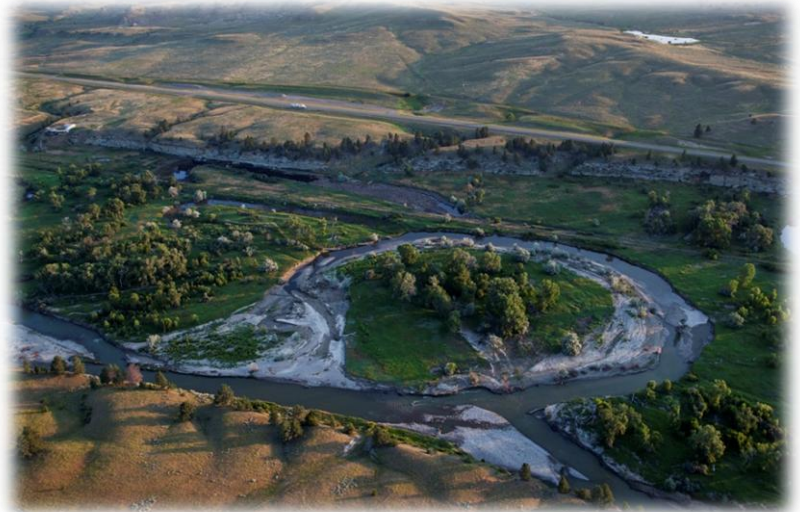
Figure 3. Meander cutoff formed by 2011 flood.

The most common form of an avulsion that occurred in 2011 is a bendway cutoff. This happens when a meander bend forms a new, shorter channel through its core. This is a common, natural river process that leaves floodplain swales known as oxbows. As they evolve, oxbows generally form first as open water wetlands, then continually fill in with fine sediment to become a low, arc-shaped floodplain swale/wetland. Meander cutoffs have posed problems for producers in the corridor, as the avulsions have commonly isolated land, eroded fields, and abandoned infrastructure (pump sites, diversions, bridges, etc.). As such, these sites have been commonly considered for re-activation; that is, putting the river back into its original pre-avulsion channel.

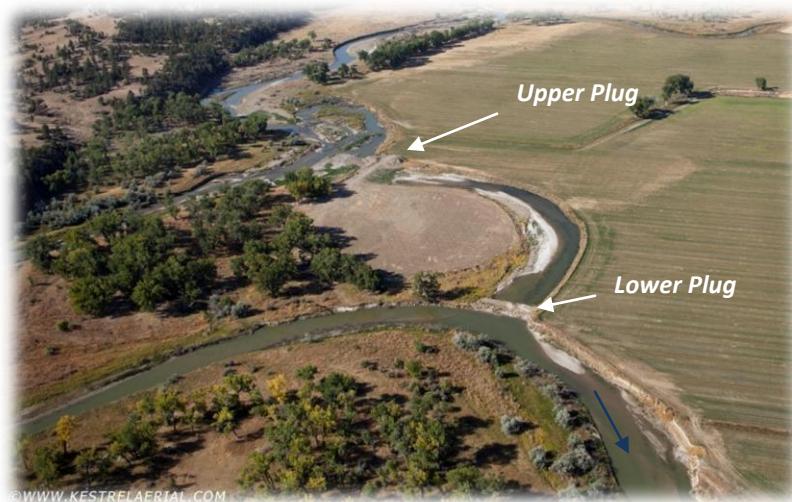
Figure 4. View upstream of plugged avulsion.

In most cases, these issues have proven insurmountable, and avulsions have been left in place. As described in Section II of this BMP, there may be significant long-term benefits to this approach. In some cases, those issues are less severe, and producers have pursued re-activating the old channel. This has generally been achieved by placing plugs across the avulsion and using the plug as an access route/crossing. If this approach is undertaken, the following considerations are recommended:

- a. Rather than completely isolating the avulsion with high plugs or completely filling it, it can be designed to serve as a high flow channel that will contribute to groundwater recharge, water quality improvement, riparian renewal, floodwater storage, and floodplain protection. These benefits are all described in Section II of this BMP. Converting an avulsion to a higher flow feature requires the construction of a stable grade control on the upstream end that is well-tied- in to the active streambanks, and has an elevation crest that is designed to overtop at a set flow. This necessarily requires significant hydrologic design efforts, including an evaluation of the stage/discharge relationship at the head of the avulsion. The downstream face of the grade control will require an armor treatment to prevent its failure due to overtopping scour and headcutting.

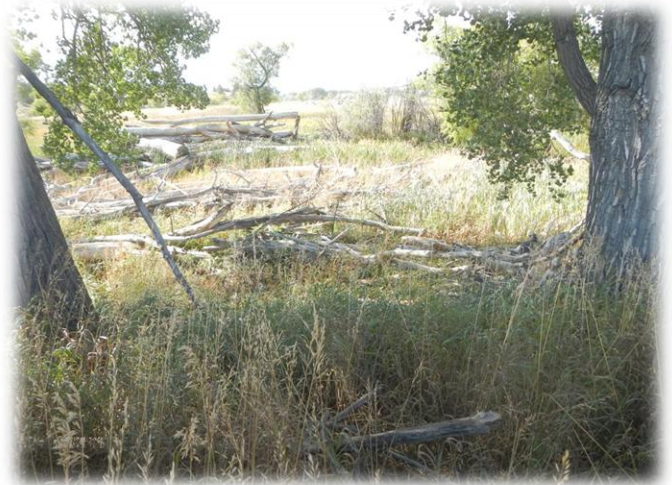
Figure 5. View of flood debris trapped in wetland swale from edge of irrigated field. Photo credit: Karin Boyd.

- c. **Flood Protections:** Several producers in the basin have noted that flooded fields were less impacted if they were protected by vegetated floodplain swales that captured sediment and debris. These features can act as a “strainer” during floods that trap potentially damaging sediment and woody debris. Oxbows also provide flood retention, storing water to reduce flood discharges downstream and prolong streamflow.
