June 27, 2019

Musselshell River Flood Rehabilitation River Assessment Triage Team (RATT II) 2018 Summary Report

Prepared By:
Karin Boyd
Applied Geomorphology, Inc.

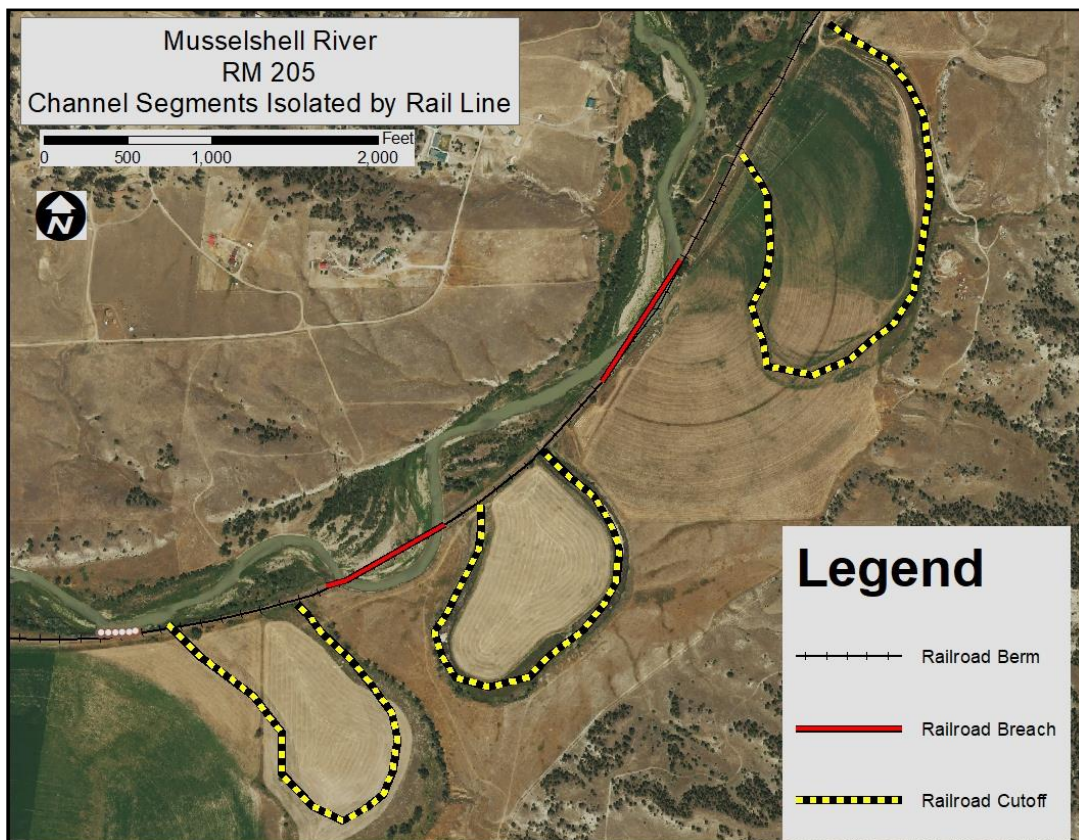
Figure 4. 2011 Air photo showing mapped meander segments isolated by rail berm above Musselshell.

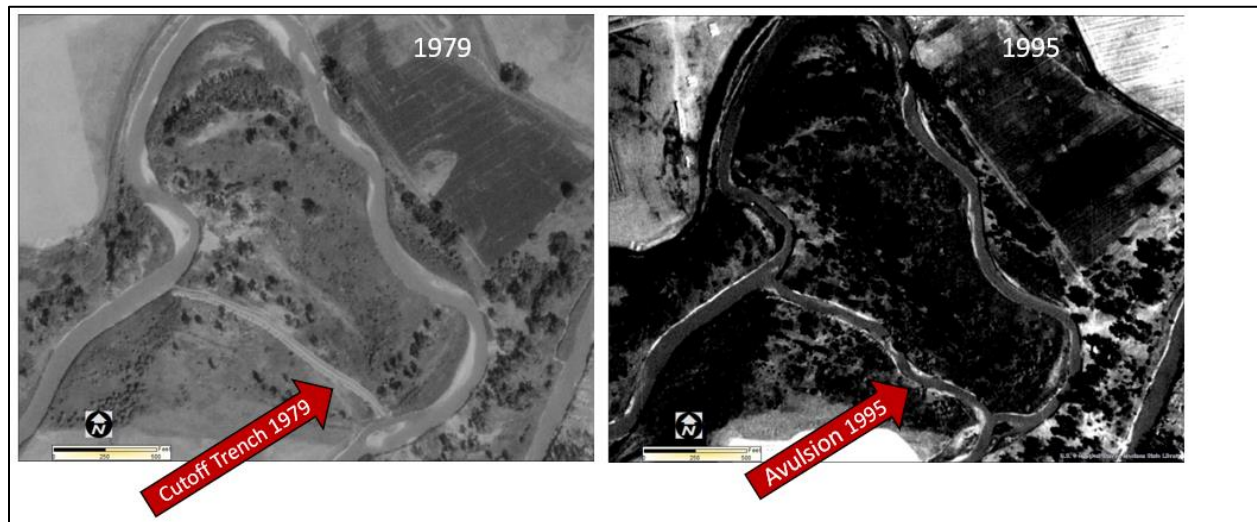
In addition to the straightening by the railroad in the early 20th Century, the river has been shortened as part of agricultural development as well. In looking at LiDAR data and older imagery it is clear that excavation of “cutoff trenches” was a pervasive practice, presumably intended to relocate the river away from fields (Figure 5).

Figure 5. Example of a cutoff trench dug by 1979 that drove an avulsion by 1995; trench is about 1,200 feet long.

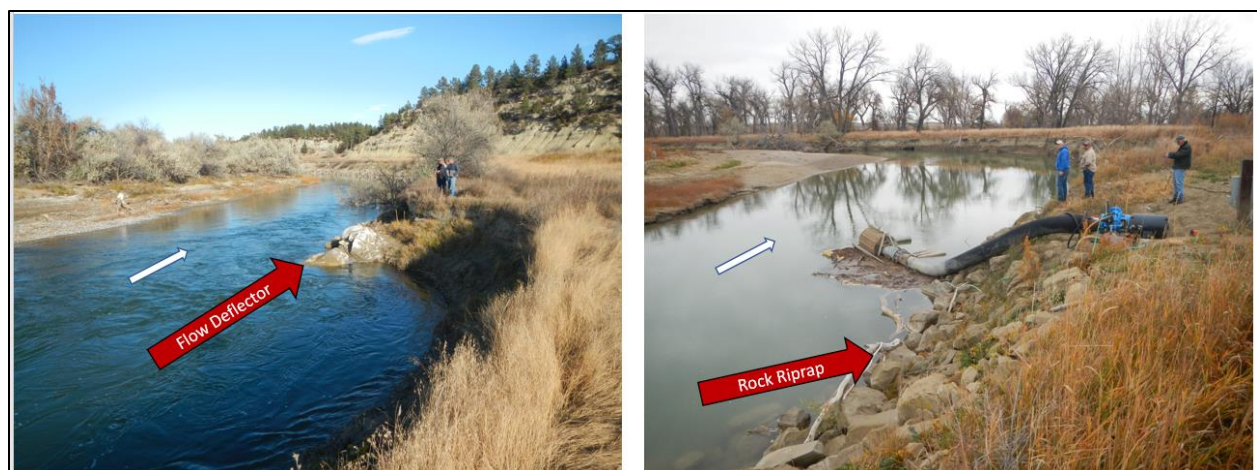
Bank armoring is common on the river, especially where fixed infrastructure (bridges, pumps, canals) or productive fields have been threatened by bank erosion. Most armor consists of either flow deflectors or rock riprap (Figure 6). This armoring has locally arrested channel migration and hardened the location of the river, sometimes in locations where the river has been intentionally straightened.

Figure 6. Example flow deflector (left) and rock riprap (right) placed to protect infrastructure.

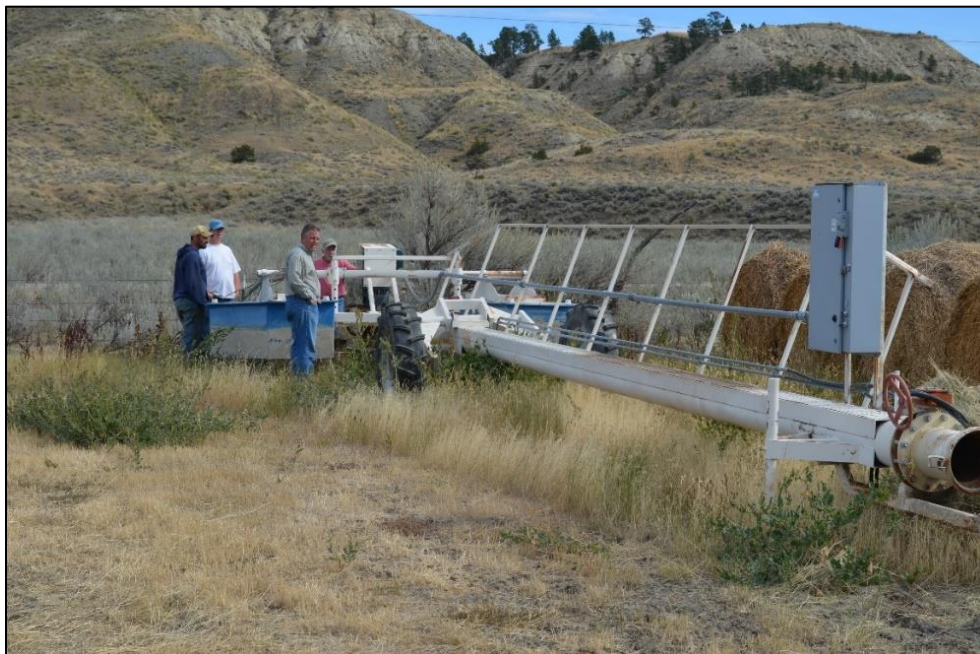
Figure 8. Example portable pump on lower river (2011).

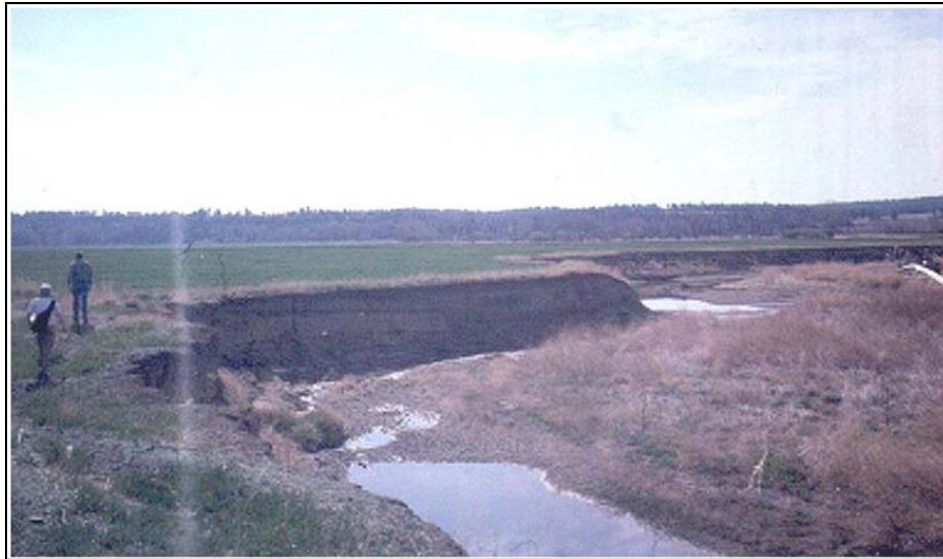
Floodplain development over the last century has included the conversion of riparian forest to irrigated fields. Hundreds of acres of riparian floodplain have been cleared, most of which occurred prior to the 1950s. Figure 9 shows a photo of the floodplain condition in the early 2000s, with a farmed high bench next to the active channel, and a relatively low poorly vegetated inset surface on the other. Figure 10 shows riparian clearing and field development that occurred sometime between 1953 and 1979; also note the constructed trench in this photo sequence that captured and moved the river to accommodate the newly developed field.

Figure 9. Developed floodplain, Musselshell River (Musselshell Conservation District, 2004).

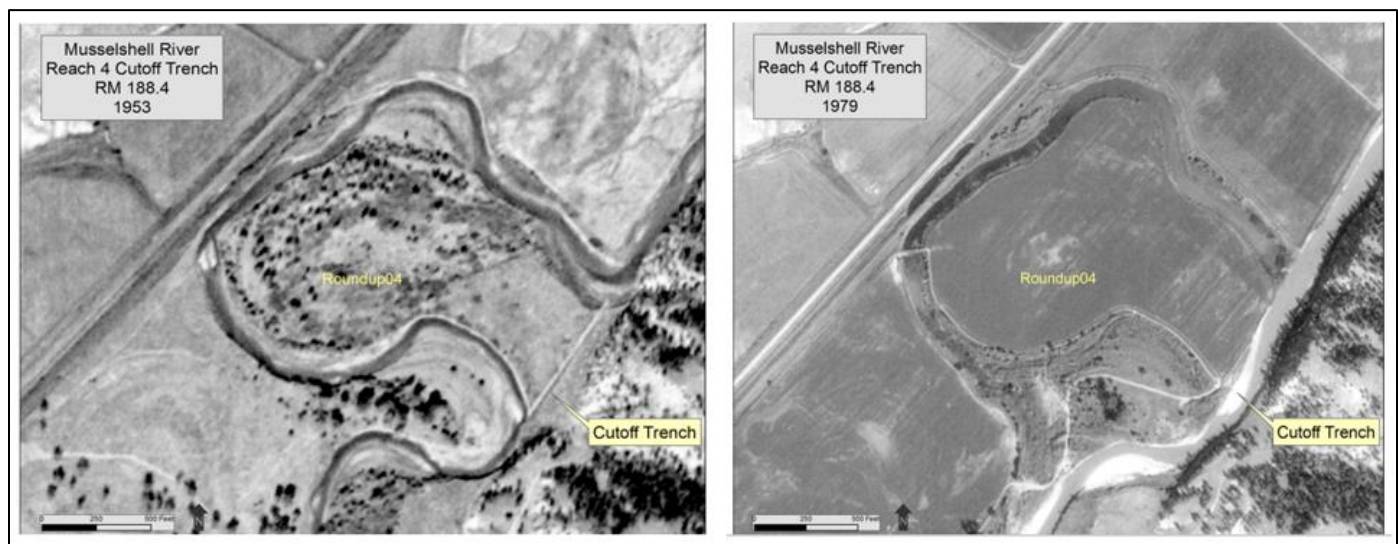
Figure 10. Air photo comparison from 1953 (left) and 1979 (right) showing clearing of woody riparian vegetation as part of field development.

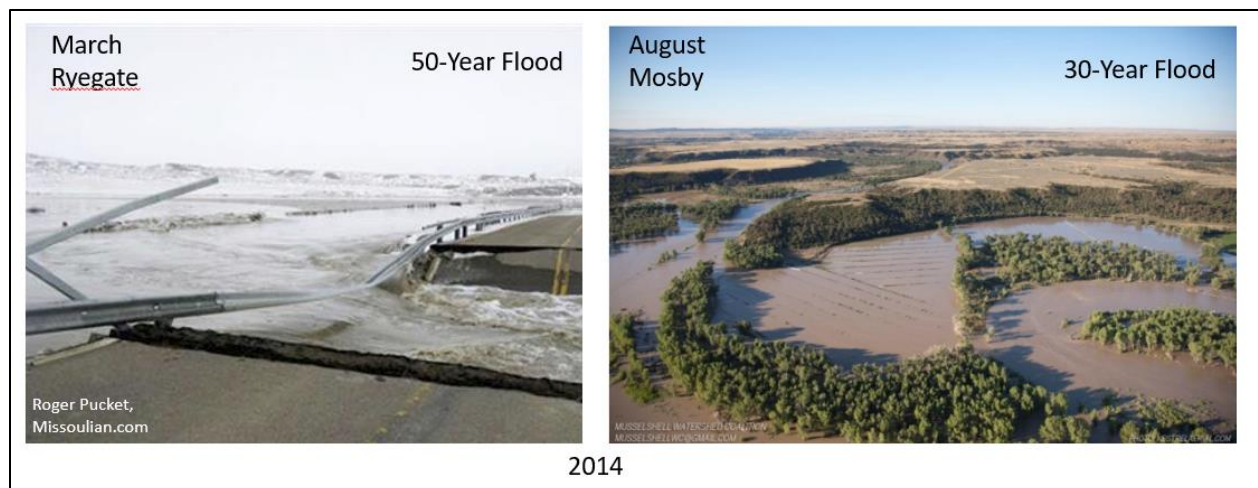
Figure 15. Photos from the 2014 flood showing March ice-jam flooding in Ryegate and August flooding at Mosby (Missoula.com and Kestrel Aerial Services).

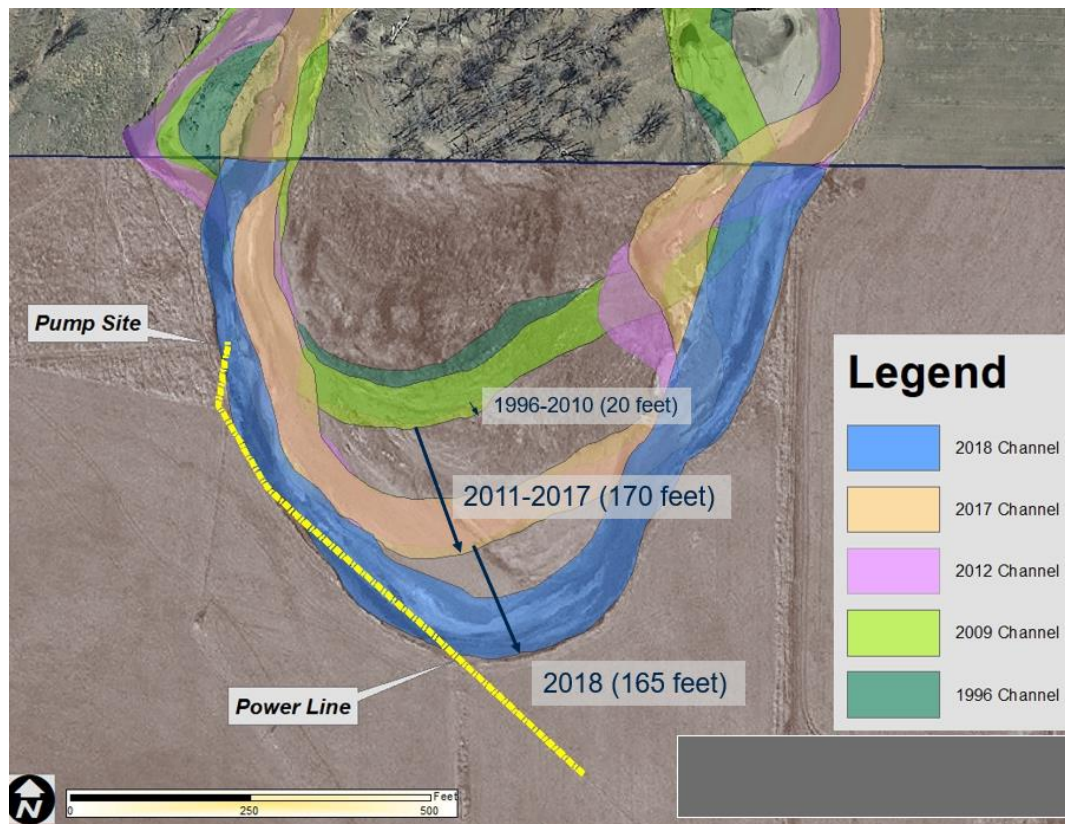
Bank erosion was the most common problem we were shown on the river. In many cases this erosion took out pump sites (Figure 18 and Figure 19) or fences (Figure 20). In places outside bend erosion during the 2018 flood exceeded 100 feet. Typically, the biggest problems were where the erosion was threatening infrastructure or roads. Figure 21 shows high bank erosion into a field road and Figure 22 shows erosion into an access road (old railroad grade) just downstream of the Delphia-Melstone siphon.

Figure 19. Digitized banklines for site shown in Figure 18.

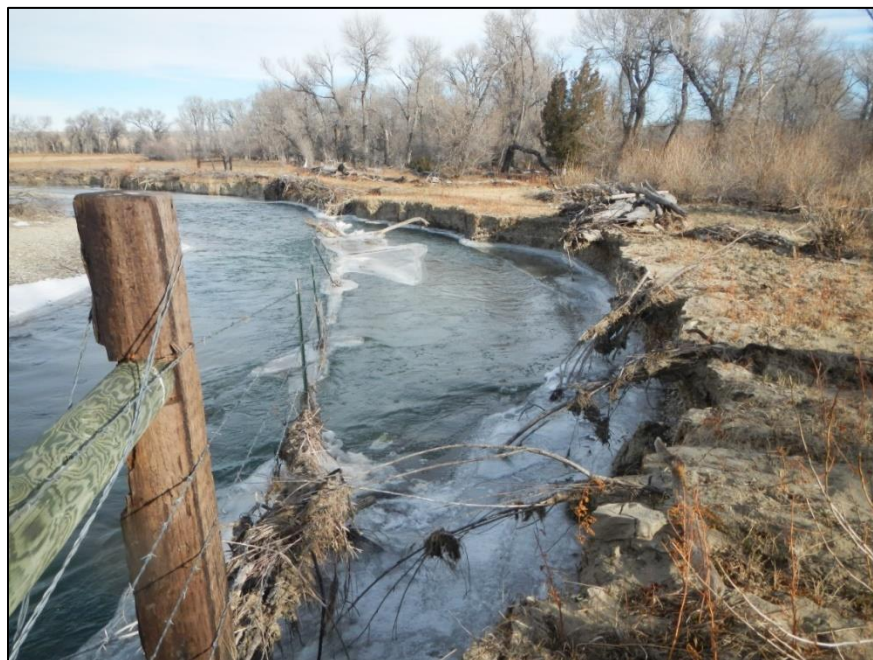
Figure 20. View upstream of erosion through fenceline above Roundup.

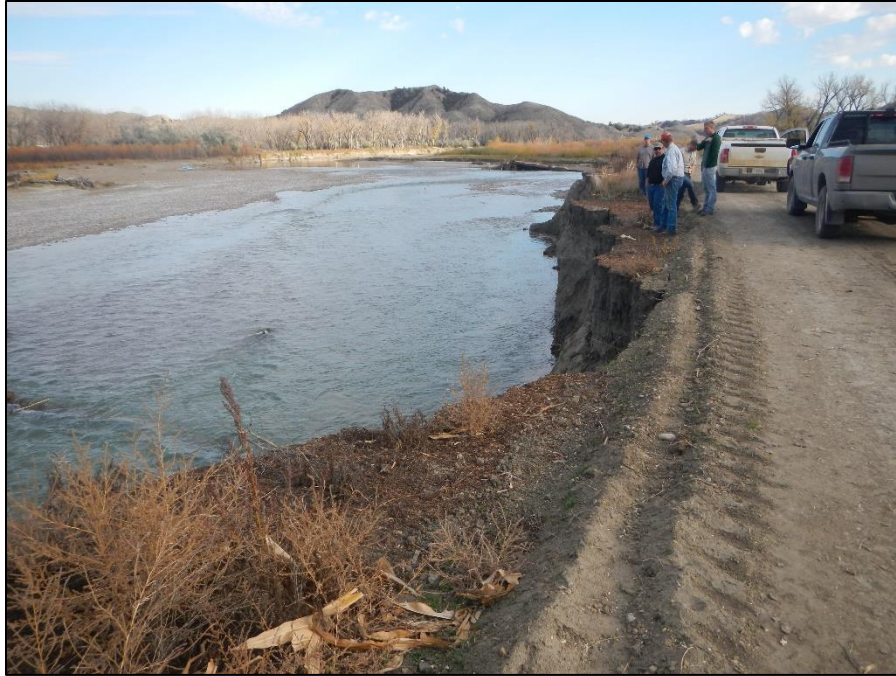
Figure 21. View upstream of high bank erosion into road below Mosby.

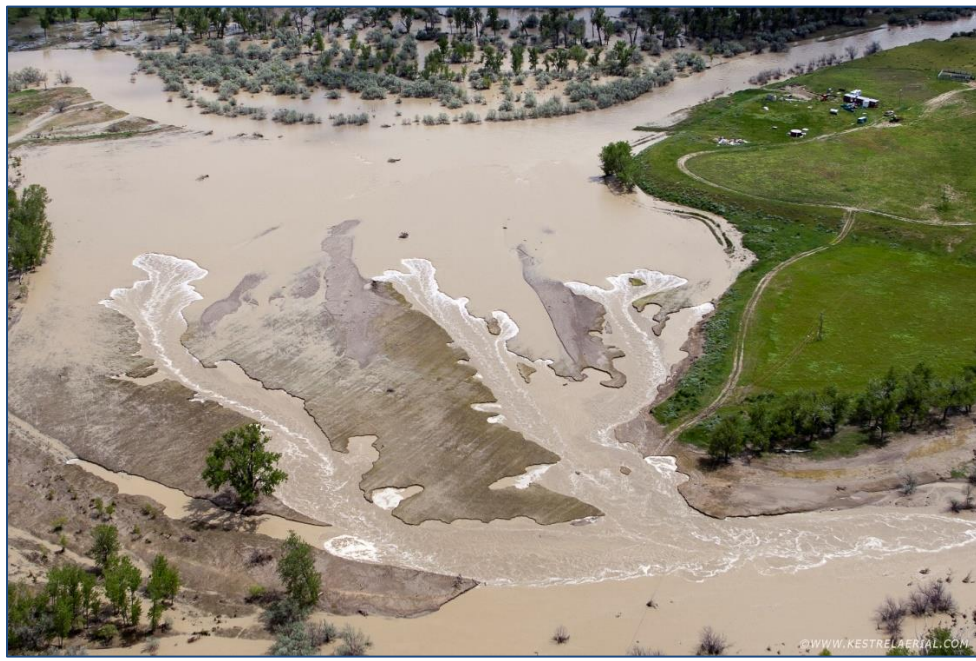
Figure 28. 2011 flood photo of avulsion in process (upstream migrating headcuts) below the Musselshell River Road Bridge (Kestrel Aerial).

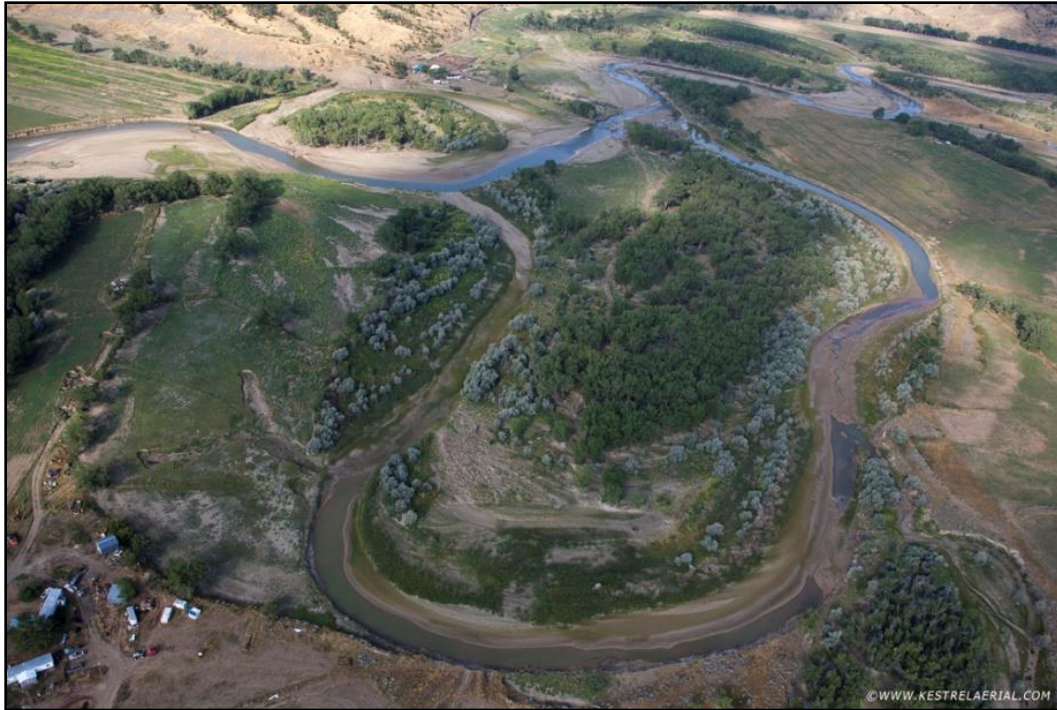
Figure 29. Abandoned channel below Mosby resulting from 2011 avulsion/chute cutoff (Kestrel Aerial).

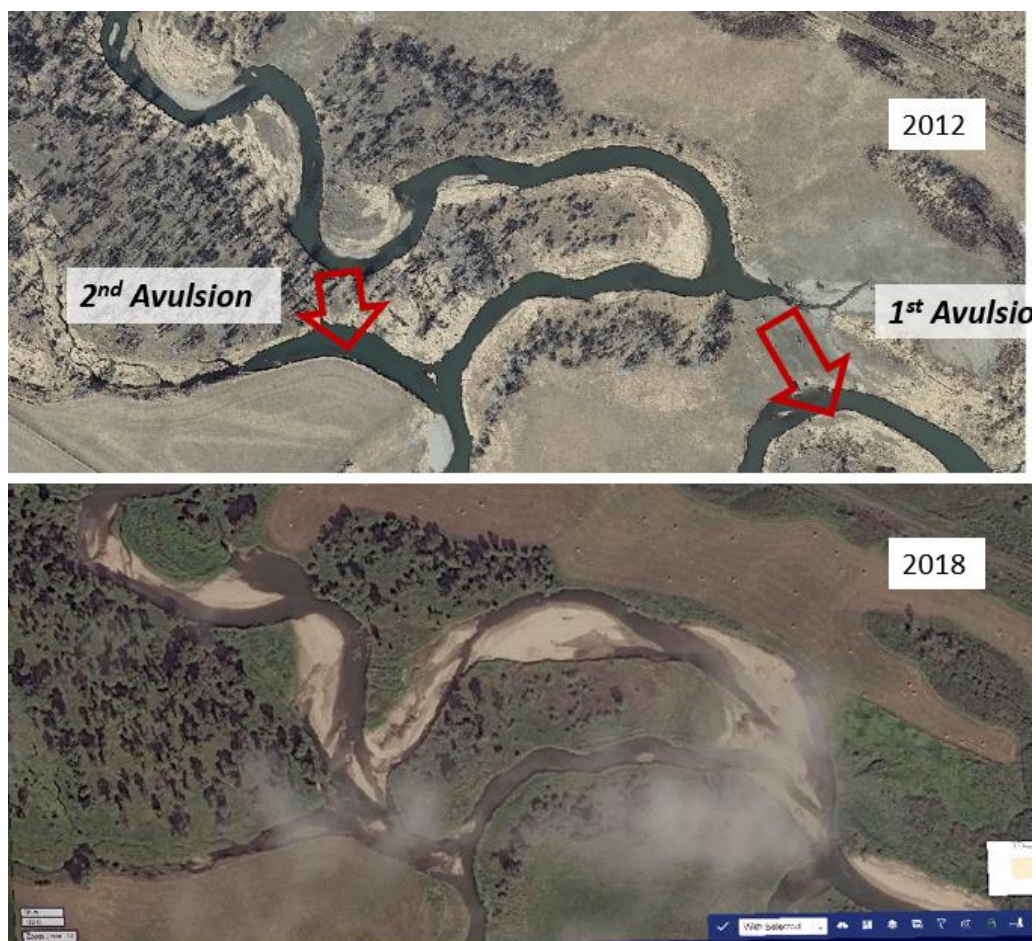
Figure 31. Wheatland County site showing conditions in 2012 (top) and 2018 (bottom).

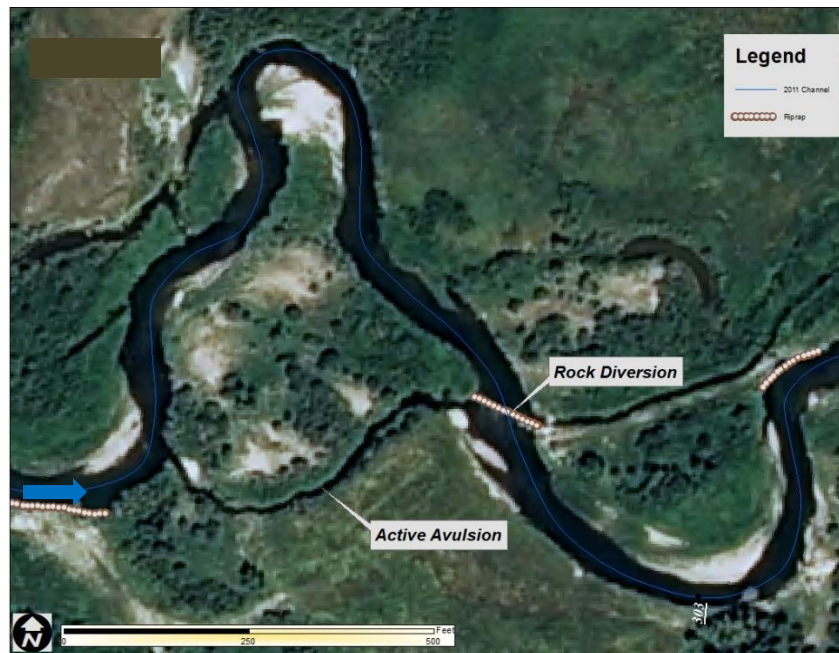
The biggest risk to operations with an avulsion tends to be the isolation of pump sites or diversions from the river, as well as the secondary effects of channel steepening and accelerated bank erosion. Avulsions can also isolate fields. Upstream of Harlowton for example, a developing avulsion threatens to bypass a diversion structure (Figure 33). In cases like this it may be most cost-effective to relocate the diversion or consider the conversion to portable pumps.

Figure 33. 2011 air photo showing avulsion channel/meander cutoff.

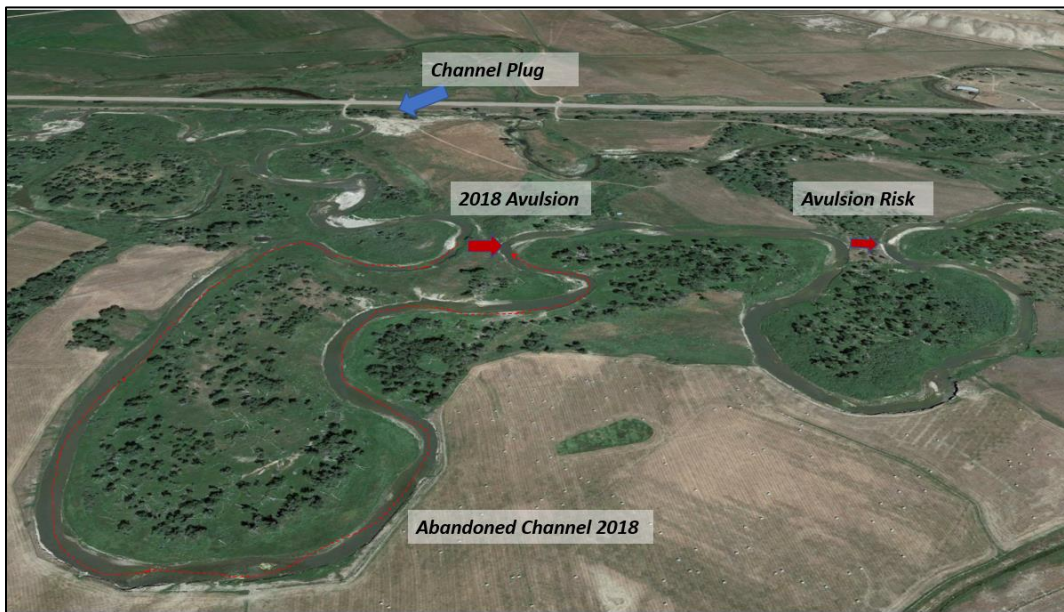
In understanding the evolution of the Musselshell River, it is important to consider the effect of avulsions on channel slope. Figure 34 and Figure 35 show a site near Shawmut, where a long meander loop cut off in 2018 (“2018 avulsion” labeled in Figure 34). Downstream there is another bend that is highly compressed and at risk of cutting off. The 2012 LiDAR data can be used to draw a topographic profile along the post-avulsion channel path, to show how much the river would steepen through the avulsion path. In Figure 35, for example, the 2018 avulsion created a drop of over 5 feet in the river, with another potential 4-foot drop on the bendway downstream. Because of these drops, floodwaters that flow over the neck of a meander will create a waterfall that will downcut, carving a series of headcuts that migrate up through the avulsion path. Once the avulsion has occurred, this headcutting will continue upstream potentially resulting in channel downcutting well upstream of the avulsion itself.

Figure 34. Northward oblique view of avulsion sites on south channel (flow is left to right).

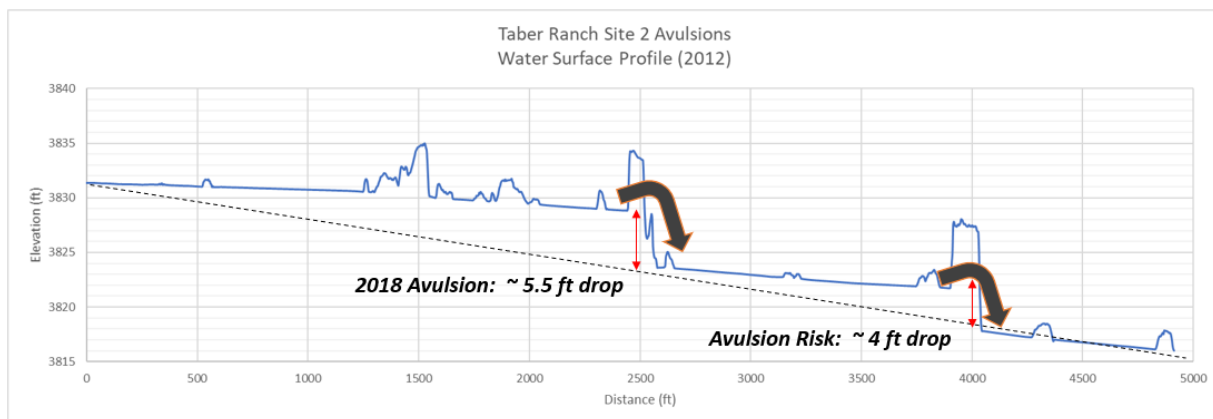
Figure 35. Profile pulled through avulsion paths in Figure 34 showing vertical drops at avulsion points. Dashed line shows potential long-term steepened profile which includes several feet of downcutting above avulsion pints.

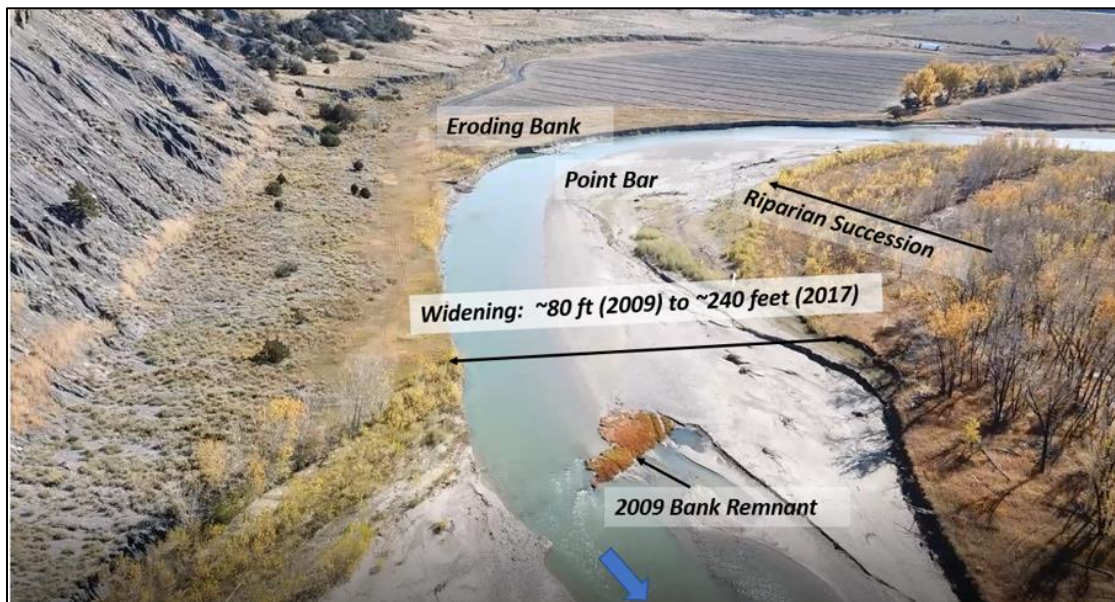
Another common flood response on the river was channel widening. On the lower river, for example, the channel width has tripled in some areas since 2009 (Figure 36). This widening has been accompanied by large gravel bar formation, bank erosion, and riparian expansion on developing gravel bars.

Figure 36. Cumulative impacts of floods on channel process, including widening, point bar formation, bank erosion, and riparian succession (young cottonwood establishment).

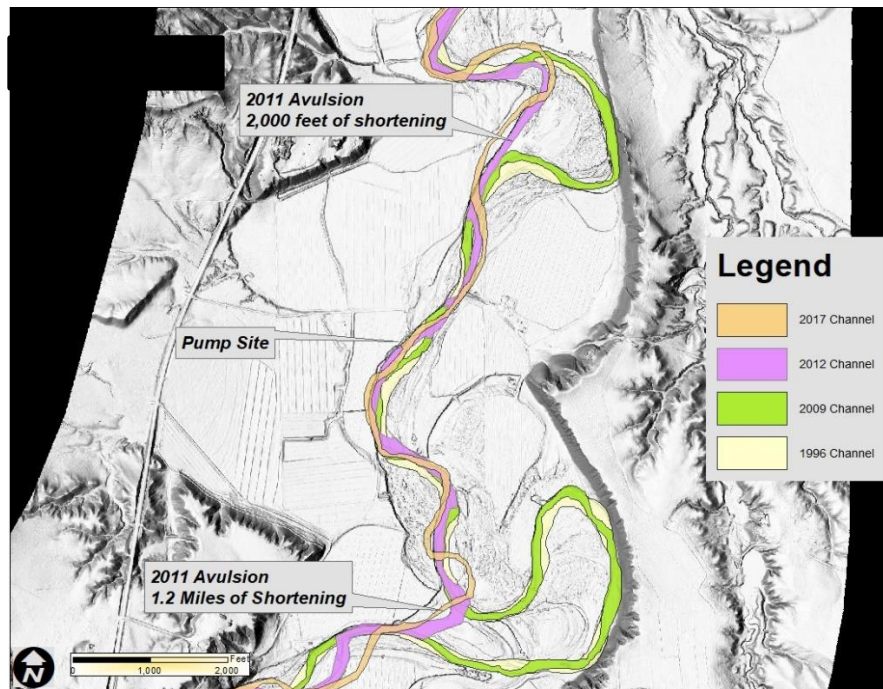
One common channel response to straightening is downcutting because as a channel straightens, it steepens and then has more energy to erode its bed. Vertical downcutting may also occur where there is a high density of bank armoring that prevents the river from gaining length by moving laterally. Figure 37 shows an area above Flatwillow Creek where two avulsions shortened the river by over a mile and a half in 2011. In between the two cutoffs, a pump site was damaged by subsequent bank erosion. There was also clear evidence of downcutting at the pump site, where downcutting was intercepted by a natural grade control formed by a shale reef that crossed the river (Figure 38).

Figure 37. 2012 LiDAR hillshade showing two 2011 avulsions that shortened the river by over 15 miles.

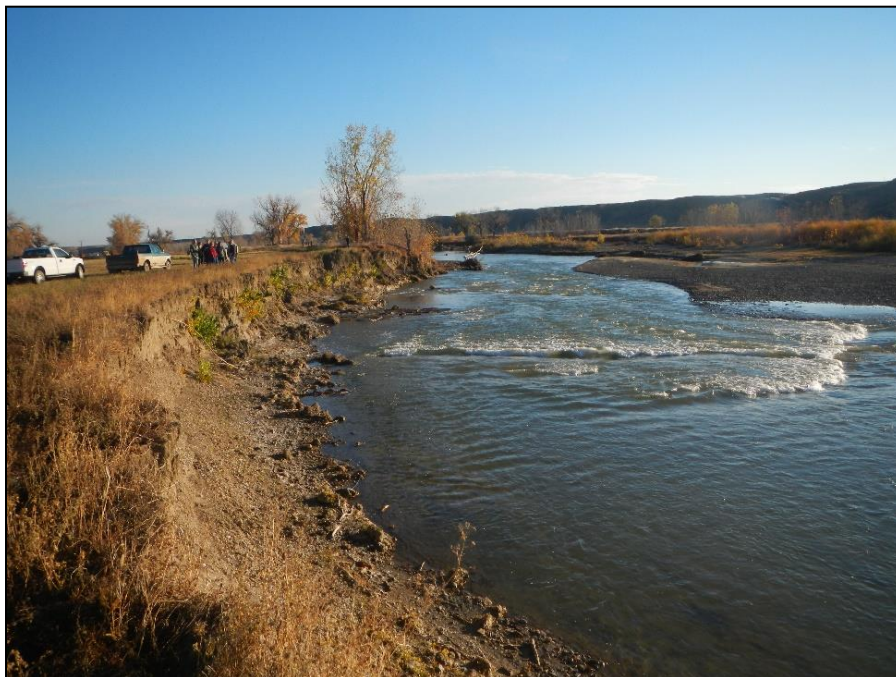
Figure 38. View downstream of headcut in channel bed, caught on a shale reef.

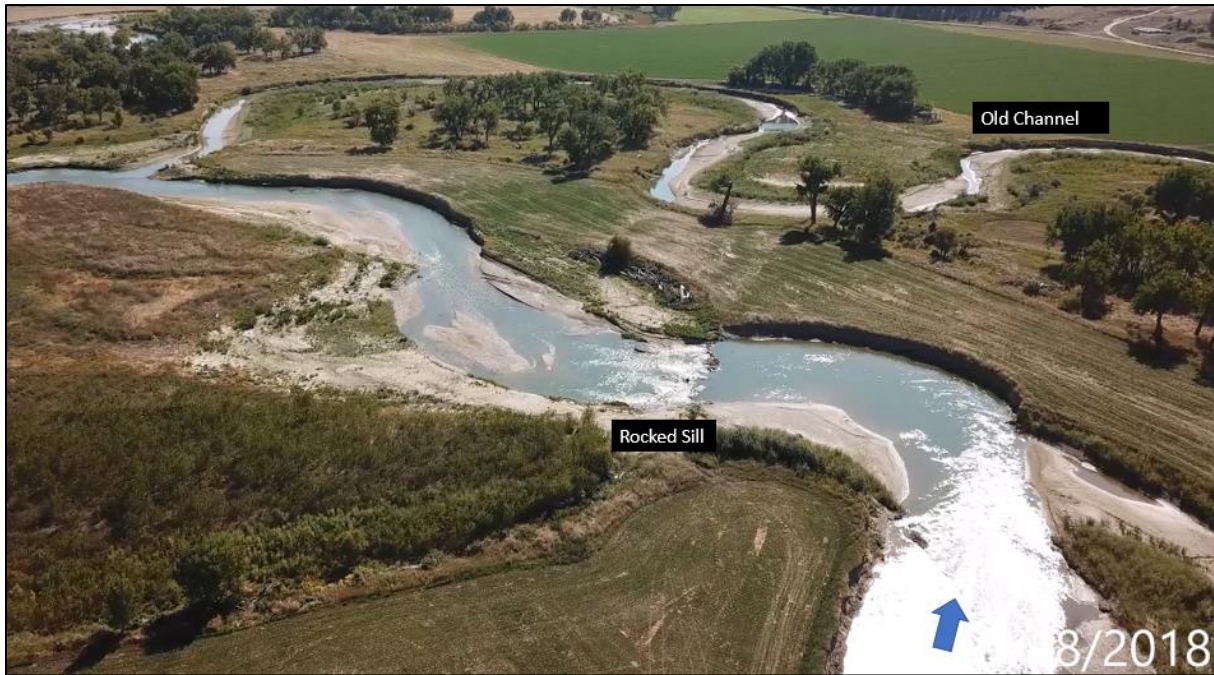
Downcutting was also evident on avulsion paths that were shorter than the pre-2011 channel. Figure 39 and Figure 40 show a steep grade break at a rocked sill that was reinforced through an avulsion path. The “old channel” shown in Figure 39 is the pre-2011 channel. It is clearly longer and much narrower

than the modern river. At this location the avulsion shortened the river by 4,200 feet and more than doubled its slope from 0.09% to 0.2%.

Figure 39. Drone image from September 2018 showing rocky sill holding graded on new channel; note much smaller width of old channel in background.

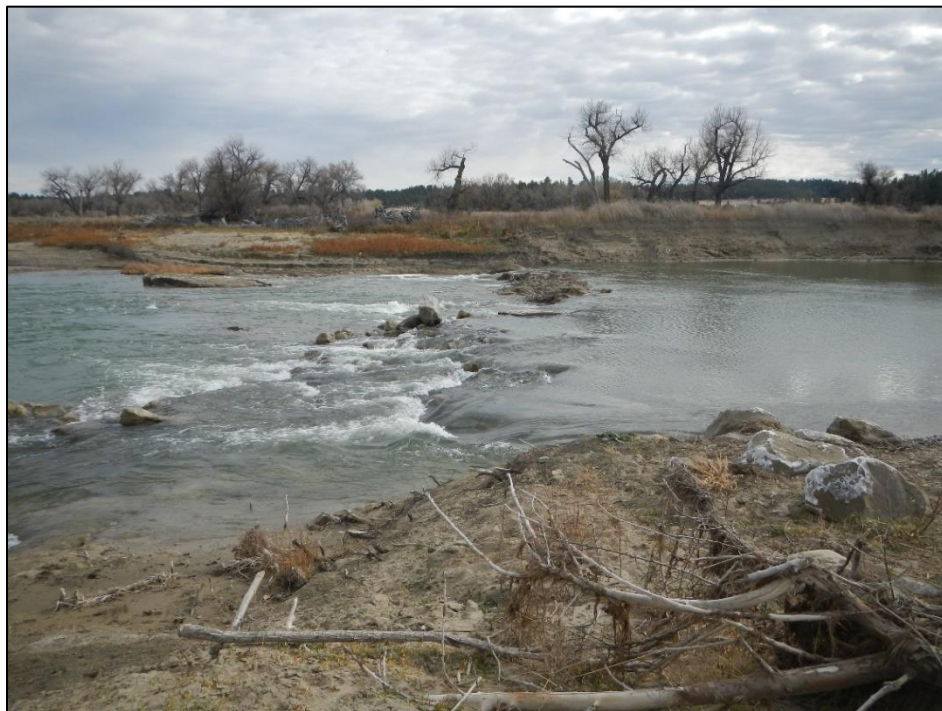
Figure 40. View across river of steep drop across reinforced rock sill.

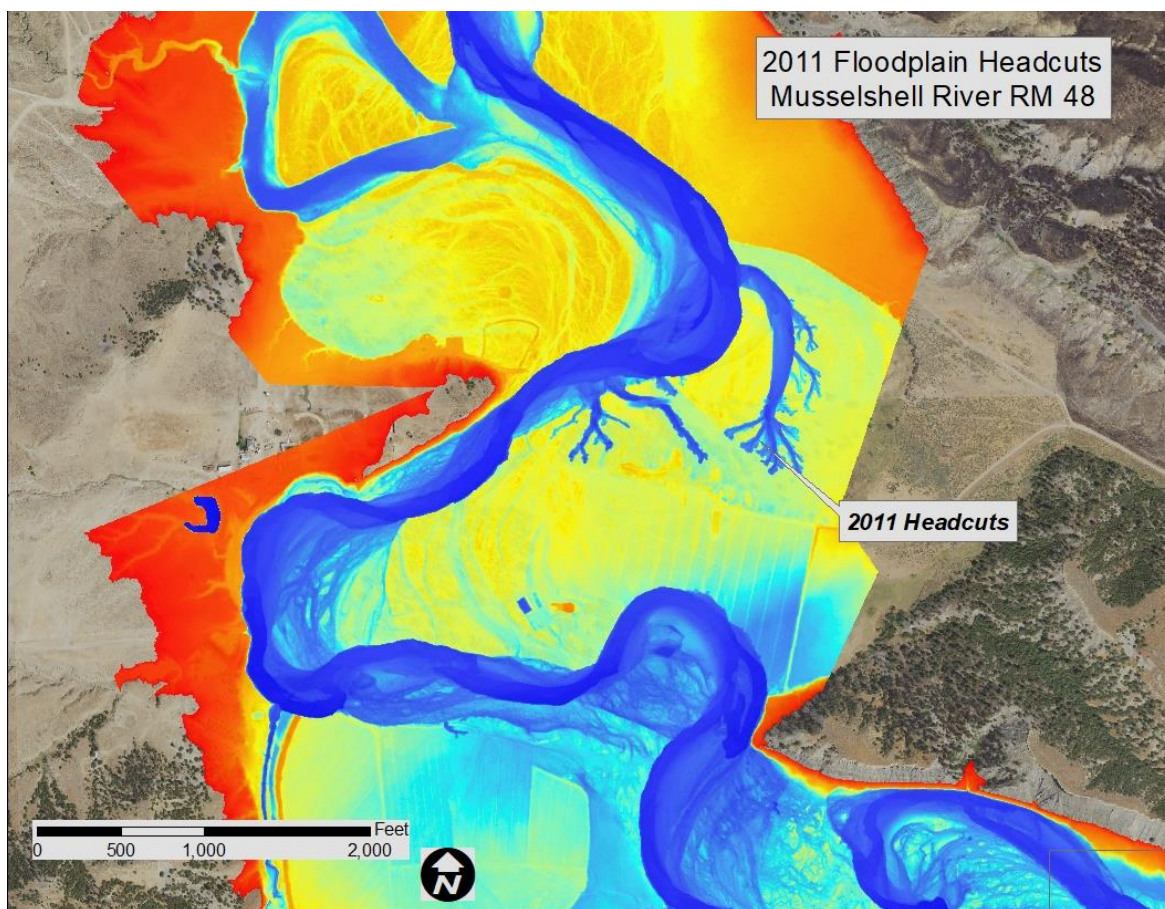
Figure 41. Relative elevation model (from 2012 LiDAR data) showing floodplain headcuts (blue fingers) in formed by 2011 flood waters below Mosby. Flow direction is to north.

As shown in Figure 41, the LIDAR data can capture potential avulsion paths that are difficult to see on air photos. Another example is shown in Figure 43, where a bendway that has a large pump site is clearly at risk of experiencing an avulsion through its core, where a ~6-foot deep channel has formed. If the bend cuts off due to an avulsion, the pump site will be about 700 feet from the main channel.

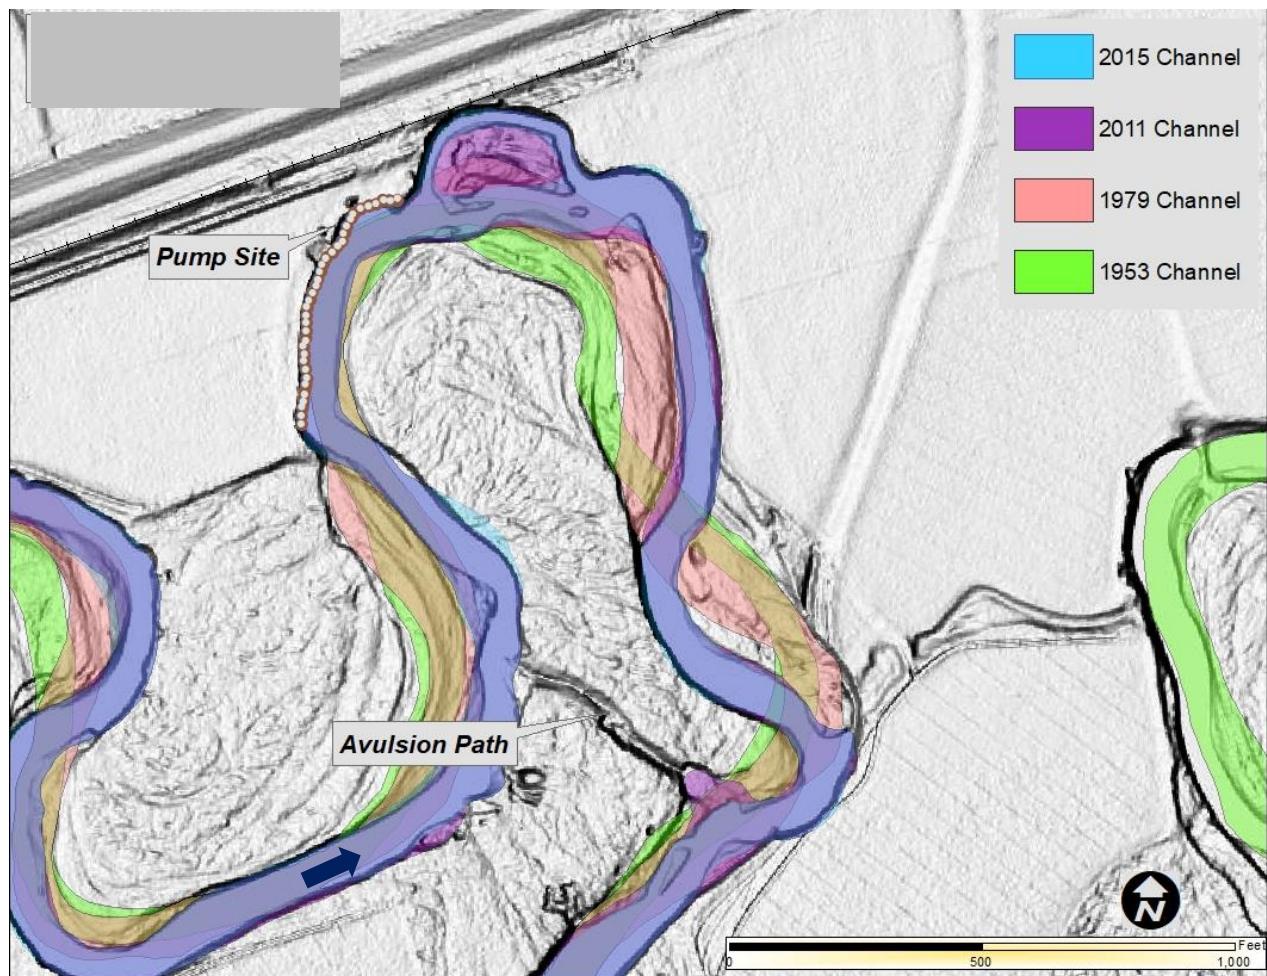
Figure 43. 2012 LiDAR hillshade showing prominent channel forming an avulsion path.

Our recommendations for these areas generally depended on the level of risk, which includes the likelihood of an avulsion as well as its consequences. At the site shown in Figure 43, where loss of the bend would isolate a major pump site, the avulsion route should be carefully monitored as a minimum. More proactive approaches to lower the risk of a cutoff include grading out the avulsion path or adding roughness elements such as large wood to slow down flows and reduce the potential for the path to enlarge. In many cases, locating an alternative pump site in the event of an avulsion is a good way to integrate avulsion risk into operations.

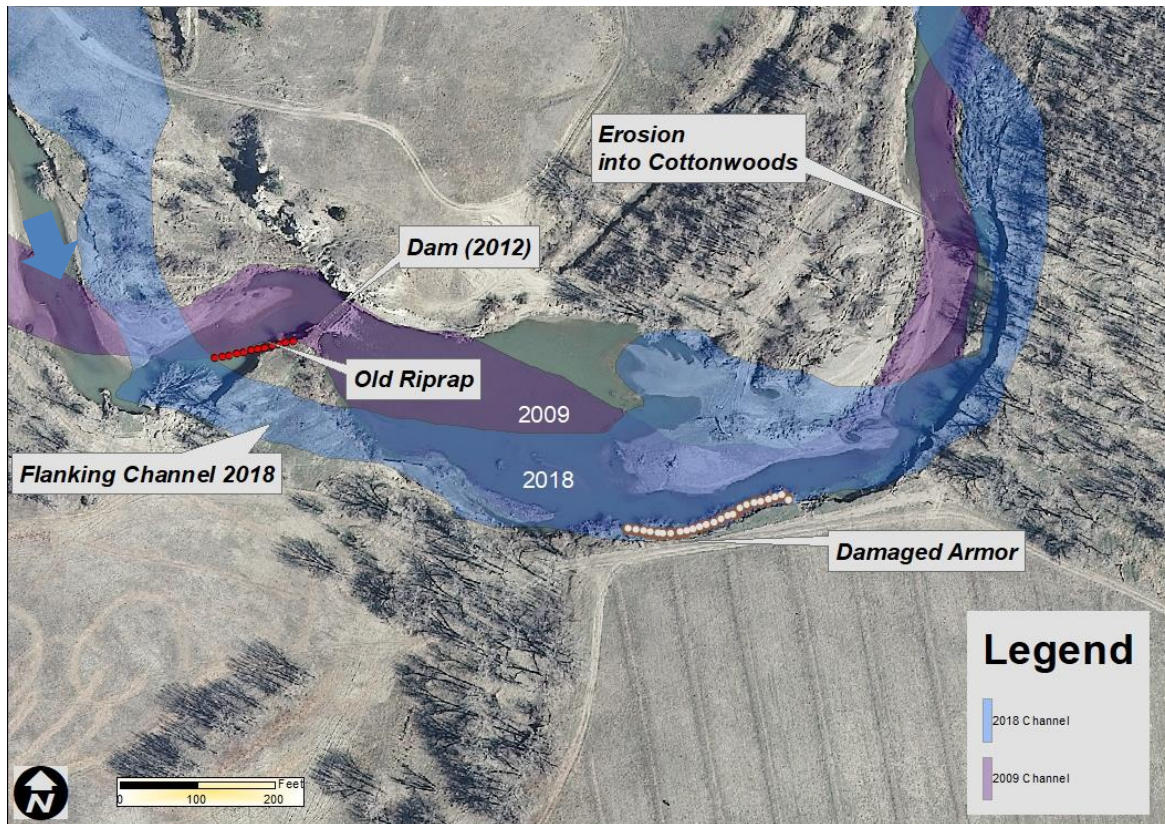
In 2011 we visited wholesale structure flanking at the Naderman, Anderson, and Egge Diversion Dams. These dams have not been rebuilt, and producers have shifted to pumps. In 2018, one more dam flanked to our knowledge, the Newton/Pedrazzi Dam a few miles downstream of Roundup. The dam flanked on its south side accompanied by a tripling of channel width (Figure 51 and Figure 52). This structure had been slated for removal after it was abandoned after the 2011 flood. The upper ditch also eroded out, and the producers shifted to pumps. Currently, the dam is largely buried and does not appear to impact channel function (Figure 52).

Figure 51. 2012 air photo showing Musselshell River path in 2009 and 2018, capturing flanking of dam to south (flow direction is left to right).

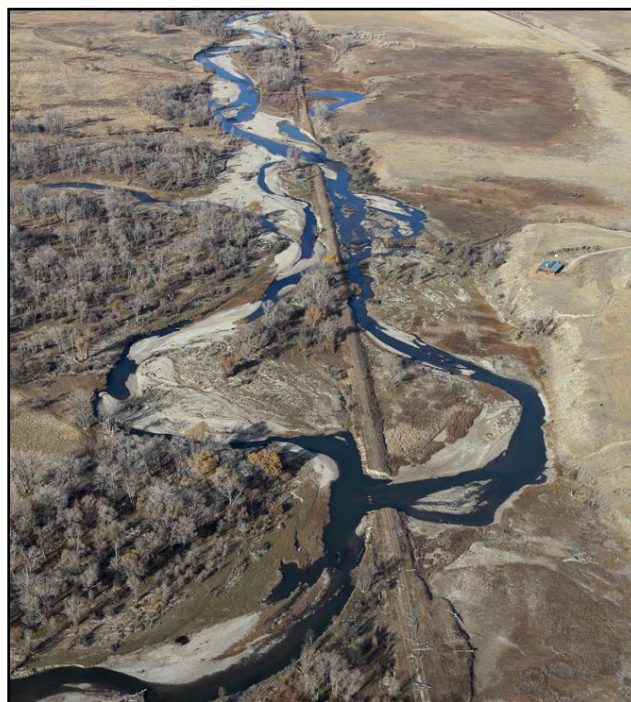
As described previously, the Milwaukee Line railroad berm closely follows the river between Melstone and Two Dot. During the 2011 flood this berm breached completely in 31 places. In one location near Shawmut the river relocated to the opposite side of the berm (Figure 53). Railroad berm breaches are recognized as somewhat of a “double edged sword” on the Musselshell, in that the breaches dissipate high-energy flows and improve floodwater storage which potentially mitigates flooding downstream, but in some cases the water gets behind the berm without a clear path back to the river. Because the isolation of historic floodplain area by the berm has been extensive, reconnecting the river to the historic floodplain area is a clear opportunity for improved ecological function on the floodplain as well as flood mitigation. To that end, our approach regarding the breaches is to identify means of allowing floodplain access behind the berm (not patching breaches) but providing improved drainage back to the river down-valley from the breach.

Figure 53. View upstream (west) of long railroad grade breach that occurred in 2011 east of Shawmut (Kestrel Aerial).

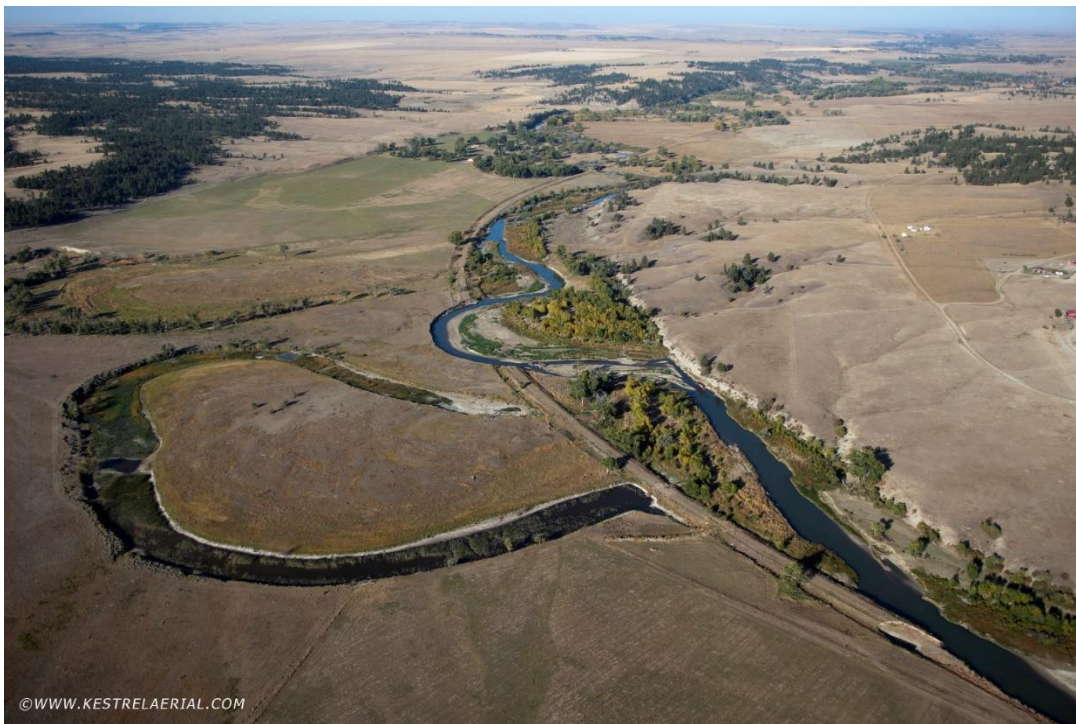
Figure 55. View upstream of railroad berm breach below Painted Robe Creek -- photo taken on September 20, 2012.
