June 27, 2019

Musselshell River Flood Rehabilitation River Assessment Triage Team (RATT II) 2018 Summary Report

Prepared By:
Karin Boyd
Applied Geomorphology, Inc.

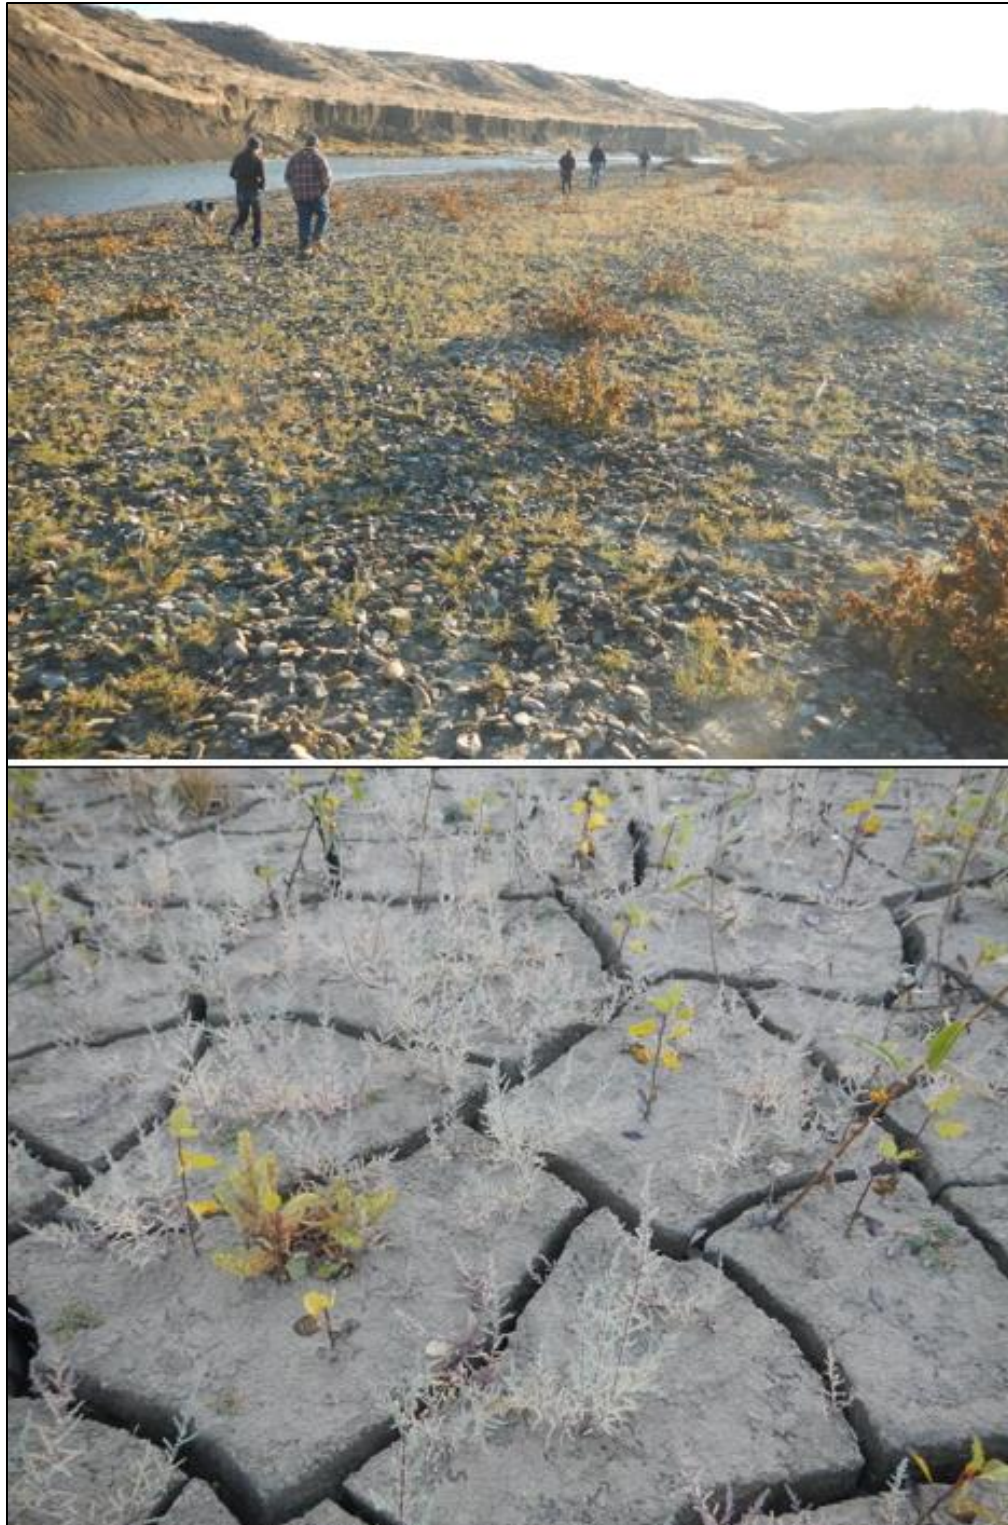
The expansion of salt cedar onto open sand and gravel bars in 2011 and 2018 was striking. Figure 57 shows 2018 flood deposits colonized by both cottonwood and salt cedar seedlings. In some locations the salt cedar densities dwarfed that of the cottonwoods. Weed management will continue to be a constant battle in the Musselshell River corridor for years. Where cottonwoods are establishing, promoting their survival through grazing management and salt cedar controls will greatly help with natural flood recovery on streambanks, gravel bars, and floodplain areas.

Figure 57. Cottonwood and salt cedar seedlings on 2018 flood deposits.

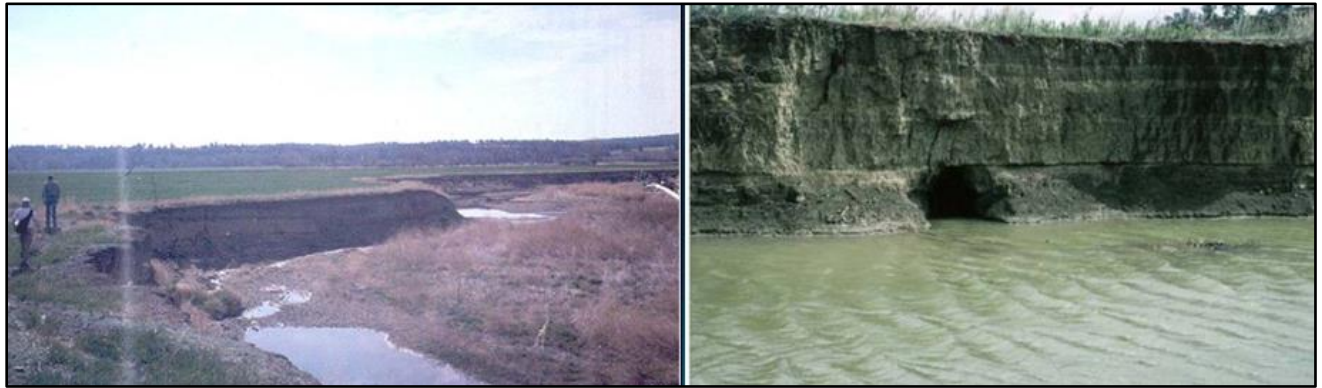
Figure 60 shows photos of the Musselshell River taken as part of an assessment by the Lower Musselshell Conservation District in 2004 (LMCD, 2004). By that time, the river was downcut, the floodplain cleared, and the water table was reportedly 6-10 feet deep on the perched floodplain. These conditions created concerns regarding sediment production, as bank erosion was active. A physical features inventory completed decades earlier in 1980 by the Montana Water Quality Bureau (Pederson, 1980), reported that between Shawmut and Melstone (~160 miles), there was a total of 34,680 feet of rock riprap, 3,320 feet of log riprap, 45 rock jetties, 158 car bodies, and half a million feet of eroding

Figure 60. Floodplain clearing and channel downcutting on the Musselshell River by the early 2000s (LMCD, 2004).

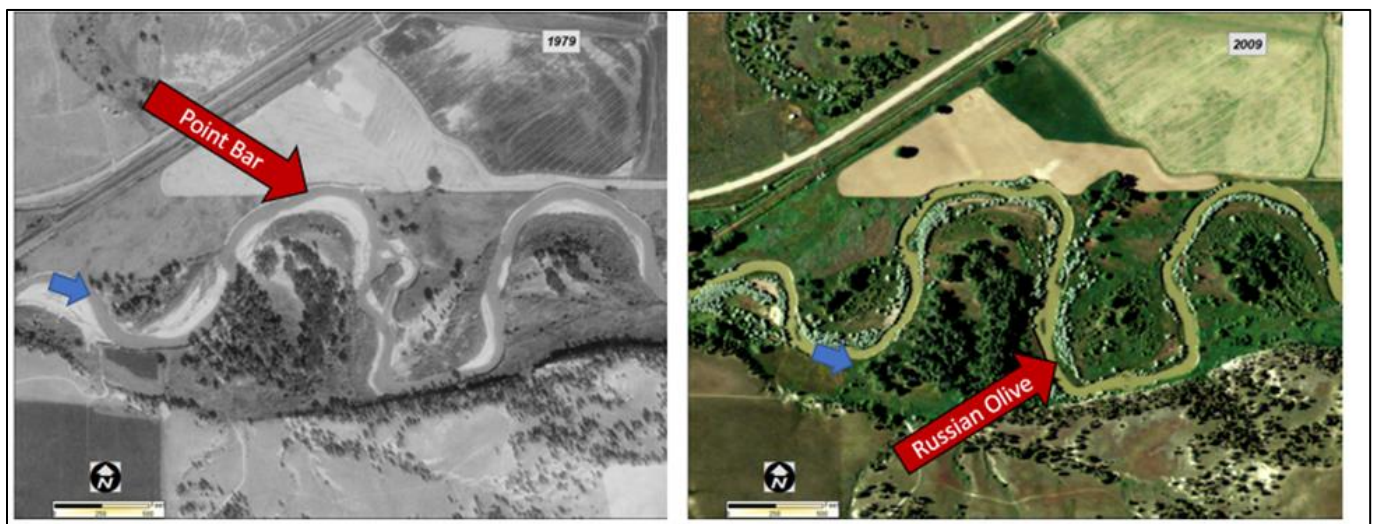
Figure 61. Change in Musselshell River below Roundup from 1979 (left) to 2009 (right) showing narrowing of channel, loss of open bars and expansion of Russian olive, which can be seen as sage-colored vegetation in the 2009 image.

The air photo comparison shown in Figure 61 shows that, by 2009, the Musselshell River had “atrophied” following decades of low flow. Dewatering had become a chronic problem, and the diversion of all flows for irrigation purposes was a much bigger concern than flooding. We do not have first-hand experience of the river’s condition in 2009, but reports indicate that, at least locally, streambanks were fine grained and high, the floodplain was cleared, and the channel was relatively small. Figure 62 shows a photo of the Musselshell River from Montana River Action. The date of the photo is unknown, but it is probably fairly reflective of the stream prior to 2011. The photo shows a high cutbank on the left and a small inset floodplain developed on the right, which indicates downcutting. There is no woody riparian vegetation on the inset floodplain surface (grassed platform on the right side of the channel) and the river is dewatered.

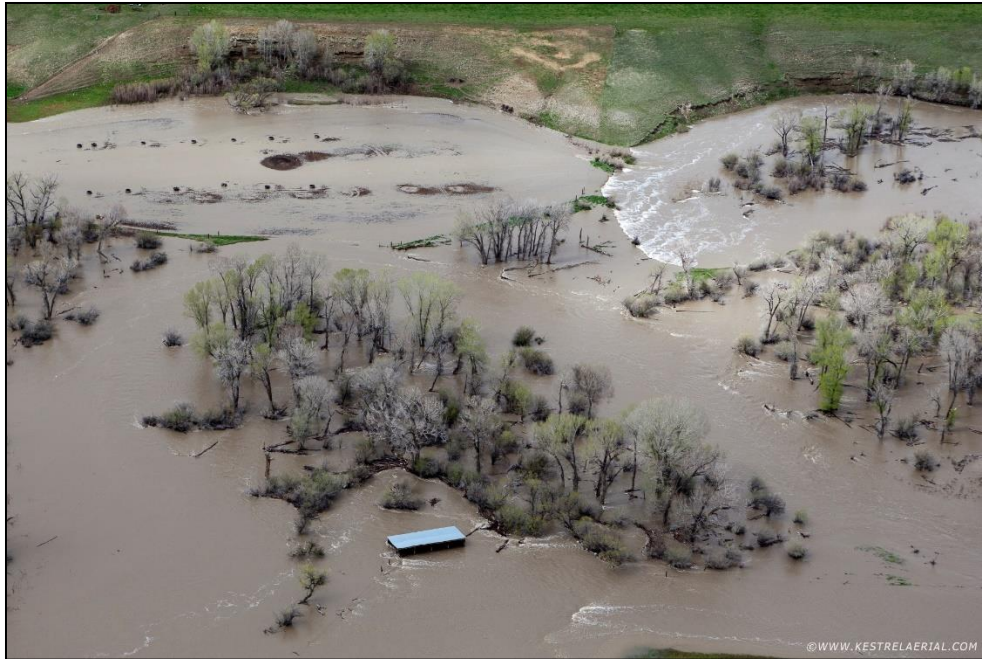
Figure 63. Floodplain inundation and erosion during the 2011 event dramatically changed the face of the Musselshell River.

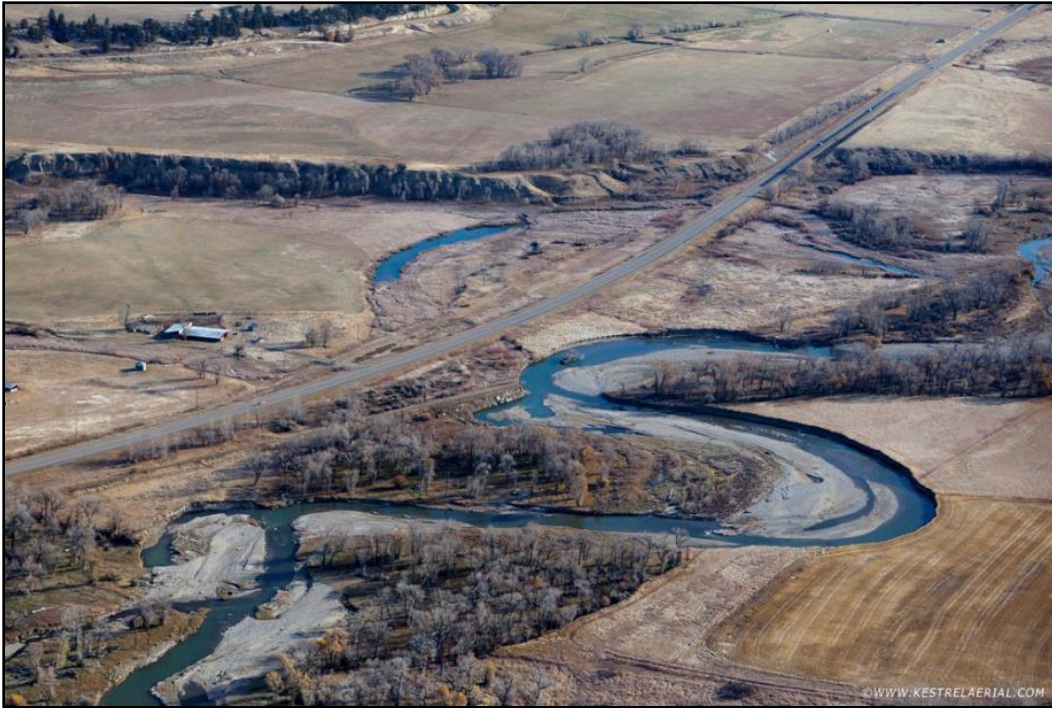
Some of the river response to the 2011 flood actually drove geomorphic recovery from previous impacts. The river eroded into cultivated fields, lengthening in some areas and creating new lower floodplain surfaces on open gravel bars (Figure 64). Cottonwood seedling recruitment was described as both unprecedented and spectacular (Figure 65); some transects estimated the establishment of 129,000 cottonwood and 17,000 willow seedlings per acre during the summer of 2012 (NRCS, 2012).

Figure 64. View downstream of point bar formation, bank erosion, and channel lengthening near Shawmut (kestralaerial).

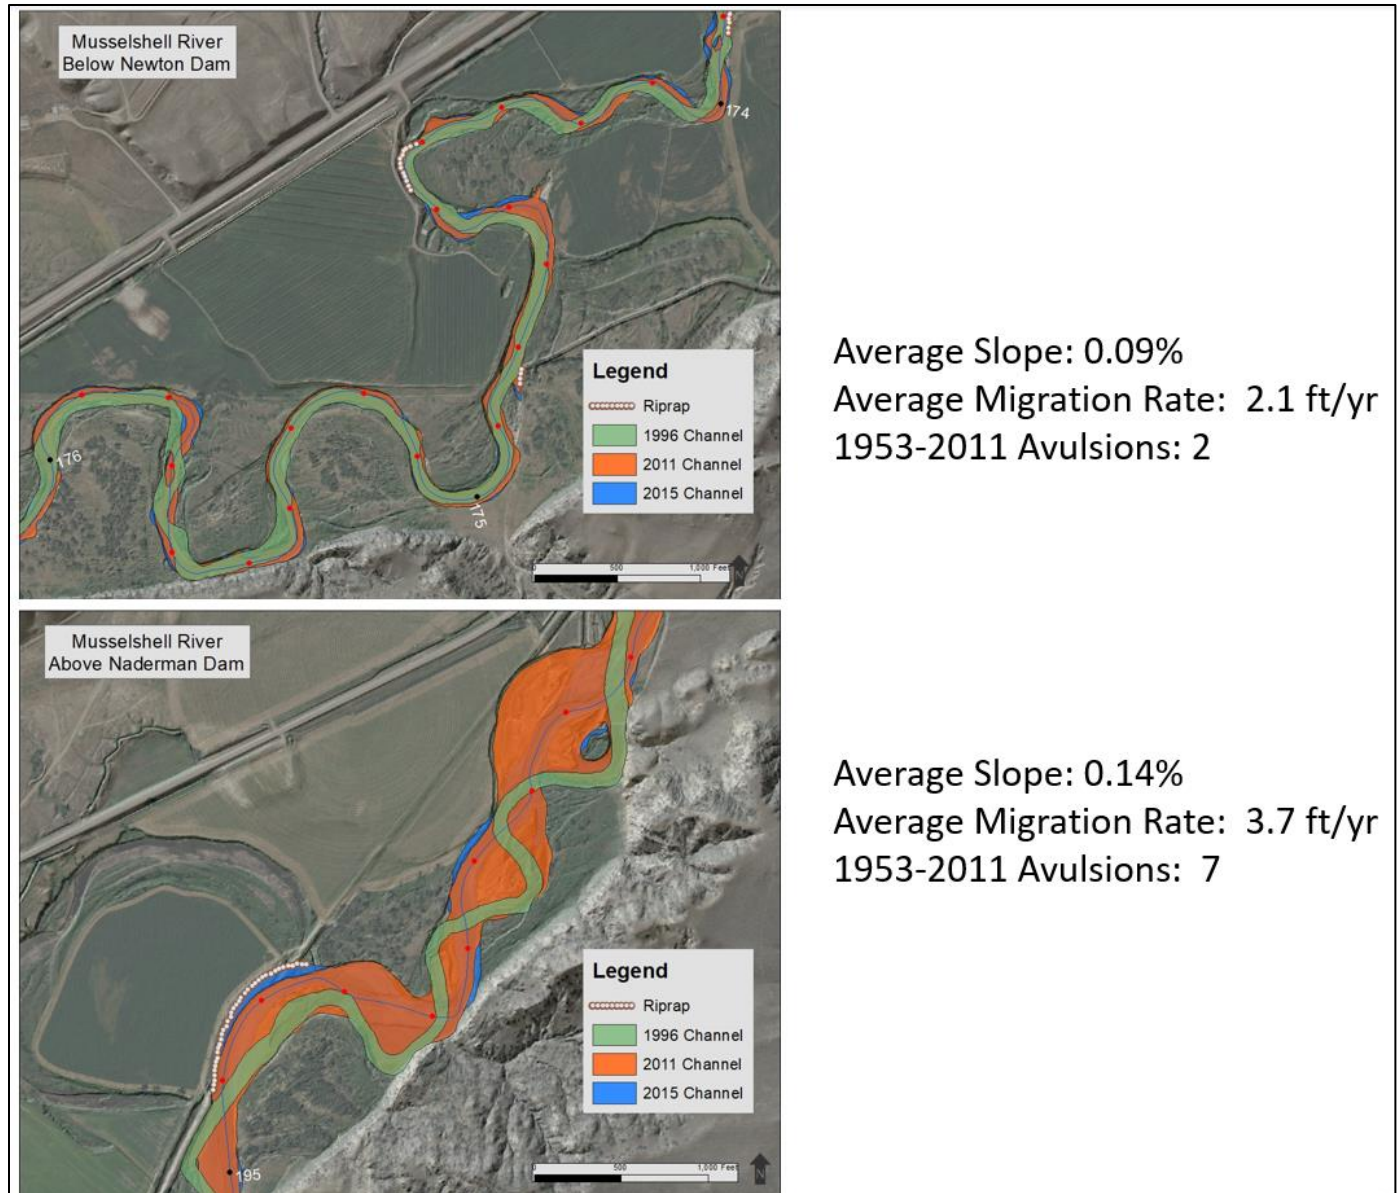
Although the 2011 flood damage was system-wide, the CMZ Pilot mapping effort (Boyd and Thatcher, 2017) showed that some areas withstood that flood event rather well. Figure 66 shows two areas above and below Roundup that responded very differently during the flood. The top of the figure shows a river segment below Newton Dam that showed only minor changes after the 2011 flood. This reach has an average slope of 0.09% (4.8 feet per mile), and an average migration rate of 2.1 feet per year. Upstream above Naderman Dam, the river has been more extensively straightened such that the average slope is almost double at 0.14% (7.4 feet per mile). The average migration rate in this reach is 3.7 feet per year. The image shows that whereas the lower slope reach showed some migration, it retained its meander planform through the flood without major channel adjustments. In contrast, the relatively straight and steep river segment above Naderman Dam experienced much more extensive bank erosion and channel widening.

It is interesting in that the work performed by Pioneer Technical on the Roundup Reach (Pioneer, 2016) identified an "equilibrium slope" value of 0.09% for the Musselshell River above Newton Dam, which is consistent with the slope captured in the top image of Figure 66. This suggests that this reach could potentially provide a rough reference condition for channel slope and sinuosity that should be considered for restoration project designs on other portions of the river.

Figure 66. Comparison of bank movement in relatively low slope area below Newton Dam (top) and steep reach above Naderman Dam (bottom). Values are reach-averages.

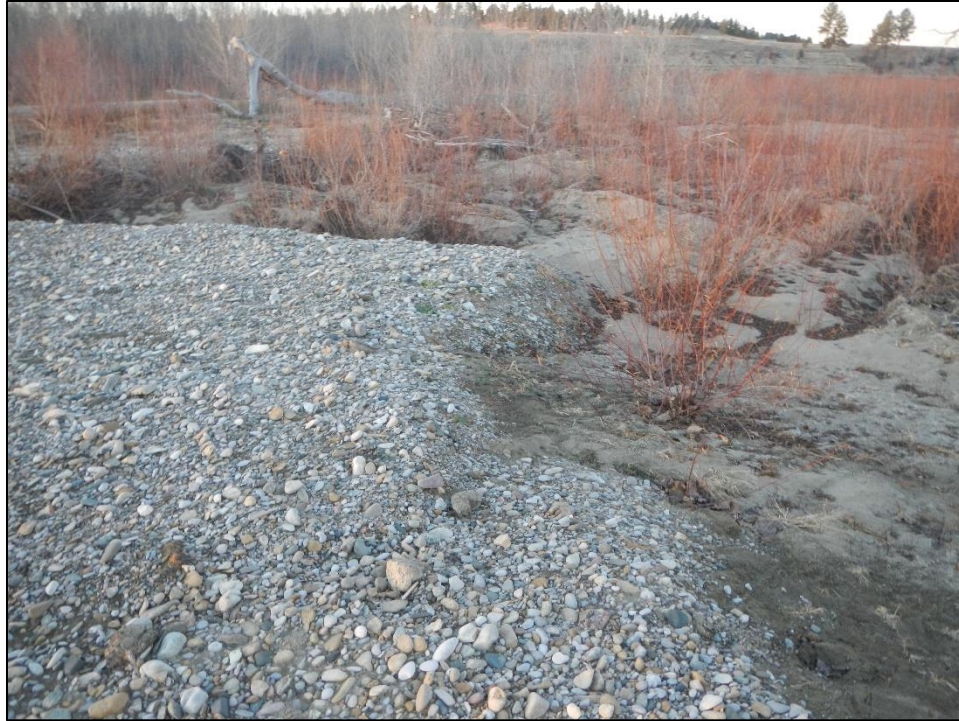
Figure 70. Raw gravel bedload deposit on point bar.

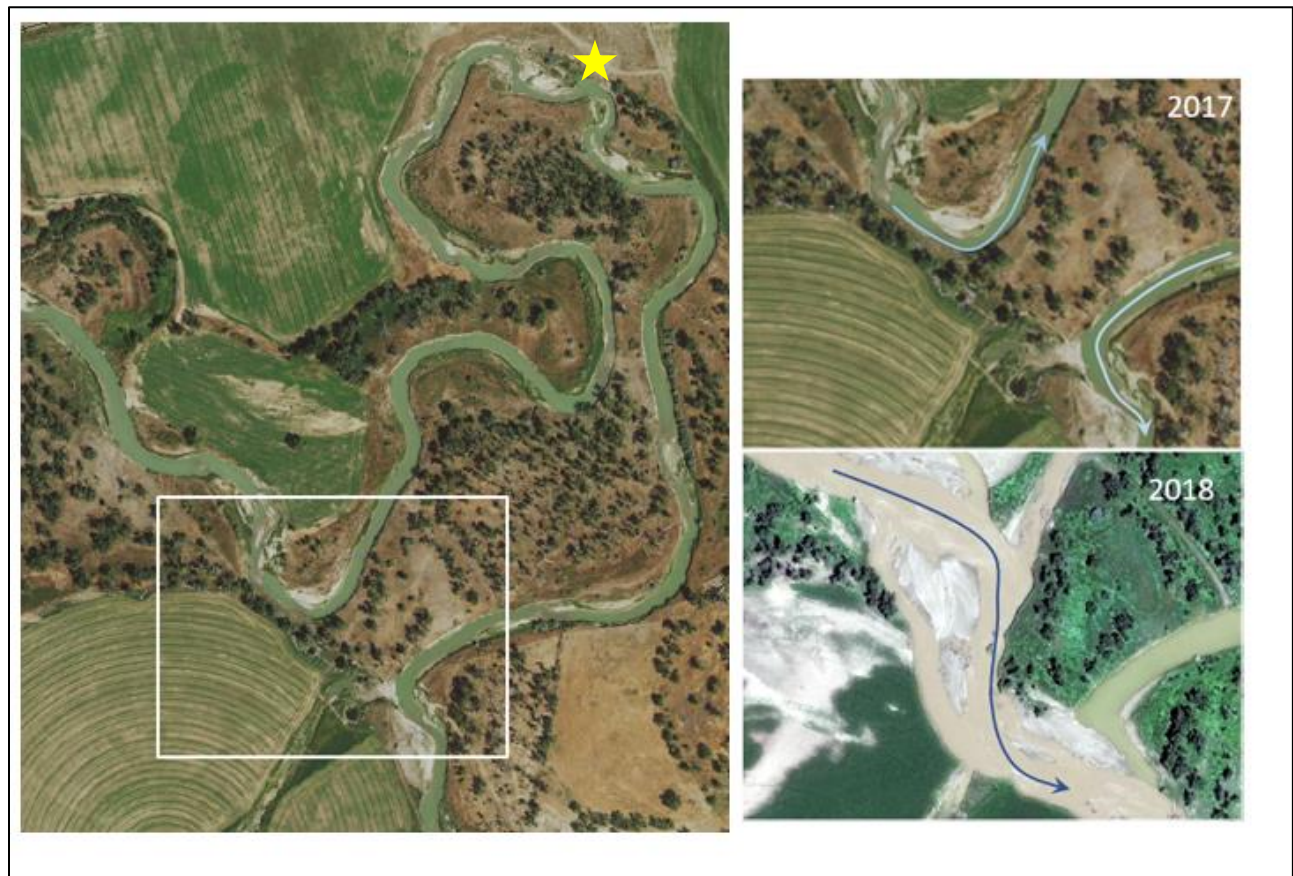
Another means of reducing channel slope and stream energy on the river is to reactivate abandoned meanders. This is a common restoration action in systems that have seen excessive straightening due to past engineering projects or floods. Figure 76 shows an example meander that cut off in 2018 and abandoned a pump site. This meander is currently under consideration for reactivation, which would include plugging the avulsion path shown in the lower right of Figure 76 and rerouting flows back to the 2017 channel (Figure 77).

Figure 76. Closeup imagery of avulsion path in 2017 (top right) and 2018 (bottom right) showing potential reactivation site; pump site is marked by star.

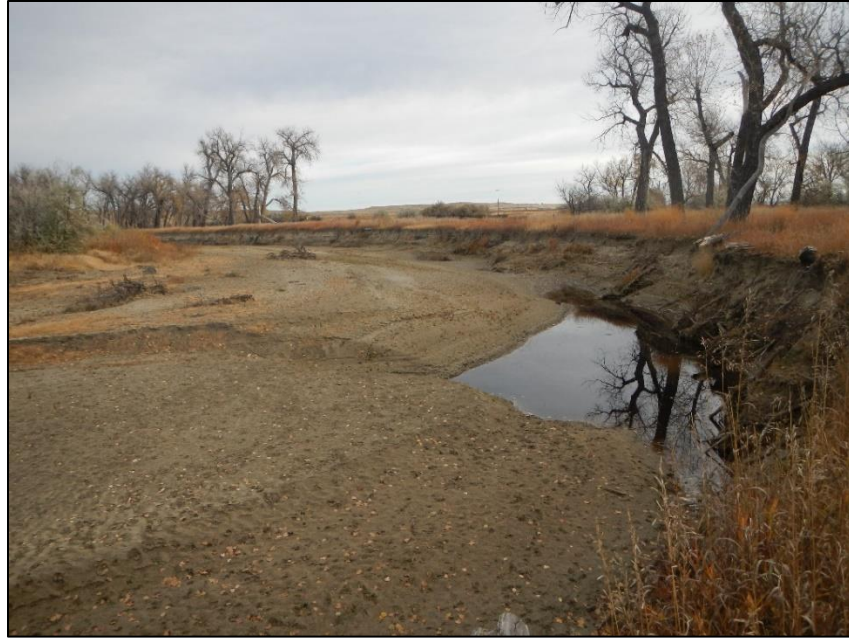
Figure 77. View downstream of abandoned channel following avulsion shown in Figure 76, 2018.

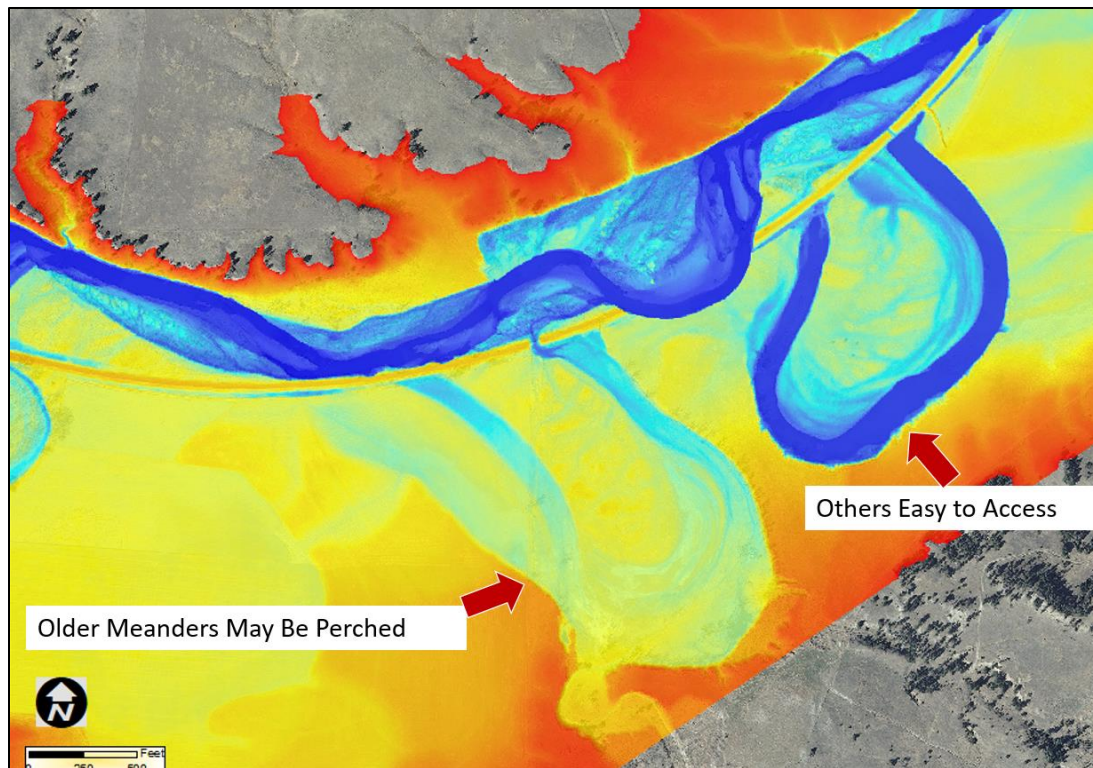
Figure 78. Example meanders that could be evaluated for reactivation; meander on right is clearly lower and would be more cost-effective to reconnect.

The LiDAR data can be very helpful when considering a reactivation project, as many of the old meanders on the floodplain have become perched due to mainstem channel downcutting (Section 1.1.2). Perched meanders can be very expensive to reactivate as they require either extensive excavation or boosting of the river itself. Figure 78 shows two examples of floodplain meanders with different degrees of perching. The same site is shown in Figure 79 with the general reactivation/railroad berm removal concept shown.

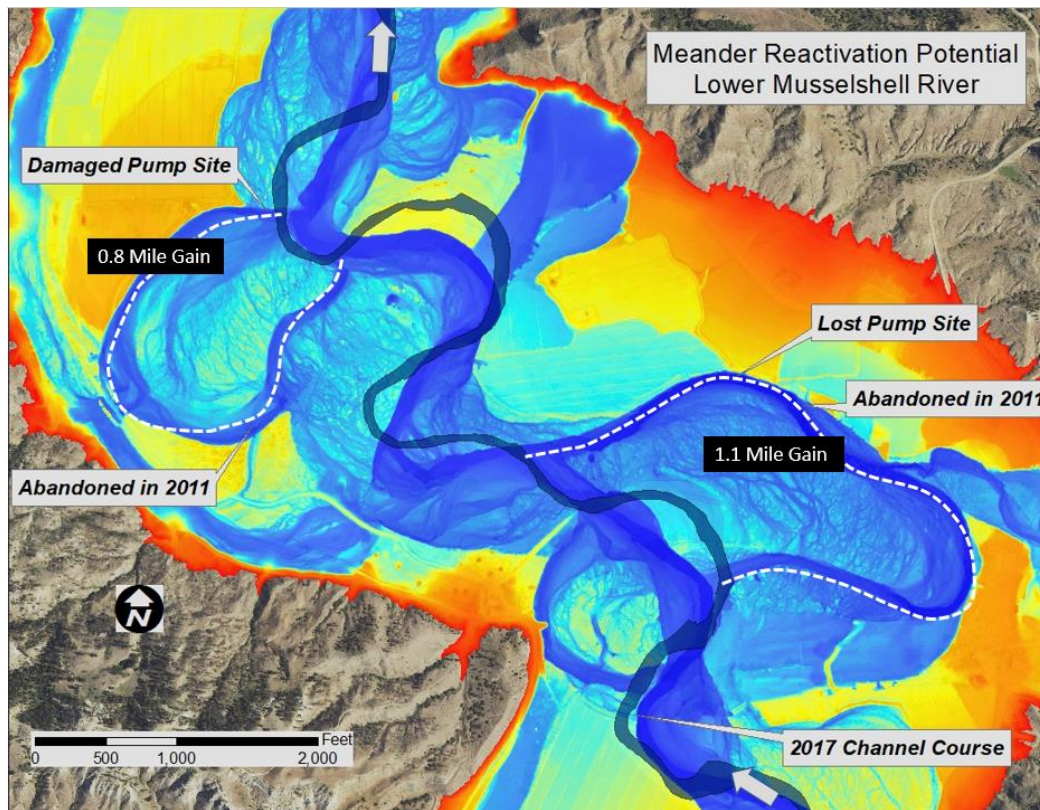
Figure 80. Potential meander reactivations (dashed white lines) below Mosby that could recover almost 2 miles of channel length and recover a pump.

In some areas of the lower river below Mosby, several miles of channel could potentially be reactivated, reducing channel slope and stream power while potentially allowing the recovery of previously abandoned pump sites (Figure 80). Reactivation of the two meanders shown in this figure would reduce the channel slope from 0.14% to 0.06%.

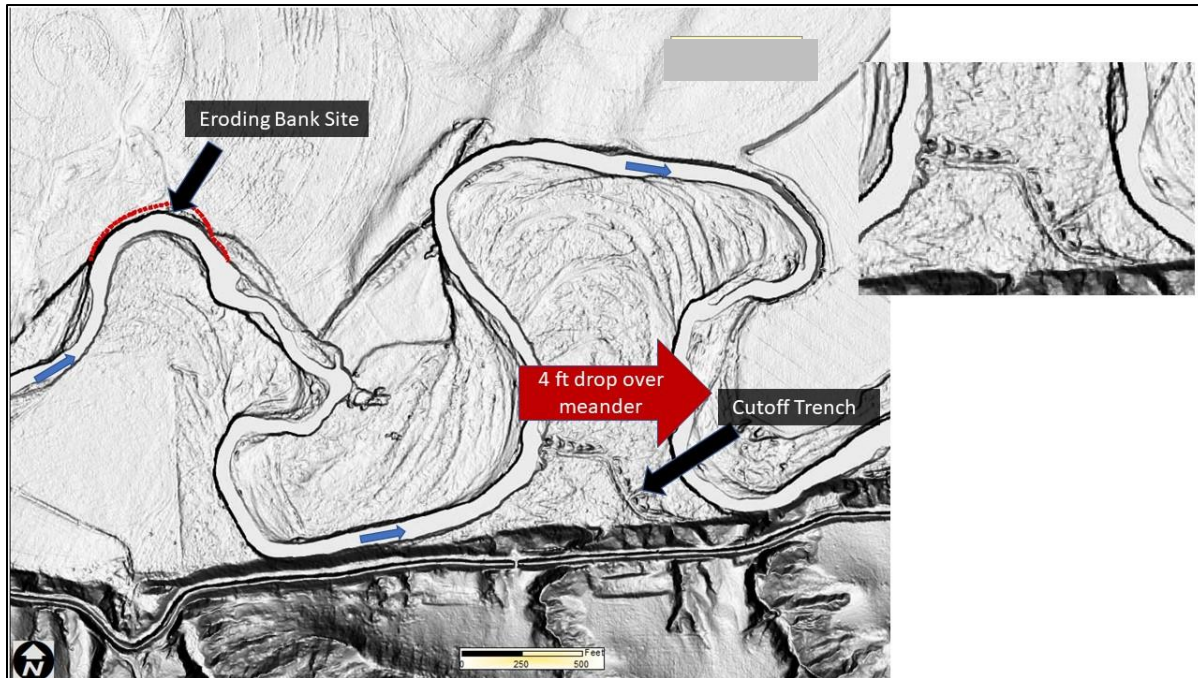
We strongly recommend against constructed cutoff trenches and intentional channel shortening. Figure 81 shows an example trench that, if captured, will create a four-foot drop in the river that will likely make erosion problems upstream much worse. We highly recommend the existing trenches be remediated and future channel shortening be stopped.

Figure 81. Example cutoff trench through meander core.

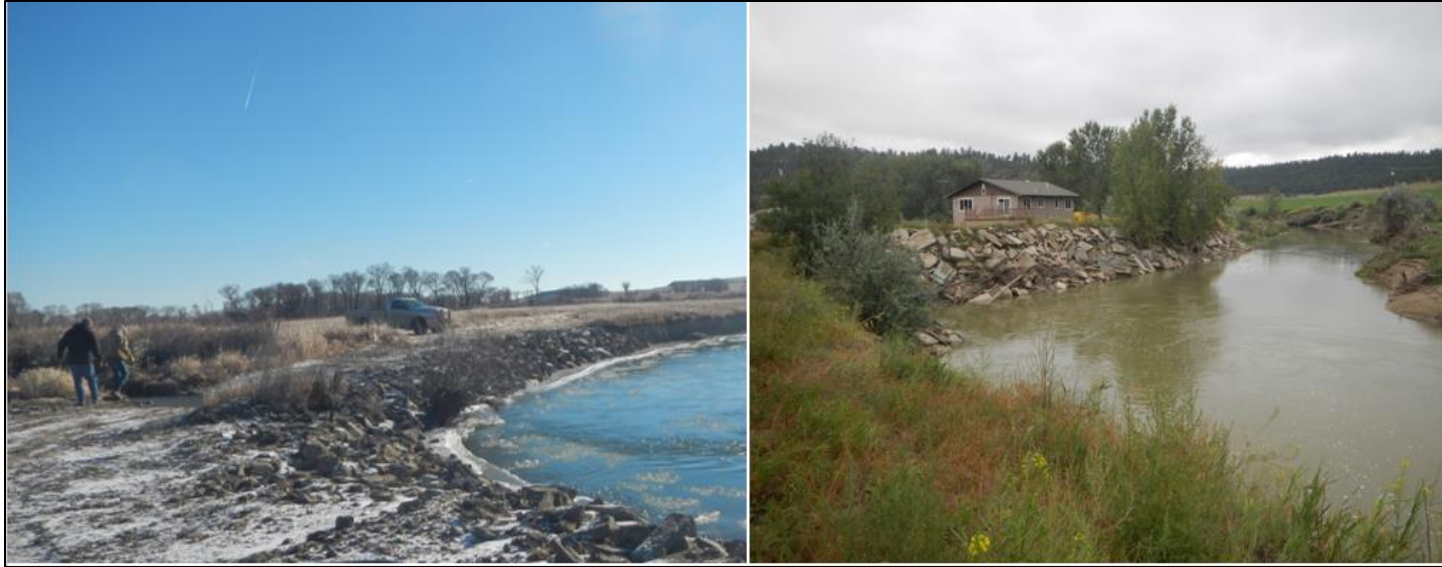
Figure 85 shows two examples of full-bank armor on the Musselshell. Both of these projects appear functional, with the photo on the left showing a relatively low riprapped bank, and the photo on the right showing a very high bank. With both of these projects, the most important part of the treatment is

Figure 85. Full bank rock riprap against floodplain surface (left) and higher terrace (right), Musselshell River.

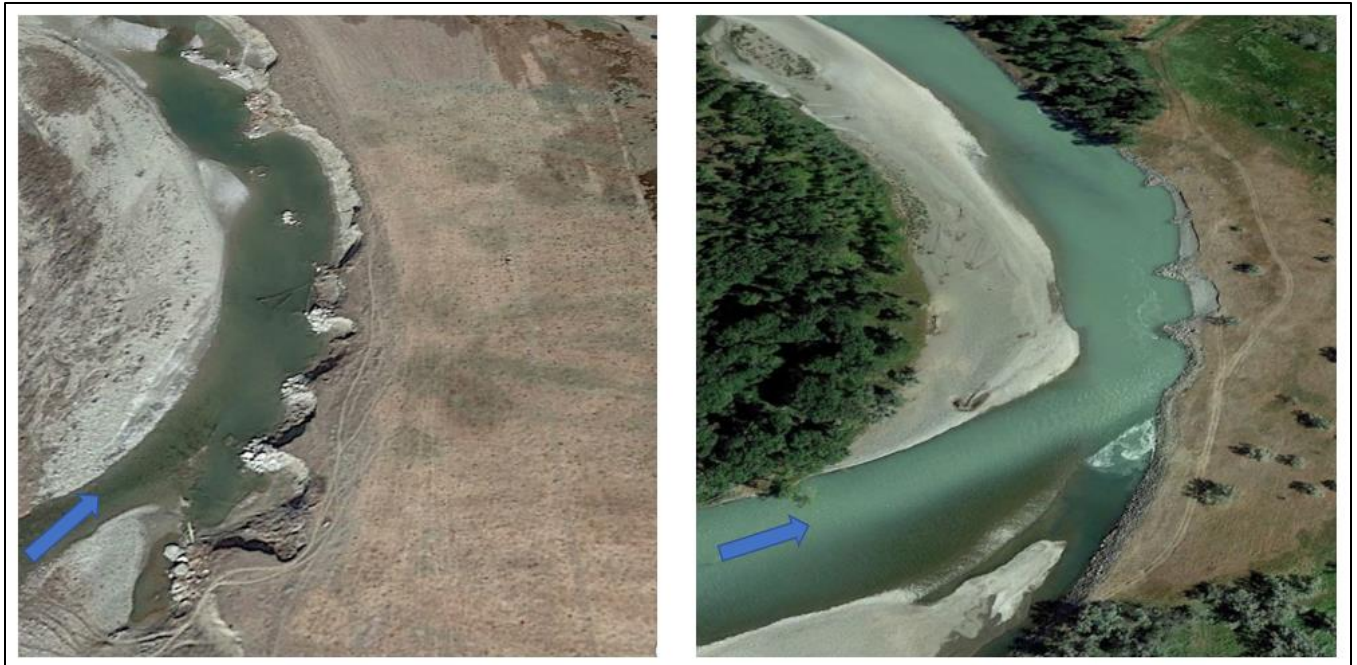
Figure 95. Erosion control barbs on Musselshell River (left) and Yellowstone River (right) showing orientation to flow, and erosion between structures.

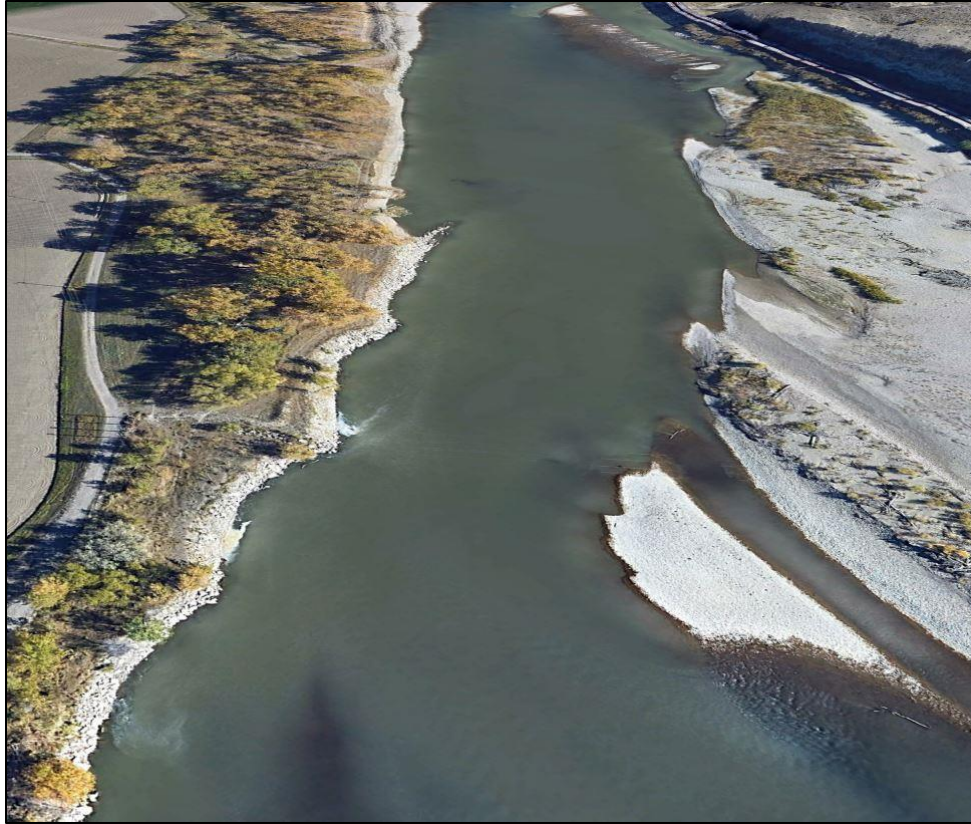
On the Yellowstone River, barbs are generally discouraged because most projects end up being converted to full bank riprap because of erosion problems between the structures (Figure 97).

Figure 97. Barb treatment converted to full bank riprap.
