## Musselshell River Flood Rehabilitation River Assessment Triage Team (RATT) Summary Report

Lower Musselshell Conservation District

Applied Geomorphology, Inc.

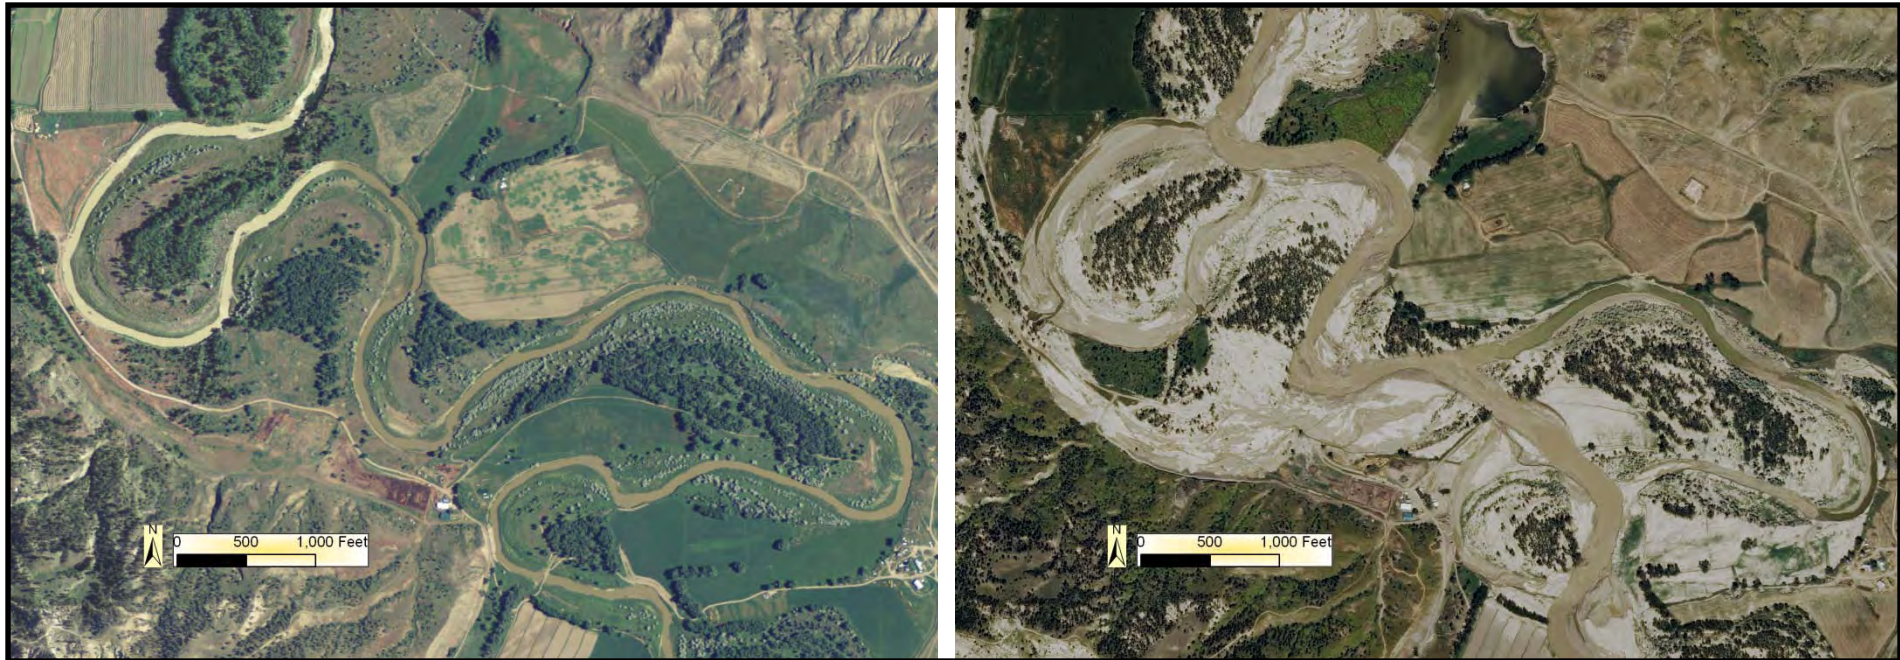
During the spring of 2011, the Musselshell River experienced unprecedented flooding that resulted in extensive damage to irrigation infrastructure, roads, bridges, residential structures, and productive agricultural fields. The peak of the flood is estimated to have had a 157-year return interval, or a 0.6% chance of occurring any given year. The flood was also long-lasting; in places, major flooding persisted for over three weeks, causing extensive bank erosion, and numerous avulsions. The river corridor was dramatically changed, and many of these changes will persist for decades (Figure 1).

**Figure 1. Pre flood (left) and post-flood (right) aerial view of lower Musselshell River below Mosby at RM 25.**

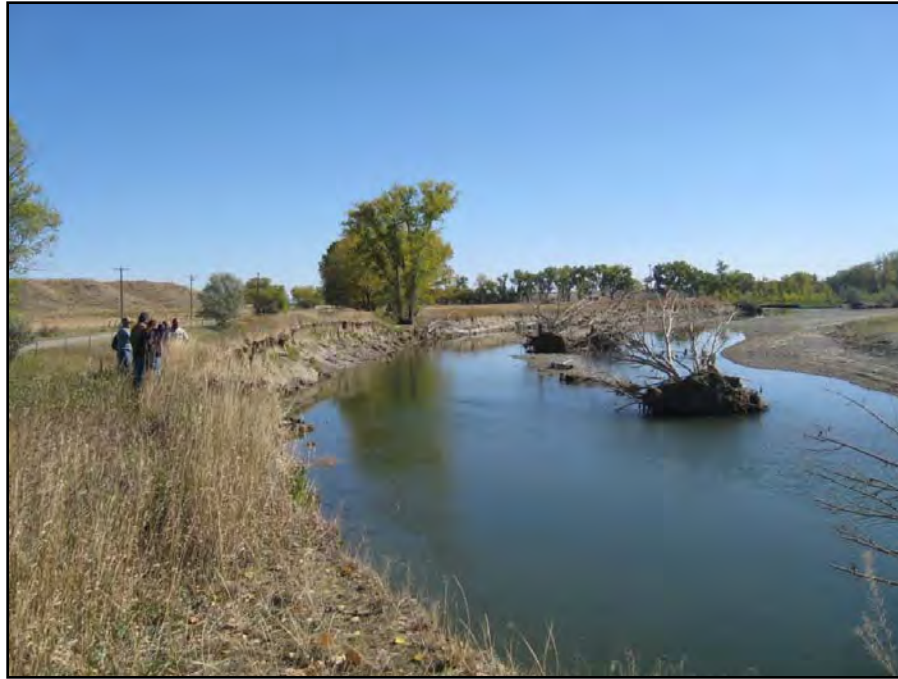
**Figure 2. River Assessment Triage Team (RATT) observing bank erosion site, lower Musselshell River.**

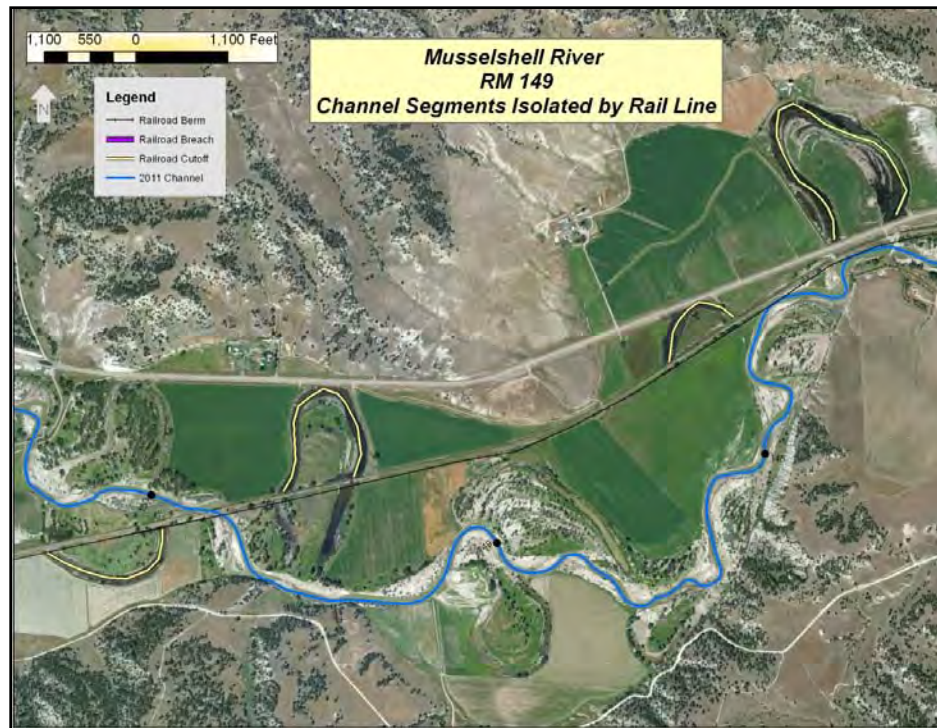
A photo of the easternmost meander on Figure 6 that was taken during the 2011 flood (Figure 7) shows that there is no surface water connection between the two features, rendering the abandoned channel an off-stream wetland. In some cases however, culverts connect the old swales to the river to allow for irrigation water withdrawal from the abandoned channels. Furthermore, breaching of the rail berm during the flood in some places reconnected the surface water connectivity between the main channel and isolated remnants (Figure 8).

Figure 6. Air photo showing mapped meander segments isolated by rail berm, RM 149.

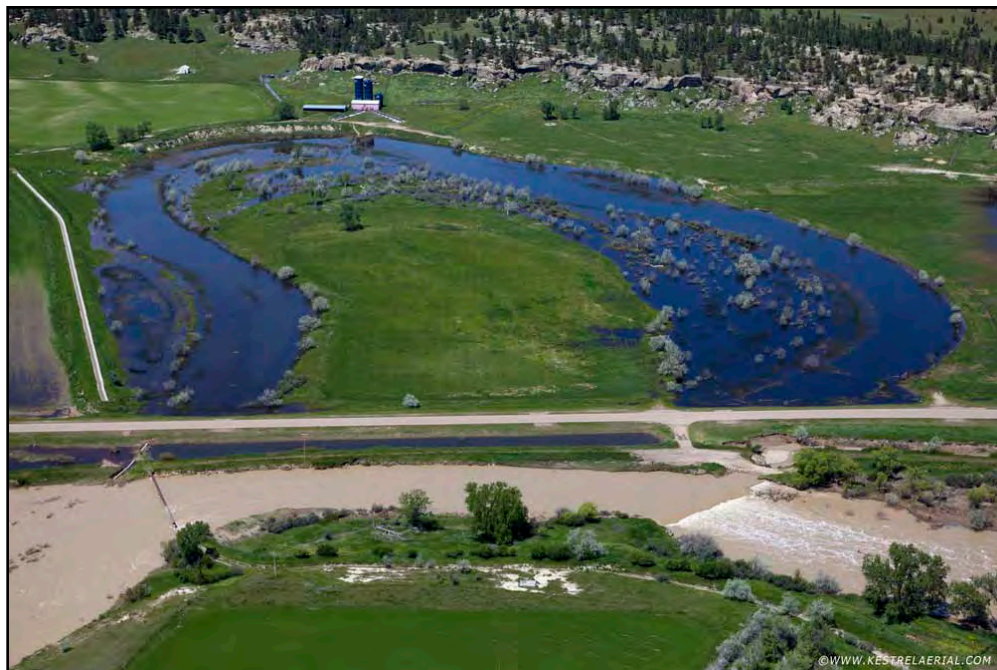
Figure 7. View north at RM 147 (5 miles west of Musselshell) of isolated meander, note Goffena Diversion dam and June 16, 2011 flood condition (©www.kestrelaerial.com).

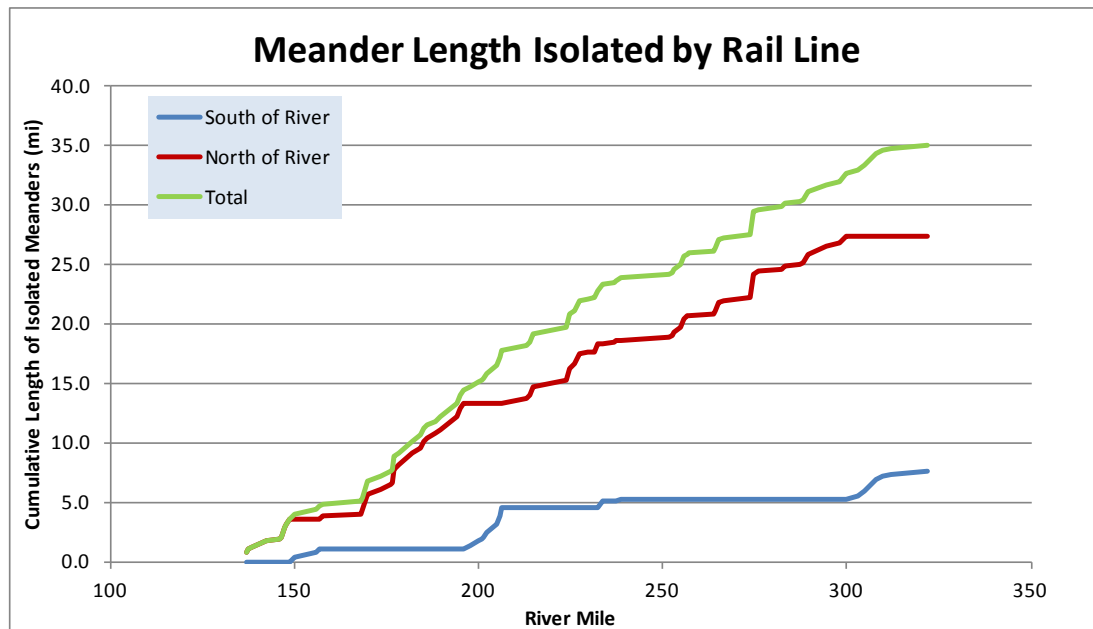
Of the 207 miles of river affected, a total of 35 miles of meander length was measured as having been isolated by the rail berm (Figure 9). This isolation occurs at a relatively consistent rate of 1000 feet of isolated meander length per mile of existing channel, which is 19% or nearly one fifth of the channel length. The majority of the isolation occurred on the north side of the river (Figure 7), and all of it was upstream of the Melstone area.

Figure 9. Estimated cumulative length of meanders isolated by abandoned rail line, Musselshell River.

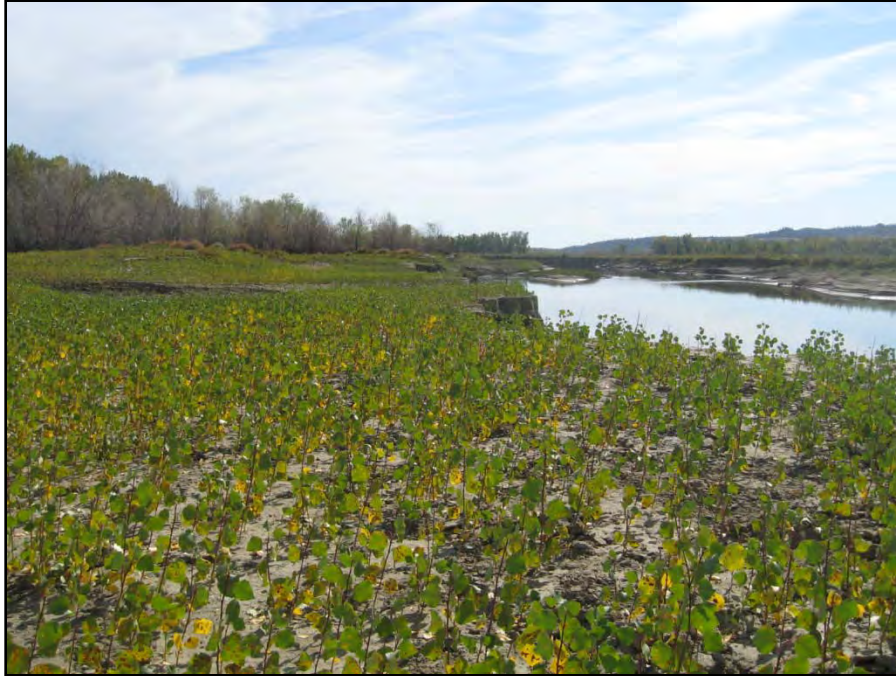
The 2011 flood created a rare opportunity to improve the diversity and distribution of riparian plant communities on the Musselshell River. Flood-induced erosion has locally reconnected the river to previously isolated tracts of floodplain. Extensive coarse sediment deposits in the channel and on the adjacent floodplain have created a perfect seedbed for cottonwood and willow species. An incredible number of seedlings were observed by the RATT team during the summer and fall of 2011, especially in the middle and lower portions of the basin (Figure 10).

**Figure 10. Cottonwood seedlings on floodplain, RM 27.**

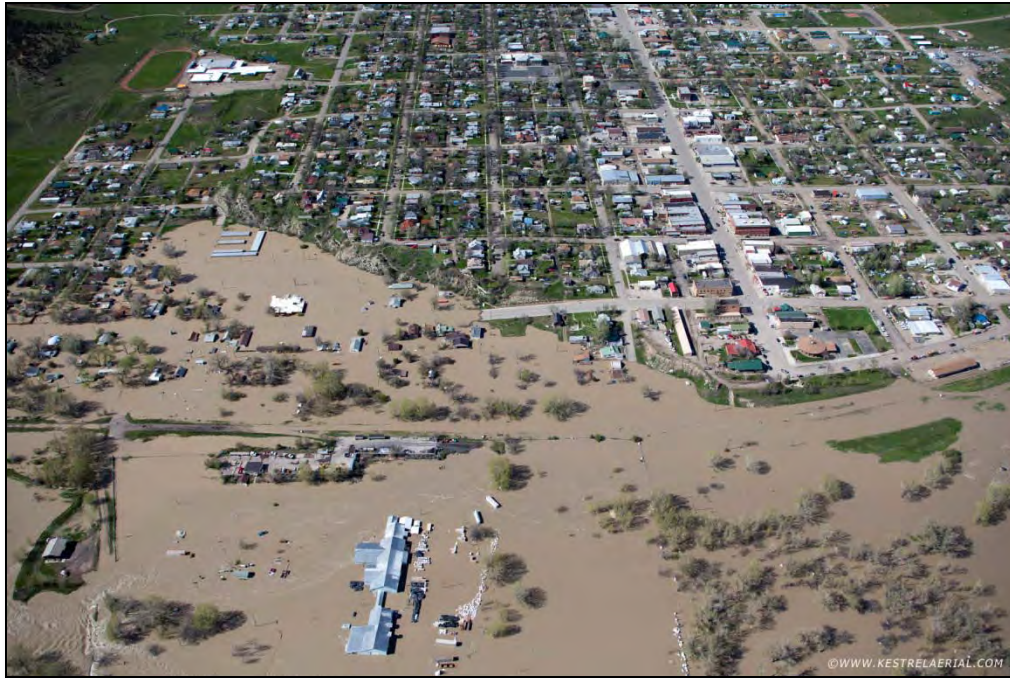
**Figure 16. May, 26, 2011 photo of flooding in Roundup (©www.kestrelaerial.com).**

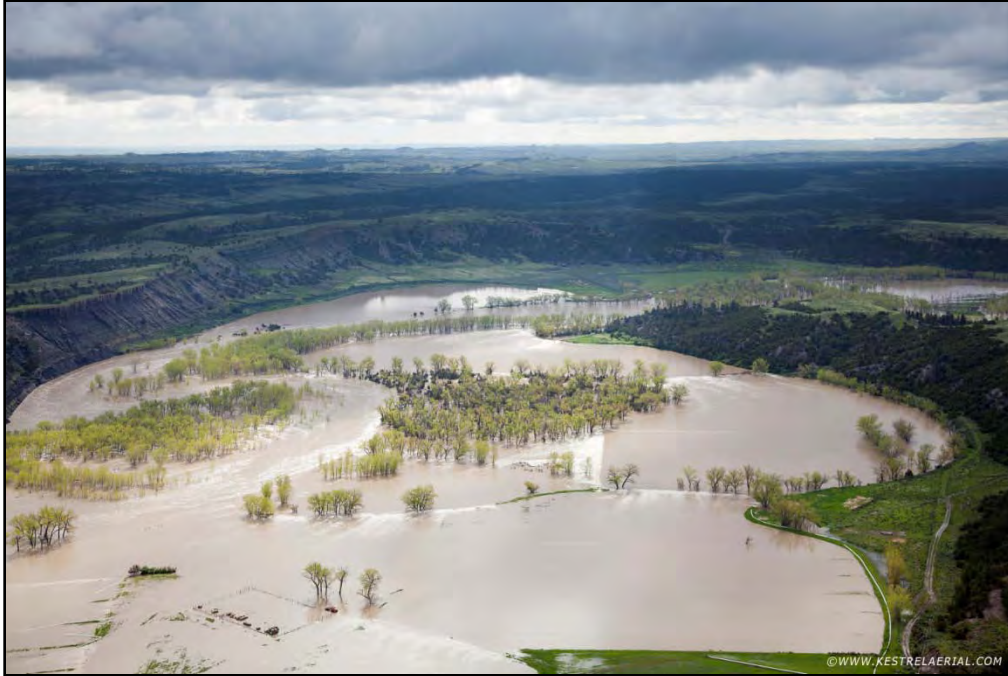
**Figure 19. View upstream at RM 48 below Mosby on May 23, 2011 (©www.kestrelaerial.com).**

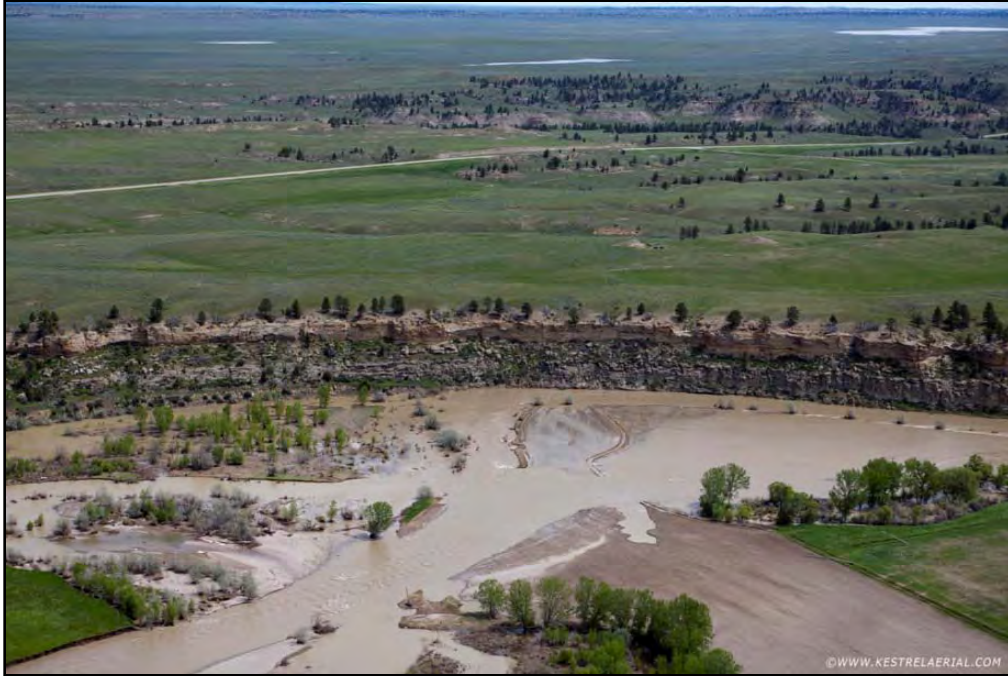
In the upper part of the watershed, the edges of the river valley are fairly erosion resistant due to sandstone outcrops (Figure 23). In lowermost reaches, however, the Bearpaw shale is prone to both erosion by the river and mass failure when it becomes saturated. Hillslope sloughing on the edges of the river valley are common on the lower river where Bearpaw shale is predominant (Figure 24). The geologic conditions create the basic setting for the pre-settlement form and pattern of the River as it traverses the Musselshell River Valley.

**Figure 23. Erosion-resistant sandstone valley wall near Ryegate (RM 239), June 16, 2011.**

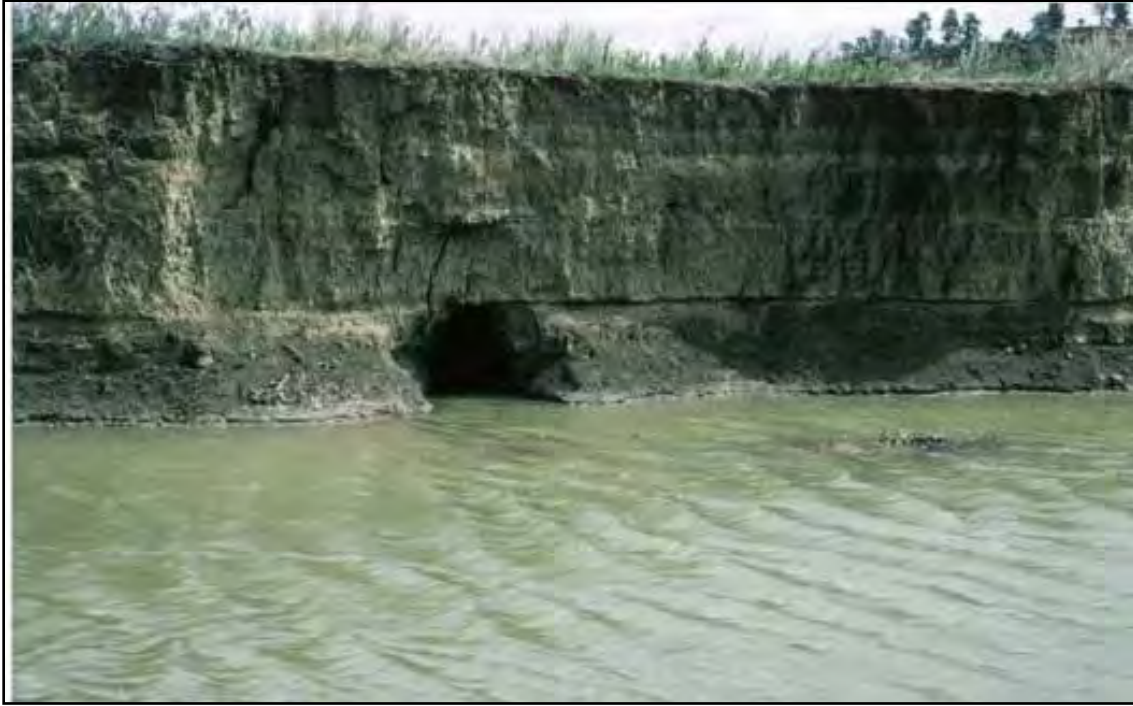
documented. Essentially, the shortening of a meandering river causes that river to steepen. This in turn results in an increase in stream velocities, which causes downcutting in systems where the bed materials are erodible. Downcutting increases bank height and causes an “entrenched” condition where the historic floodplain becomes perched above the channel and thus less accessible by floodwater. The long-term trajectory for these settings is for the entrenched channel to lengthen by eroding the high banks. As the channel meanders in the widening entrenched cross section, it deposits sediment that forms a new “inset” floodplain surface at a lower elevation that can relieve flood energy and support riparian vegetation.

**Figure 29. Photo of ~10 ft bank in entrenched channel segment pre-flood, Musselshell River (Lower Musselshell Conservation District, 2004)**

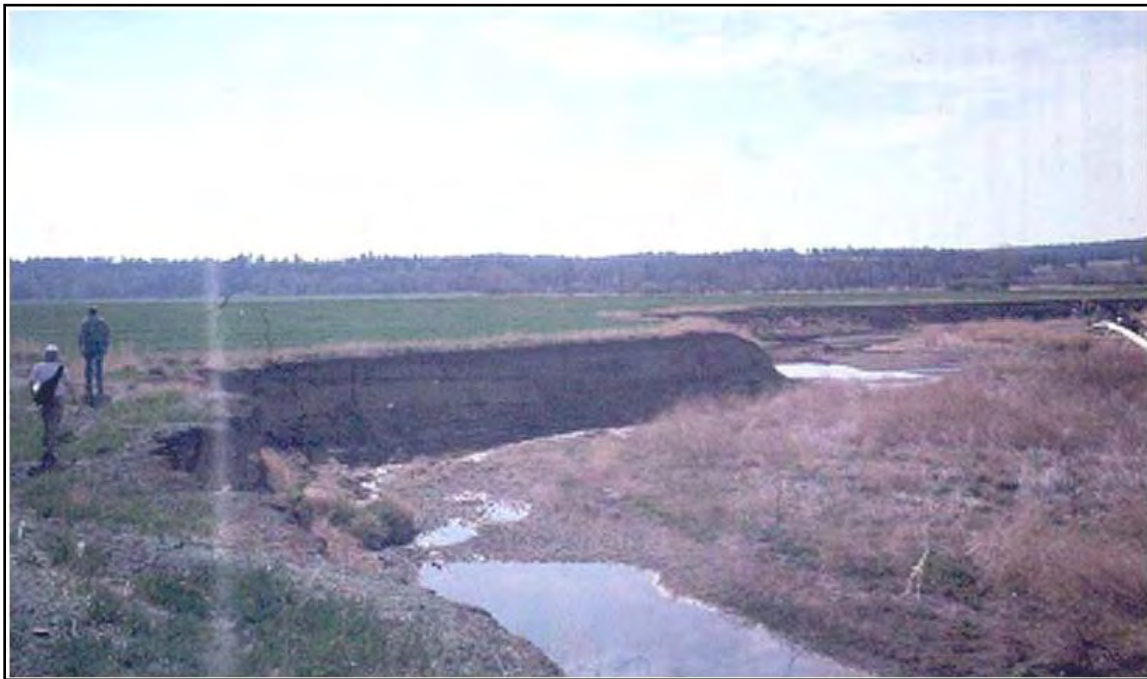
**Figure 30. Pre-flood photo of historic floodplain (left) and inset surface development (right) downstream of Roundup (Lower Musselshell Conservation District, 2004).**

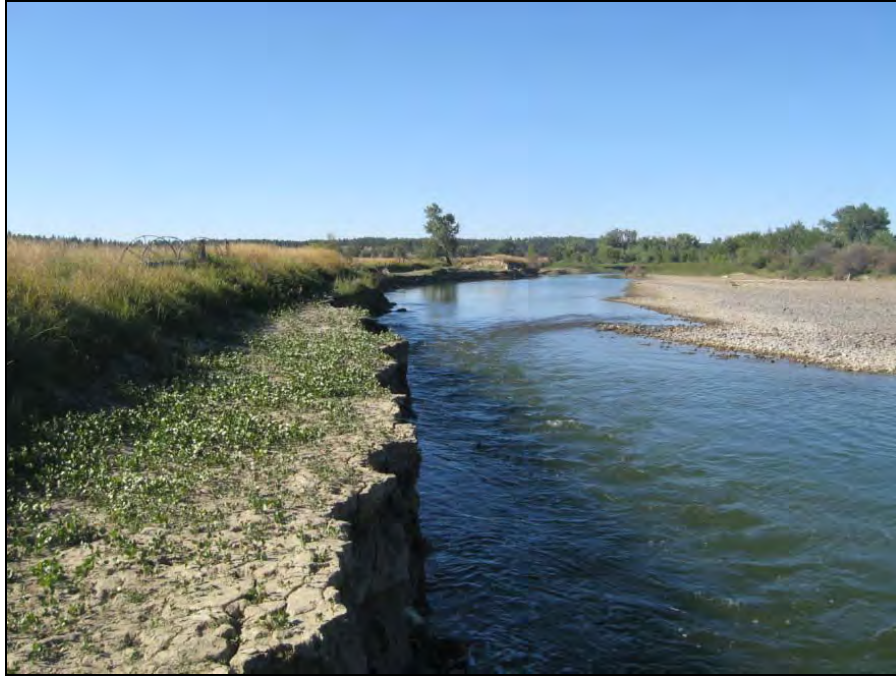
A bank erosion inventory was not performed as part of this analysis, so the quantitative extent of severe bank erosion is not available. However, field observations and cursory air photo analysis indicate that bank erosion was indeed severe throughout the entire project area during the 2011 flood. In upper reaches, bank erosion within the entrenched channel resulted in exposure of vertical high banks and local breaching of the old railroad grade (Figure 43 and Figure 44). Bank erosion often created a low bar on the opposite bank that will establish as an inset floodplain surface. This process of high bank erosion, channel widening, and low inset bar/floodplain surface development appears to have been pervasive in channel segments that were entrenched prior to the flood.

**Figure 44. View upstream of right bank erosion at RM 205; note low gravel bar on right and breached berm in background.**

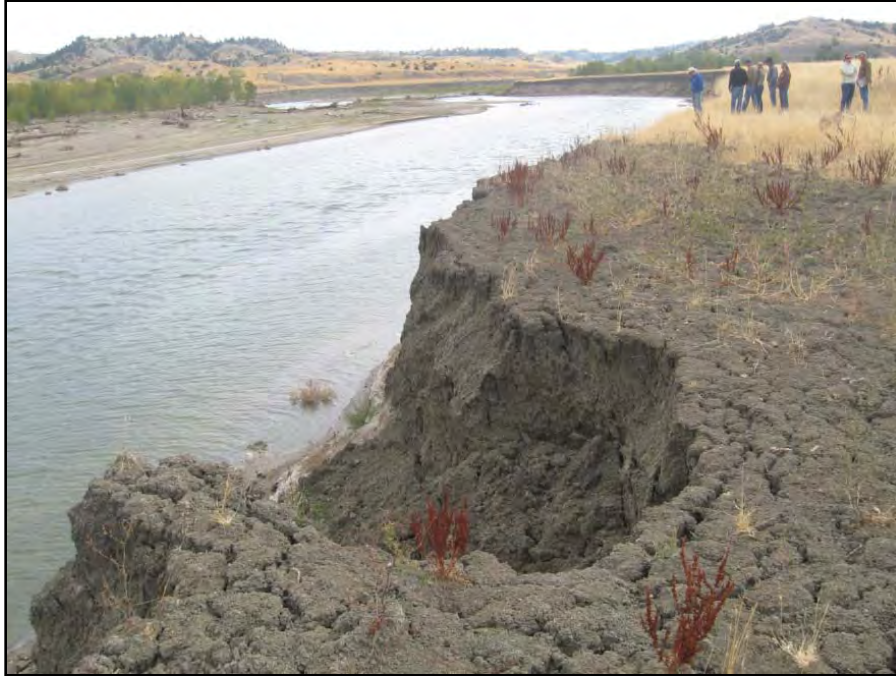
In lower reaches of the river, long duration flooding coupled with massive sediment loading from upstream resulted in extensive bank migration and point bar formation. At River Mile 41, flood-induced bank migration exceeded 850 feet (Figure 45). This consisted of high bank erosion and very large point bar formation on the opposite bank (Figure 46). The material eroded from the high bank consists of fine grained alluvial deposits derived in part from the clay-rich Bearpaw Shale. In places, undermining of this shale in the valley wall has resulted in erosion of the valley margin (Figure 47). Thus bank erosion associated with the flood included not only riverbanks and terraces, but locally the valley wall was undermined and destabilized.

**Figure 46. View upstream of eroding bankline, RM 44.**

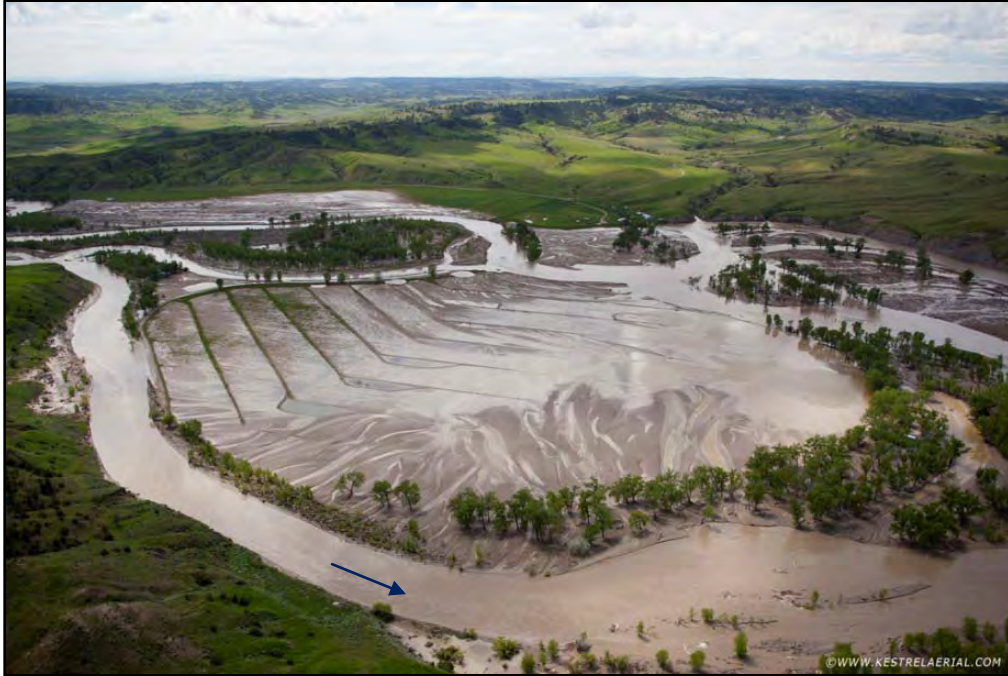
The Musselshell River flood of 2011 transported immense quantities of bedload sediment. Since the flows were out of bank for weeks, much of this sediment accumulated in low energy floodplain environments. The floodplain deposition was most substantial, both with regard to lateral extent and depth, on lower reaches of the river (Figure 60), where hundreds of acres of irrigated fields were buried by up to several feet of sand and finer sediment. Much of the deposition buried agricultural lands, and some recreational properties were affected (Figure 61). In many areas, these sediments have been densely colonized by seedlings of plains cottonwood and several species of willow (Figure 62 through Figure 64).

**Figure 62.** June 16, 2011 photo of sediment deposition on irrigated field, RM 35.5 (©www.kestrelaerial.com).

through Figure 77). In most areas, fields with up to 2 inches of flood sediment may be relatively easily reclaimed for flood and sprinkler irrigation. In these cases we recommend that the fields be cultivated deeply to insure mixing of old and new soil followed by several seasons of planting to a cover crop mix and/or small grain (hay barley). This approach will provide time for freeze and thaw sequences to help break down the clay clods as well as to improve the organic matter and biologic activity in more sandy deposits. After several crops, the soil tilth or workability should be suitable for irrigated hay production. Areas with deeper deposition of sediment will require more intensive forms of restoration to include removal and re-leveling practices.

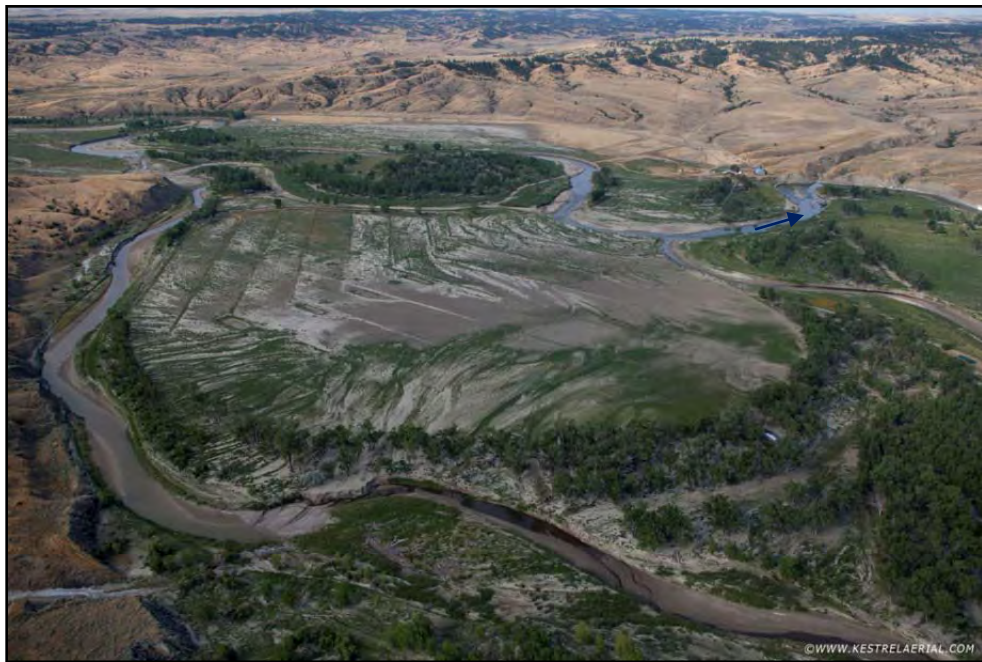
**Figure 63.** September 13 2011 photo of field at RM 35.5 showing cottonwood colonization on new sediment (©www.kestrelaerial.com).

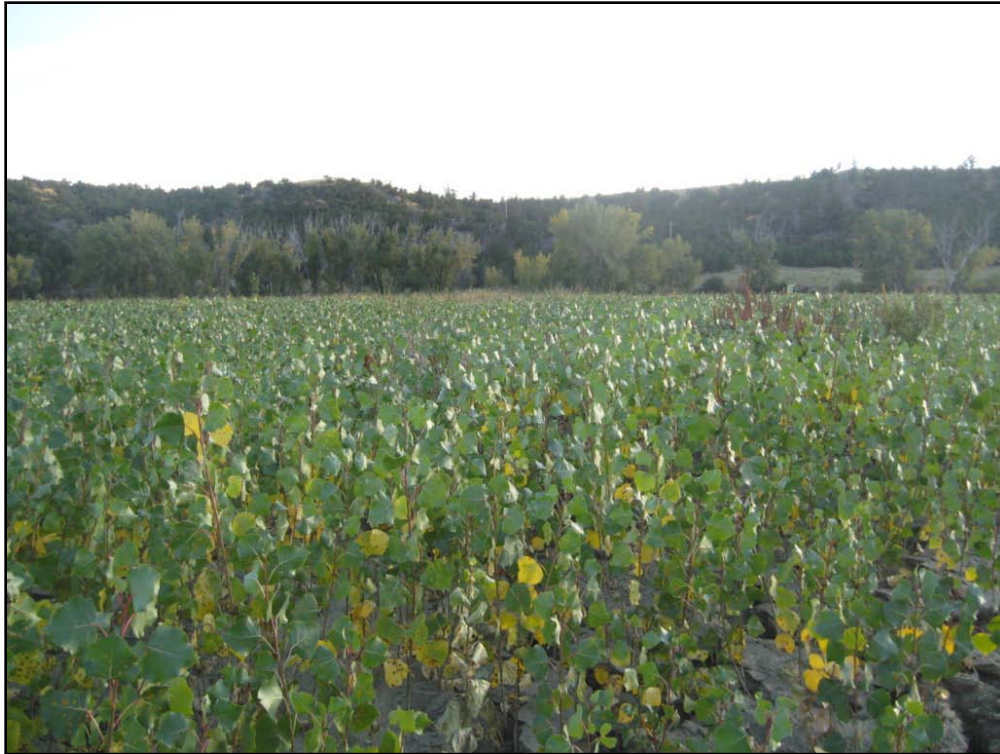
**Figure 64. Cottonwood seedlings on floodplain sediment, RM 50.**

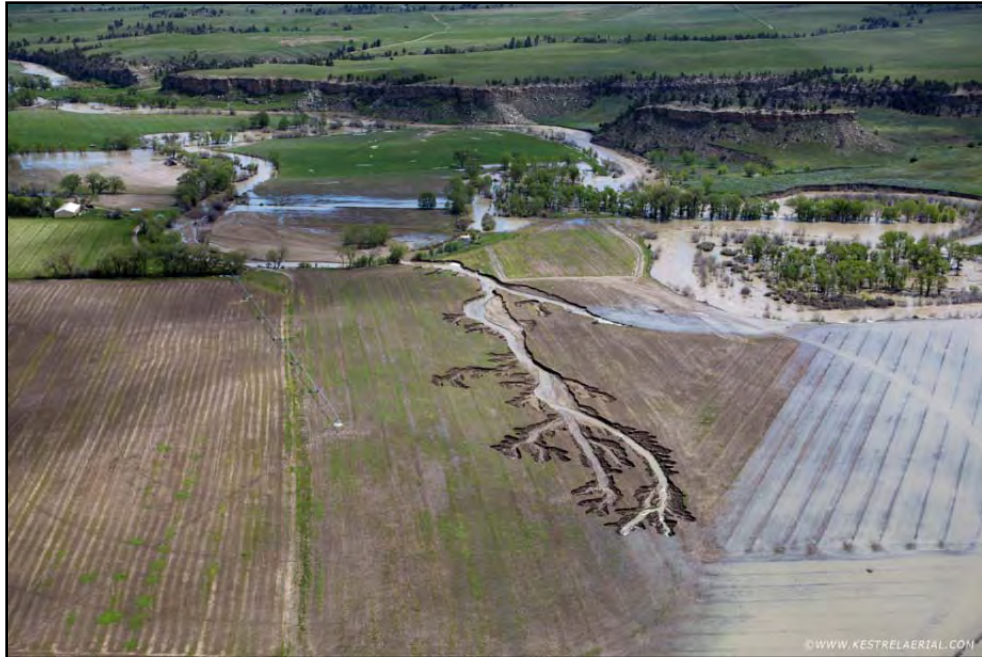
Flood-related erosion of the river's floodplain generally consisted of avulsions (Section 6.3.2), as well as channelized flow that did not develop into avulsions and local scour holes created by floodplain dike breaches (Figure 65 and Figure 66). Although these features are fairly small relative to other impacts, dozens of small headcuts formed across the floodplain that channelized flows and drove local scour. These features disrupt agricultural land use practices throughout the corridor (Figure 67).

**Figure 65. Floodplain erosion, RM 244 downstream of Ryegate (©www.kestrelaerial.com).**

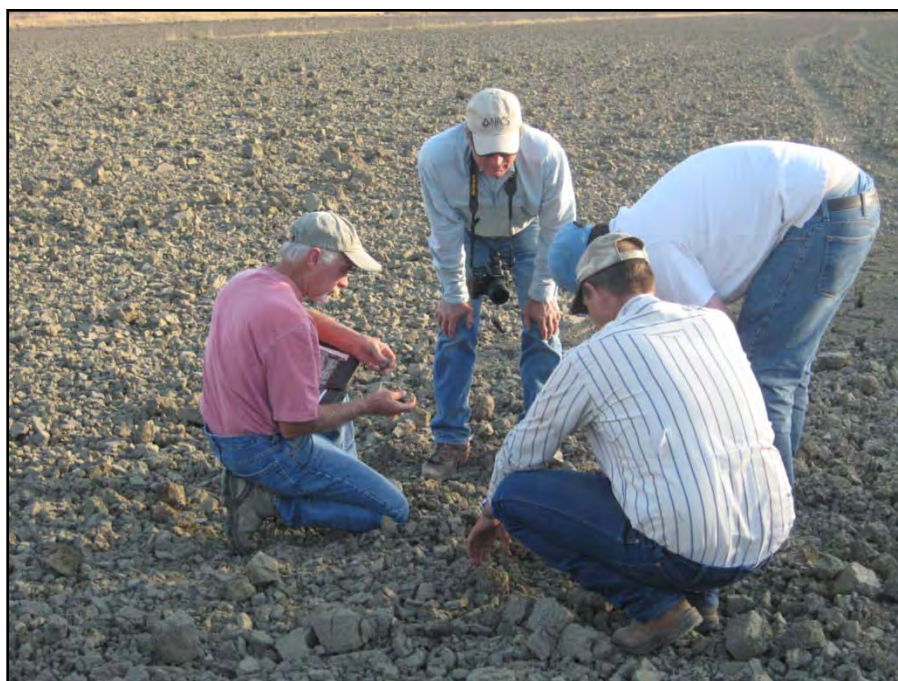
**Figure 77. RATT team evaluation of recently tilled blocky floodplain sediment, RM 26.**

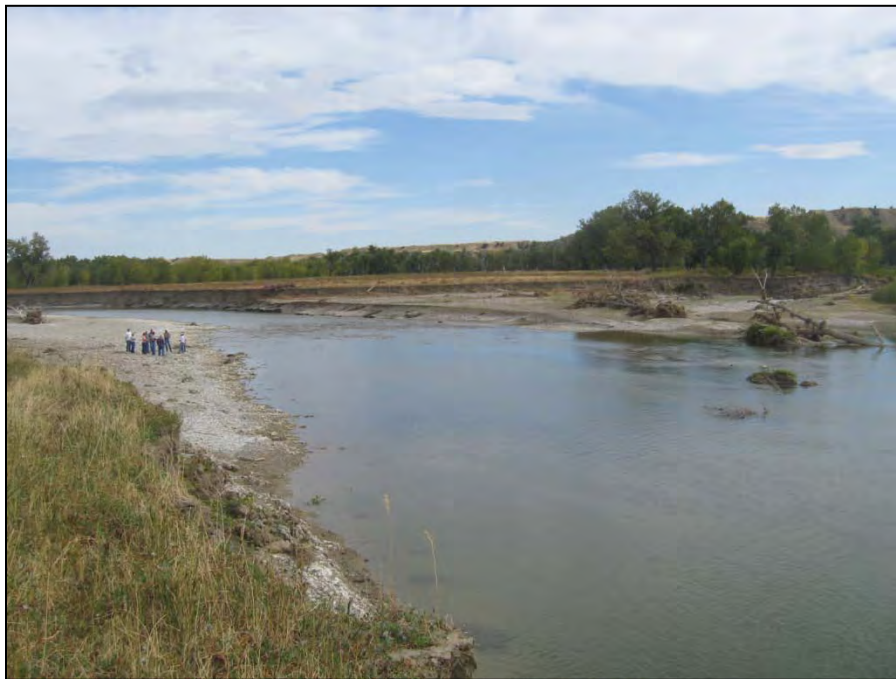
In many cases, avulsions destroyed access to irrigated fields, and regaining that access is critically important to producers. Constructing berms across avulsions to regain access is described in Section 7.1. When access is needed across the channel, low flow vehicle crossings were considered, specifically with regard to their location and construction. Crossings were sited at several locations to minimize the need to armor unstable banks, grade slopes, or import coarse material into the riverbed (Figure 79). Crossings were proposed where there was little evidence of recent channel movement.

**Figure 79. View downstream of proposed low flow crossing site, RM 65.**

Where necessary, river access ramps should be graded at a 10:1 slope, and surfaced with pit run gravel. The recommended crossing sites are shallow riffles where some existing gravels are already in place. Additional pit run may be necessary to supplement that bed material. When gravel is brought in to harden the channel bottom, the grade of the river needs to be maintained at a consistent grade above, across, and below the crossing.

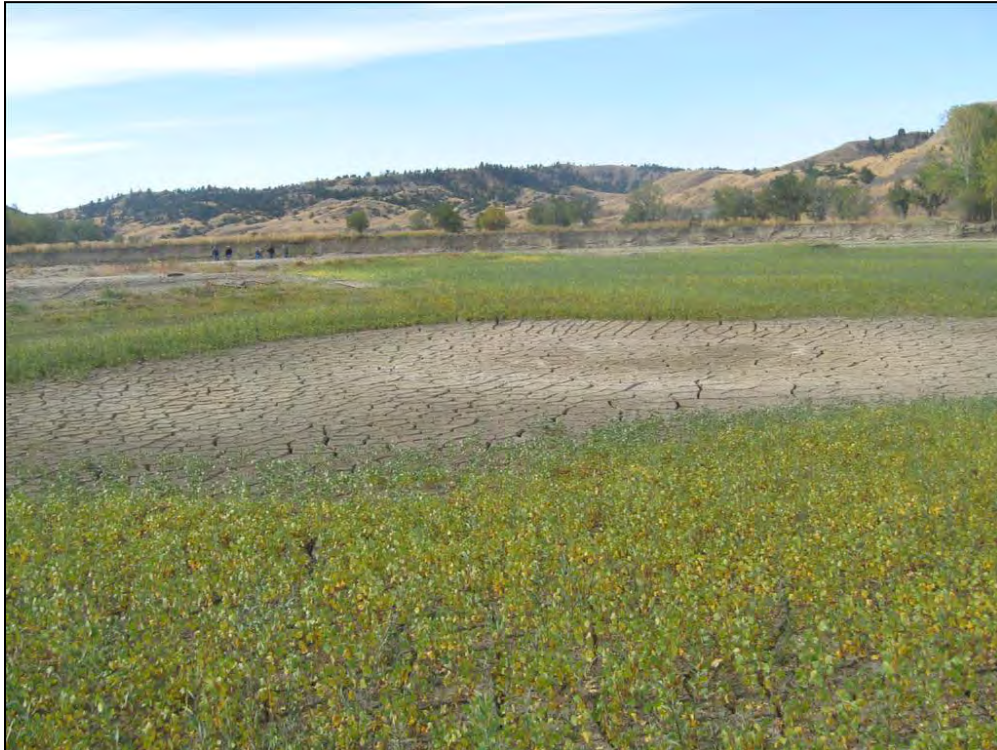
Figure 82. Cottonwood seedlings at RM 27.5; note RATT team in distance for scale.
