# ***Floodplain Dikes/Berms***

This summary of recommended Best Management Practices (BMPs) for placing, repairing, or removing floodplain dikes has been developed to support the long-term functionality of the Musselshell River floodplain while protecting infrastructure as necessary. The recommendations are based upon field site reviews and discussions with local stakeholders, and are intended for producers and residents who currently farm or maintain infrastructure in areas prone to flooding. In general however, manipulation of the Musselshell River floodplain is strongly discouraged due to the role of the floodplain in dissipating flood energy and contributing to river stability.

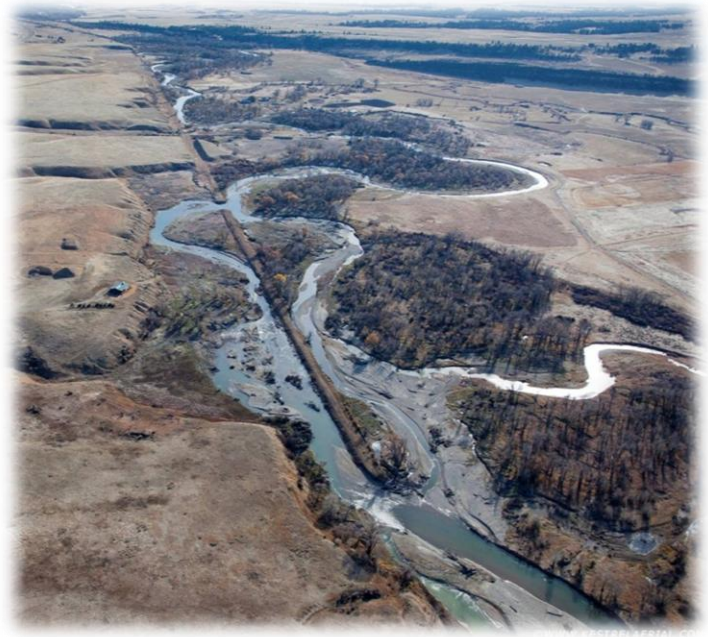
**Figure 1. View to east of railroad dike breached during 2011 flood.**

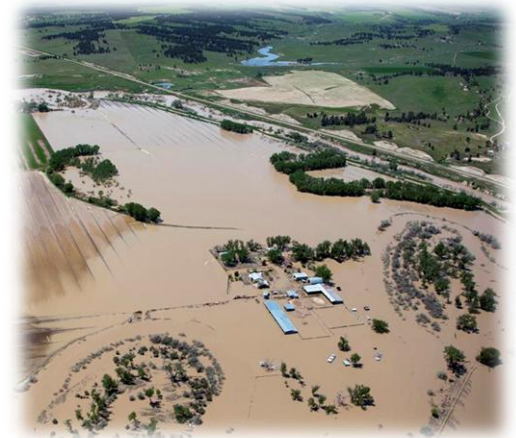
Figure 2. Flooding of floodplain structures on Musselshell River during 2011 flood

**a. Protection of Infrastructure:** Extensive flooding in 2011 resulted in significant property damage due to inundation of residences and outbuildings. Homeowners in the floodplain have expressed an interest in constructing berms to protect their existing homes or outbuildings from future floods. But by building berms, more floodplain becomes isolated, which will reduce the ability of the floodplain to dissipate flood energy in the future. Berms concentrate flows in the channel, which can increase bank erosion rates and drive downcutting or channel widening. Infrastructure-protection berms should therefore have a footprint that is as small as possible to limit the impact on floodplain and channel function. Adjacent to homes, berms can be constructed as topographically subtle, landscape features that are placed close to the buildings of concern. To minimize overall impacts, new construction should be located outside of the river floodplain. Consideration should be given to moving corrals, outbuildings, homes and other structures if possible away from the river's edge and floodplain or to areas higher in the floodplain to eliminate or reduce the size of berm needed to protect the structure. Berms should be placed without the need for riprap.

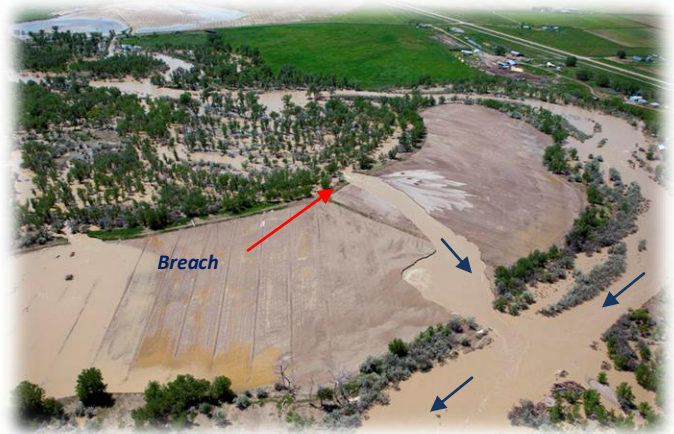
Figure 2. Breached berm and eroded field.

**b. Protection of Agricultural Land:** Agriculture-related berms constructed as spreader dikes, elevated ditches, or access roads can also affect floodplain access. The 2011 flood showed that in some cases, these floodplain berms caused severe local erosion problems, and exacerbated flooding. Numerous berms served as floodplain dams that backed water upstream, causing floodplain deposition on fields. When the berms were overtopped and breached, flows were focused through the breaches, driving field erosion downstream. Field berms on the floodplain should be constructed as low as possible, to allow floodwaters to continue down valley as shallow

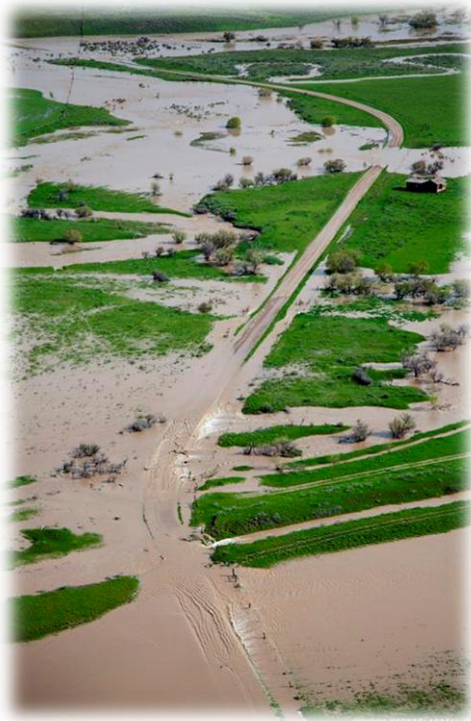
**Figure 4. Road prism forming floodplain dike/dam during 2011 flood.**

- c. Road Prisms:** Similar to agricultural berms, road prisms serve or function as floodplain dikes that commonly impound water on the floodplain and focus erosive flows through breaches. Since roads also provide access, road prism design requires balancing access during high water and floodplain function. At Harvey Road for example, the reconstructed road approach is pierced by high flow culverts that will reduce the damming effect of the road prism. Constructing roads that minimize the impoundment of water on the floodplain will allow water to drain down-valley and reduce the severity and duration of flooding, while also reducing the depth and velocity of water flowing down the main river channel.

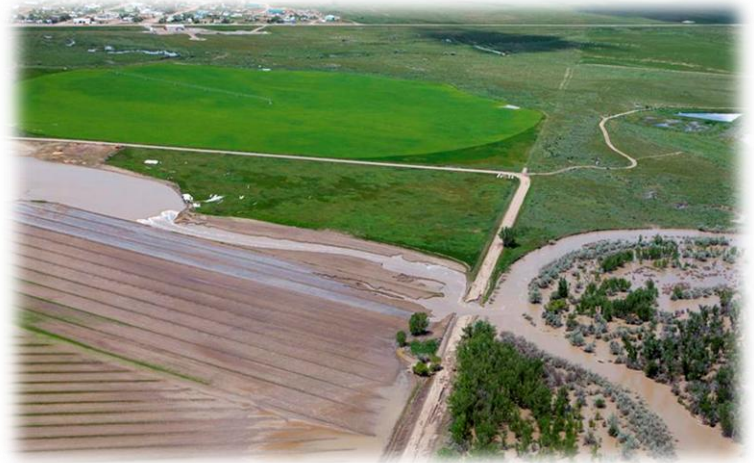
**Figure 3. Breached road prism and upstream erosion.**

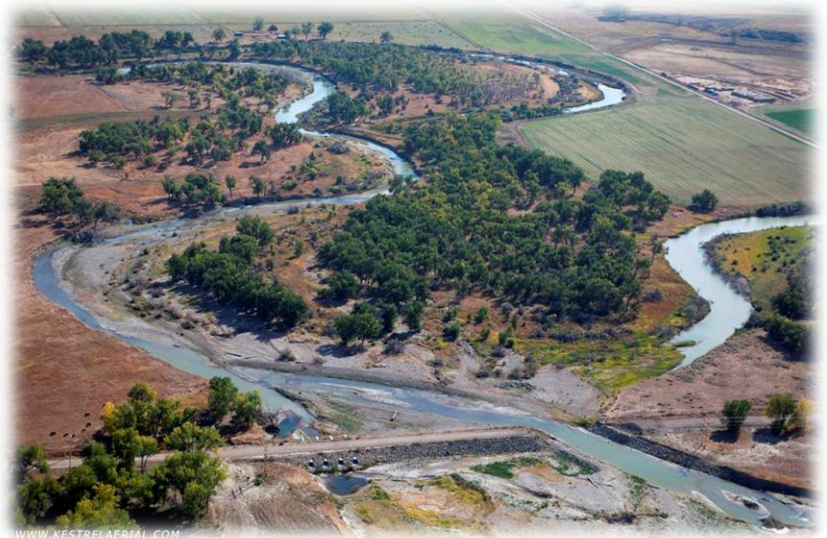
**Figure 5. View downstream of Harvey Road Bridge site showing newly constructed high flow culverts to left of channel.**

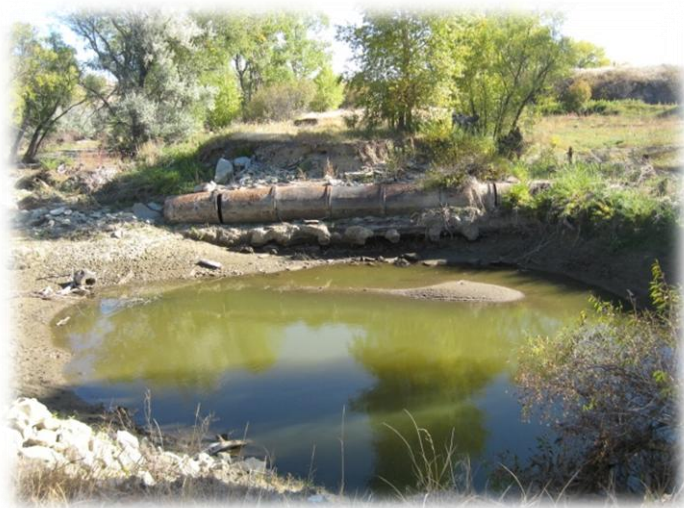
**Figure 9. Railroad berm breach where flows overtopped from the backside of the berm. Photo credit: Karin Boyd.**

Many producers have plugged or reconstructed damaged berms to restore the function of the berm, be it road access, flood control, or irrigation management. With most low berms on agricultural fields, the hydrologic impact of these repairs is low. However, with larger berms, road crossings, or especially the railroad berm, repairs will re-isolate large floodplain areas. Whether or not the breaches are plugged should consider the overall need for the project, other breach locations and floodplain drainage patterns. Where berms overtopped from the landward side for example, flows were returning to the stream corridor over the berm because there was no better relief valve. In these areas especially, maintaining an overflow return point through the breach will reduce the risk of overbank flows becoming trapped on the floodplain and possibly damaging areas normally outside of the floodplain. These breaches can be reinforced as swales that still allow transportation access, and can be hardened as necessary to prevent erosion or headcutting.

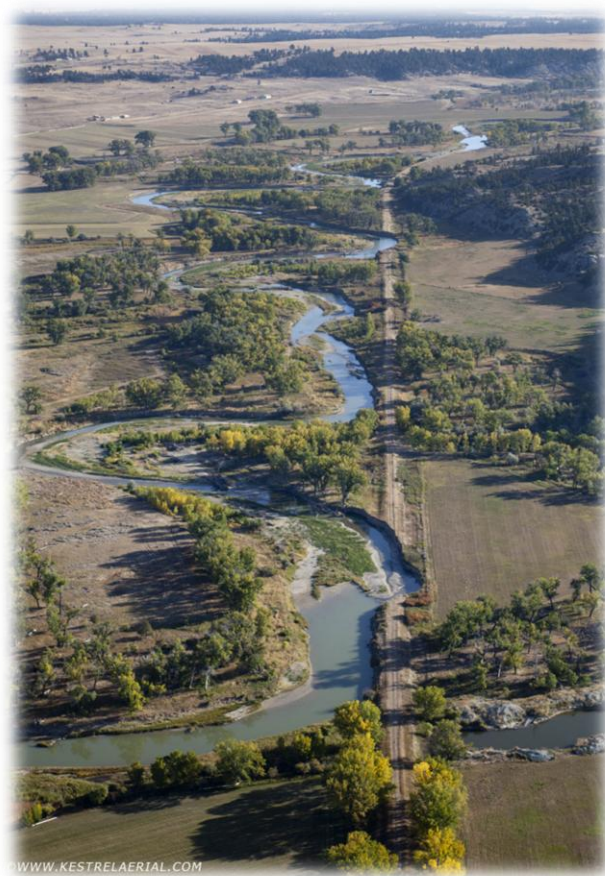
**Figure 8. View down-valley of multiple breaches; downstream breach serves as return flow point.**

grade is an un-maintained, discontinuous floodplain berm that runs largely parallel to the river corridor upstream of Melstone. As the berm continues to naturally breach and decay, it will become an increasingly severe liability to corridor residents and agricultural producers. Relying on an unmaintained, locally breached berm as a de-facto flood protection measure is a poor long-term
